APPENDIX K

Reach Summaries

Township of King
Comprehensive Stormwater Management Plan
Reach Delineation, Crossing and Extent Assessed
Figure K-1: Ansnorveldt

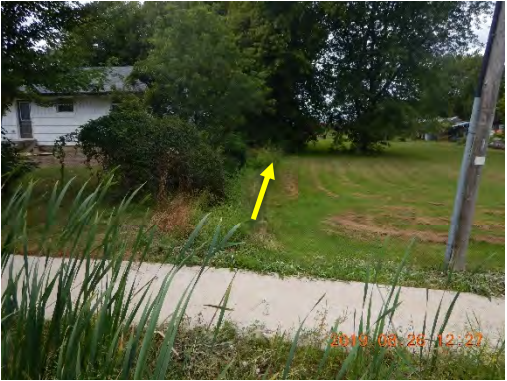
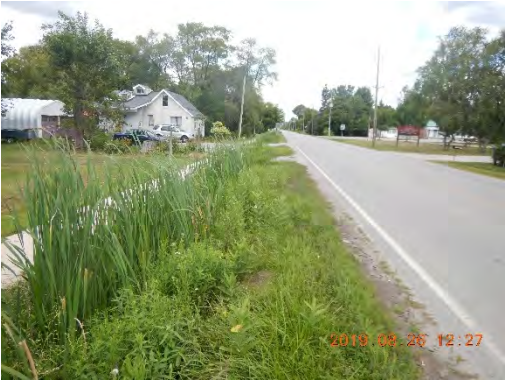
Photograph facing downstream of Reach WHA1-1 . The reach was a straightened ditch that flowed between two agricultural fields.		Reach WHA1-1a was a roadside ditch on the west side of Dufferin Street.

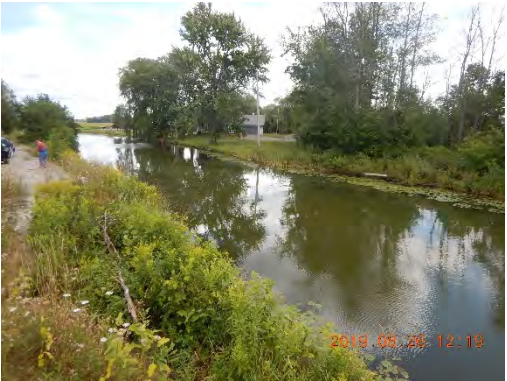
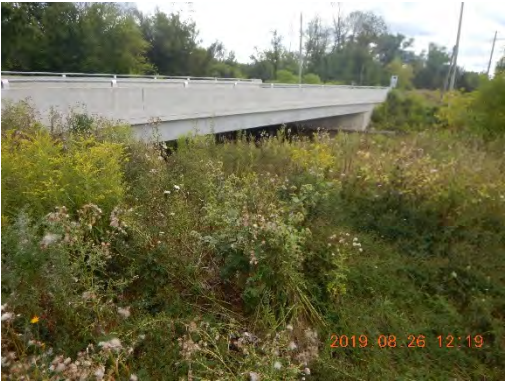
Downstream of Dufferin St. Note the exposed roots along the bank of the manicured lawn.		Upstream extent of bridge. The bridge was built in 2014.

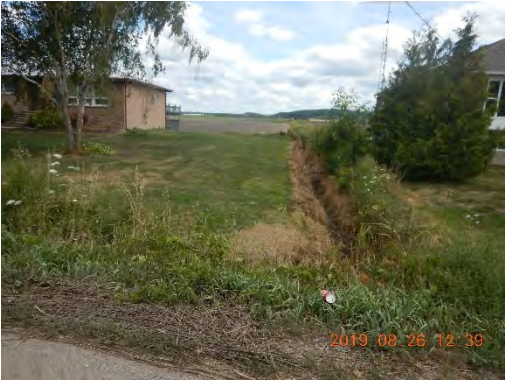
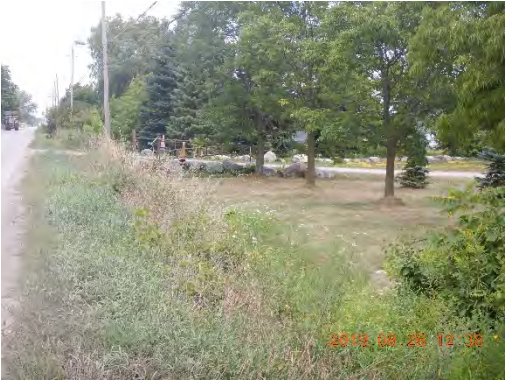
Photograph facing downstream of Reach WHA2-1 . The reach was a straightened ditch that flowed between two agricultural fields.		Reach WHA2-1a was a roadside ditch on the east side of Dufferin Street.

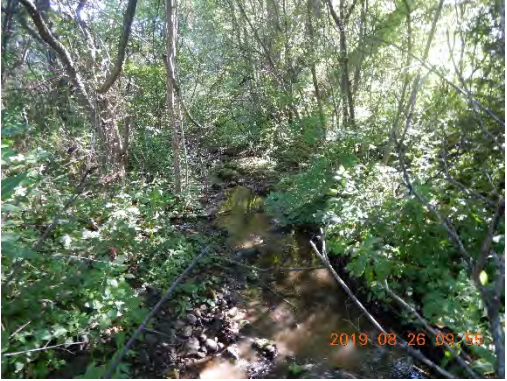
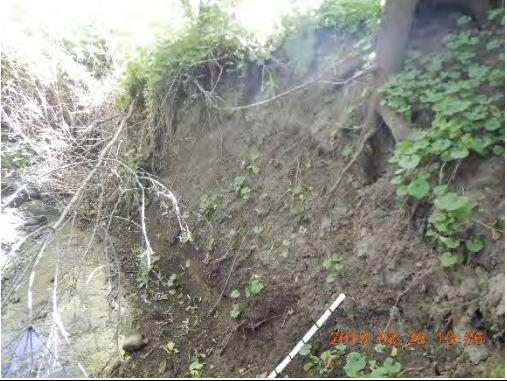
Valley wall contact along the reach near the downstream extent.		Photograph taken facing downstream towards confluence with reach WHK1 .

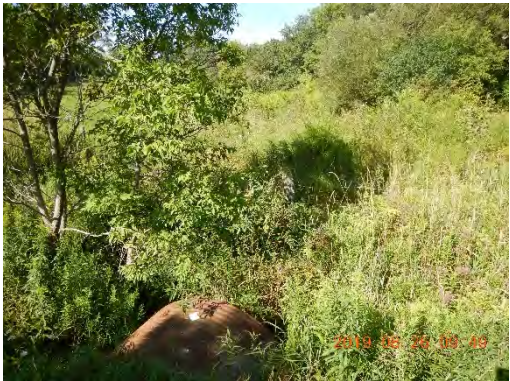
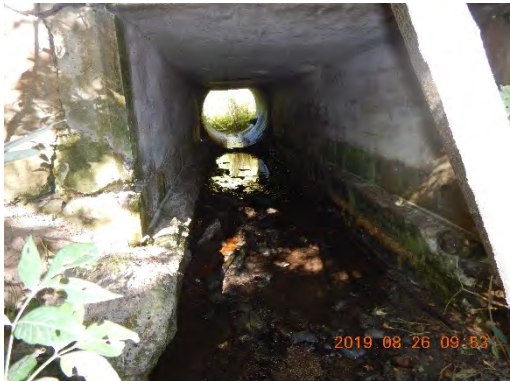
Photograph taken facing upstream from Kettleby Road.		Photograph taken facing upstream within the crossing. The CSP at the upstream end was attached to the box culvert.

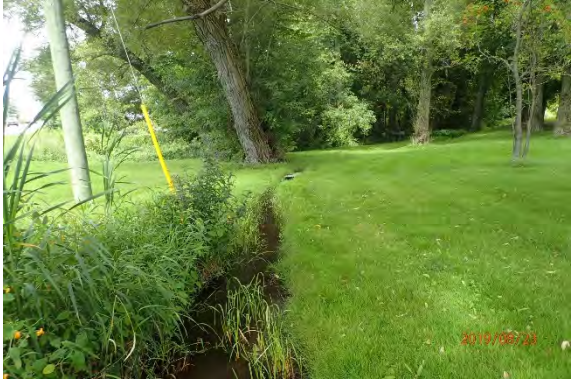
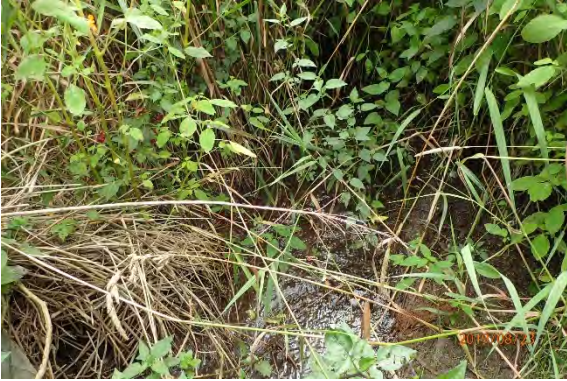
The downstream extent of the crossing flowed through a residential property with a manicured lawn. The reach was narrower downstream.		Upstream of Jane Street. The channel was less defined but wider than the downstream extent.

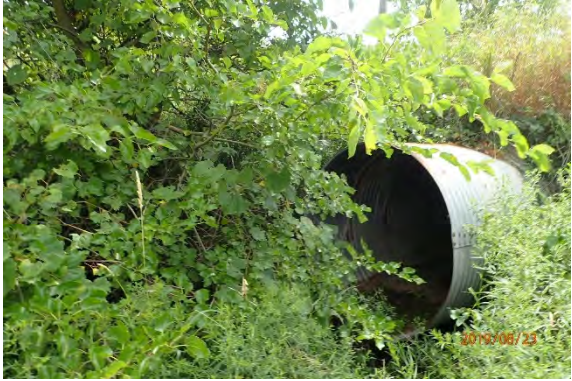
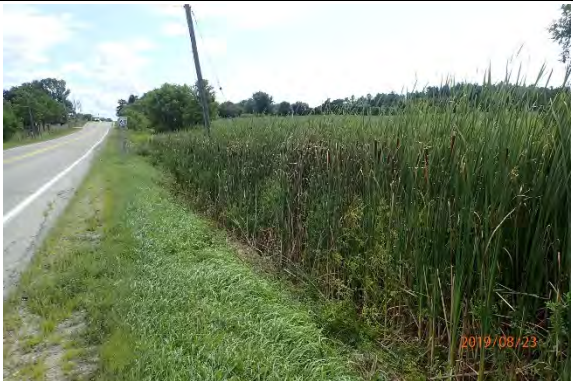
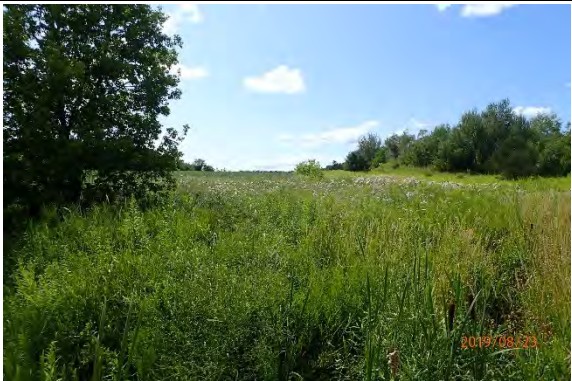
Location: Jane Street, Kettleby	Watershed: West Holland River	Type of Assessment: Roadside
Valley Type: Unconfined	Land use: Agricultural	Riparian Coverage: Continuous grasses and herbaceous vegetation
Bankfull Width (m): 1.20	Bankfull Depth (m): 0.20	Bed Substrate: Silt and gravel
RGA Score: N/A	RGA Condition: N/A	RGA Dominant Process: N/A
RSAT Score: N/A	RSAT Condition: N/A	RSAT Limiting Feature: N/A
Down's Channel Evolution: 'S' – stable	Notes: Roadside assessment at Jane Street. Channel flows into pond. Downstream of the road, the CSP was perched from the channel bed.

A wetland feature with no defined channel was observed upstream of the crossing.		Photograph facing upstream towards an agricultural field from where the reach originates.

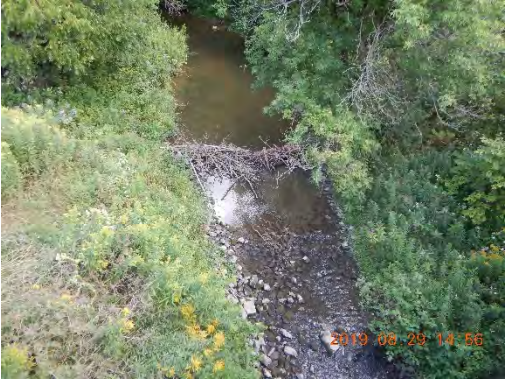
<p>Photograph facing upstream of Jane Street. Note beaver dam and a riffle sequence flowed under the bridge.</p>		<p>Photograph facing downstream of Jane Street. There was a pool upstream of the bridge with some siltation.</p>

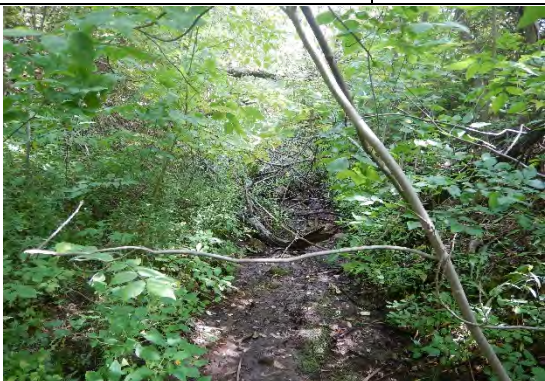
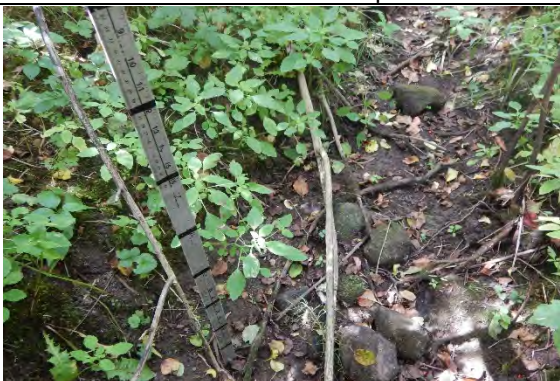
Photograph taken facing upstream from Jane Street culvert. Fairly straight channel was moderately entrenched.		No riffle-pool features were present. Bed material ranged from sand to cobbles.

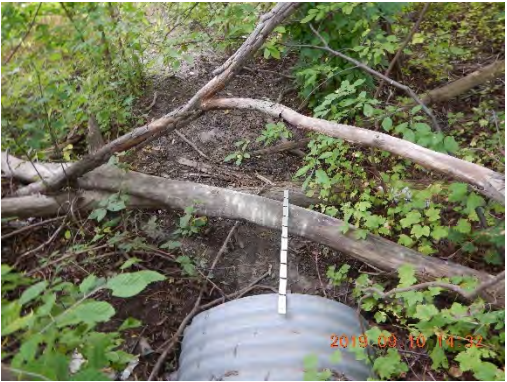
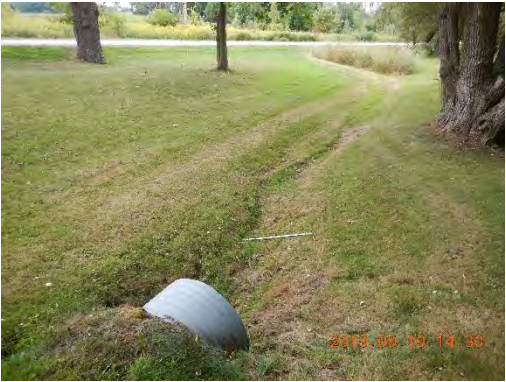
Reach HK1-2a downstream of Westgate Boulevard. There was poor bank definition.		Reach HK1-2a upstream of Westgate Boulevard. The channel flowed through a manicured lawn from Jane Street.

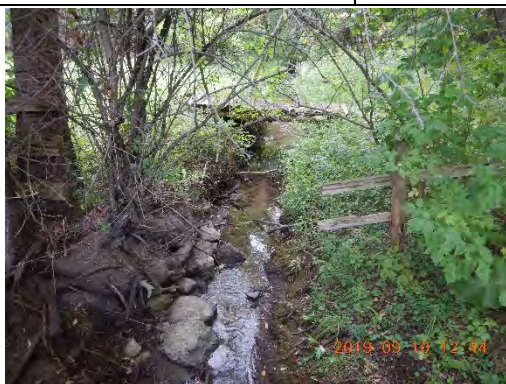
Photograph looking downstream from Martin Street. Bank erosion observed downstream.

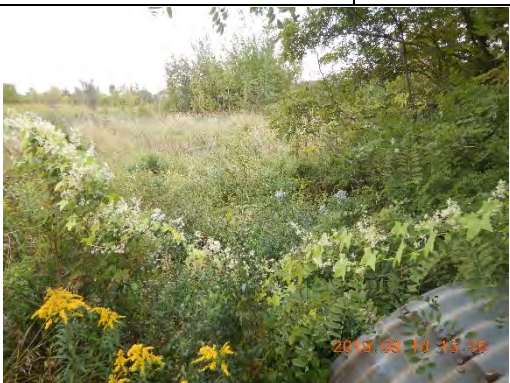
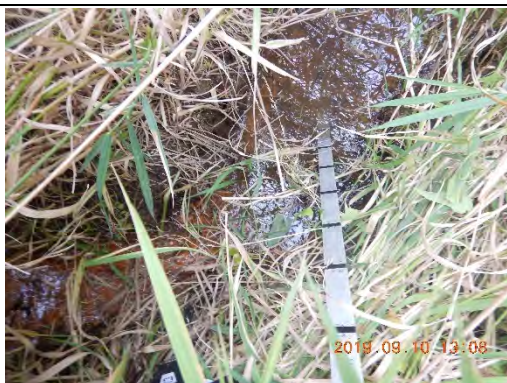
Photograph taken facing upstream from King Road.		Iron staining within the small defined channel was noted only at the downstream extent by King Road.

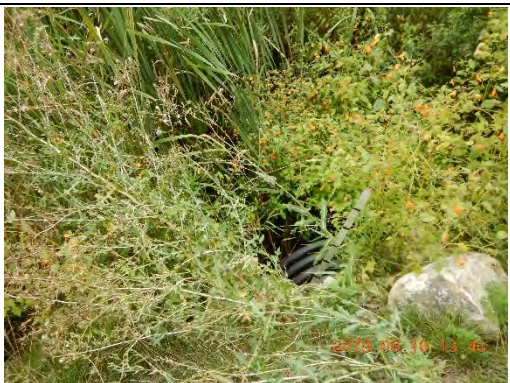
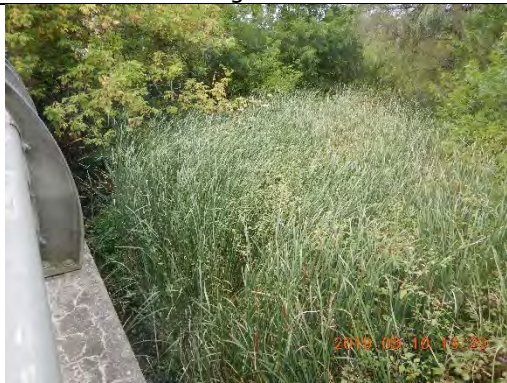
Corrugated plastic pipe at a trail crossing. A wetland feature was present upstream and downstream of the trail crossing.		The wetland feature with no defined channel continued downstream of Station Street.

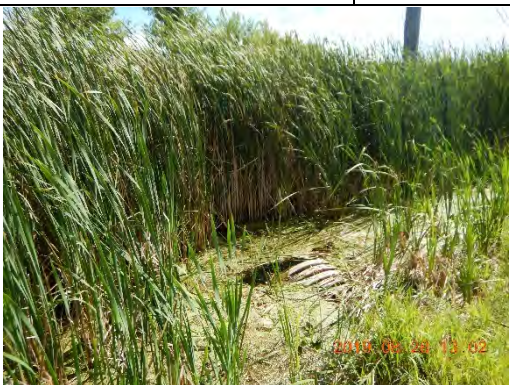
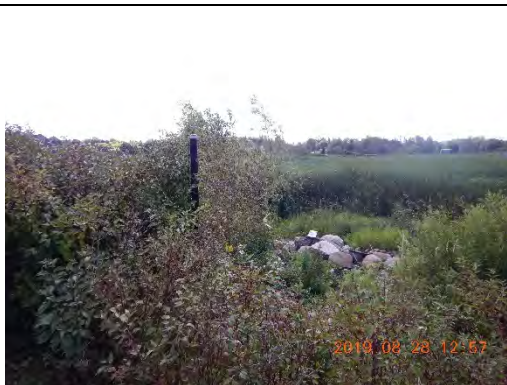
Upstream of Keele Street the CSP was almost completely submerged. The reach was full of cattails.		View of the reach from trail by stormwater management pond.

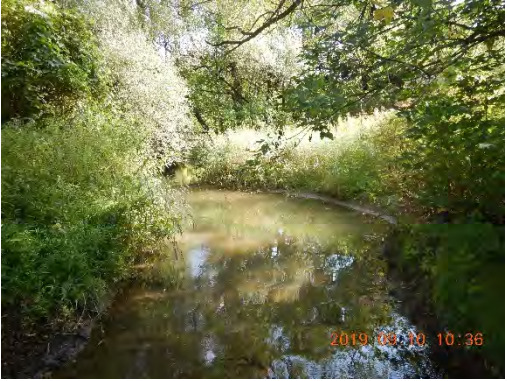
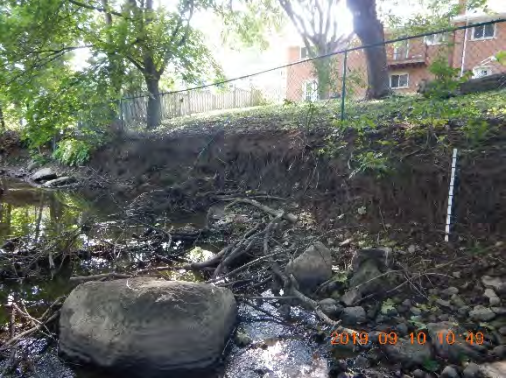
Location: Norman Drive and Keele Street, King City	Watershed: Humber River	Type of Assessment: Full reach
Valley Type: Partially confined	Land use: Park and residential	Riparian Coverage: Fragmented trees and grasses
Bankfull Width (m): 4.55	Bankfull Depth (m): 0.79	Bed Substrate: Clay, silt, sand, gravel, cobble, boulder, and till
RGA Score: 0.20	RGA Condition: In regime	RGA Dominant Process: Evidence and Widening
RSAT Score: 27	RSAT Condition: Good	RSAT Limiting Feature: Riparian Habitat Conditions
Down's Channel Evolution: 'M' – lateral migration	Notes: Observations include exposed roots, leaning trees and fences, chutes, leaning fence, old gabion basket intact, and siltation in pools. Erosion concerns at this reach.

Photograph taken facing erosion along the left bank and leaning fence at the back of a residential property.		Photograph taken facing upstream towards Keele Street crossing.

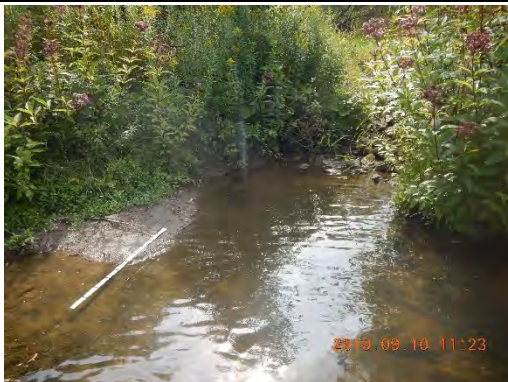
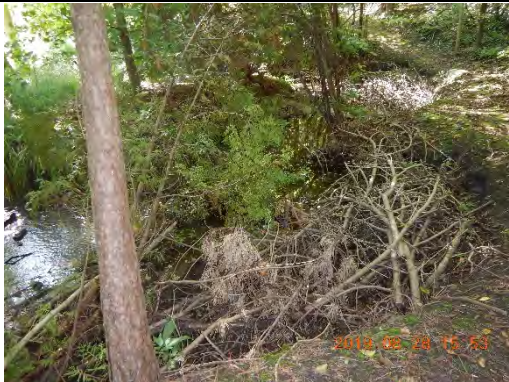
Location: Denison Street and East Humber Drive, King City	Watershed: Humber River	Type of Assessment: Partial reach
Valley Type: Partially confined	Land use: Residential	Riparian Coverage: Fragmented trees
Bankfull Width (m): 2.60	Bankfull Depth (m): 0.45	Bed Substrate: Clay, silt, sand, gravel, cobble, and exposed till
RGA Score: 0.20	RGA Condition: In Regime	RGA Dominant Process: Evidence of Widening
RSAT Score: 27	RSAT Condition: Good	RSAT Limiting Feature: Channel stability
Down's Channel Evolution: 'S' – stable	Notes: Reach becomes more confined downstream. Observations include valley wall contacts, a cutoff channel, and fallen and leaning trees.

Confluence of reach HK4-1 and into HK4 .		Creek eroding into trail. Someone has placed woody debris for bank protection.

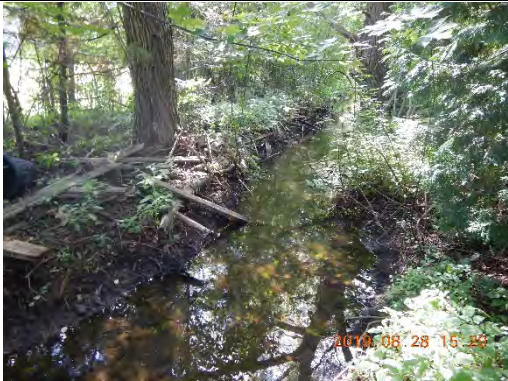
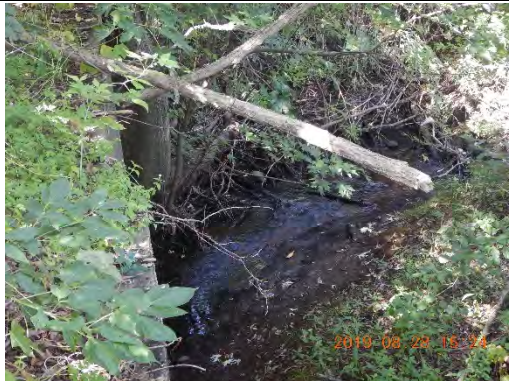
Photograph taken facing downstream, just downstream of Dennison Street. Reach followed closely to the back of residential homes. Note poor-riffle development.		Upstream of Dennison Street. There were three box culverts at Dennison Street. Manicured lawns to the top of bank were observed upstream of the crossing.

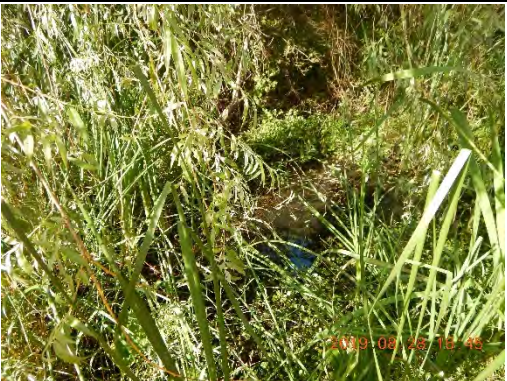
Downstream of Lockhart Lane. The CPP was submerged.		Wetland feature upstream of Lockhart Lane.

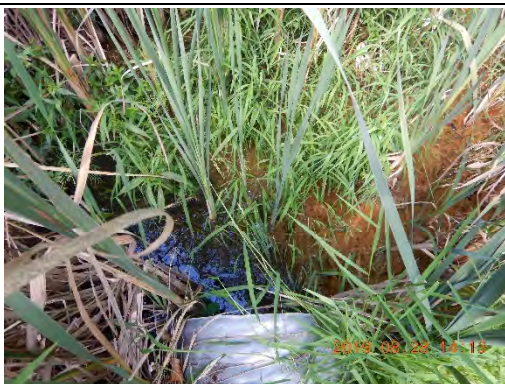
Reach **HK6-2b** was upstream of the 15th Sideroad. Iron staining was observed indicating the presence of groundwater.

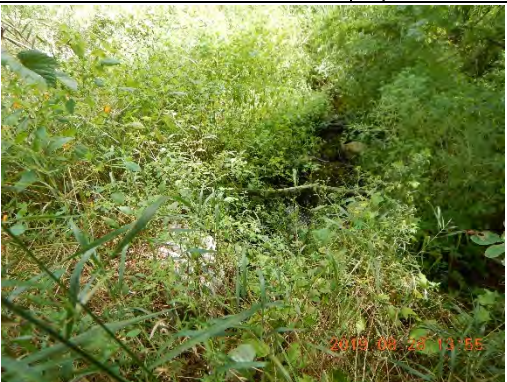
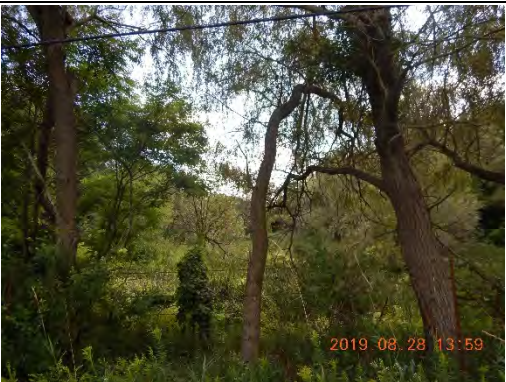
CSP downstream of reach HK6-3 . The reach was defined immediately downstream of the CSP and there was a scour pool present.		Cattails further downstream of reach HK6-3 , which was only present in aerial images as there was no access past the road.

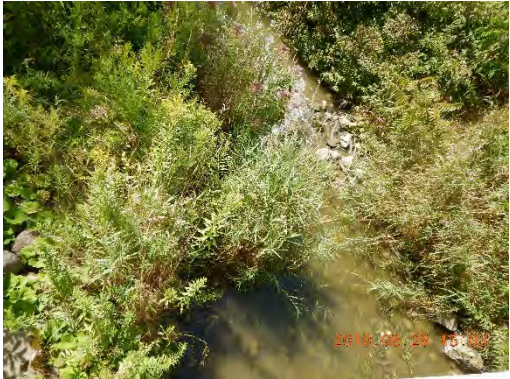
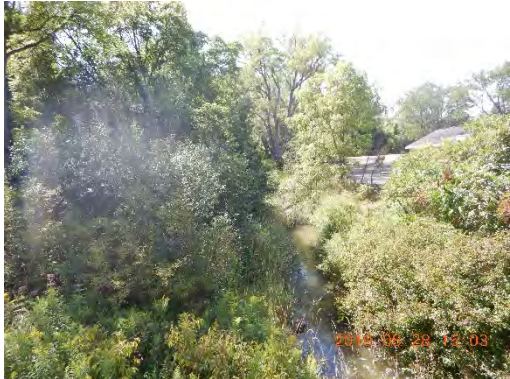
View downstream of Dufferin Street. Rip rap was observed in riffle.		Photograph taken facing downstream of Dufferin Street.

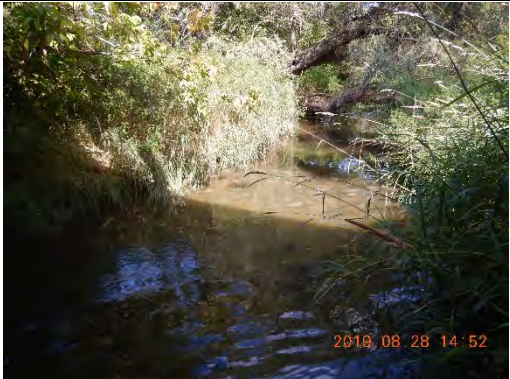
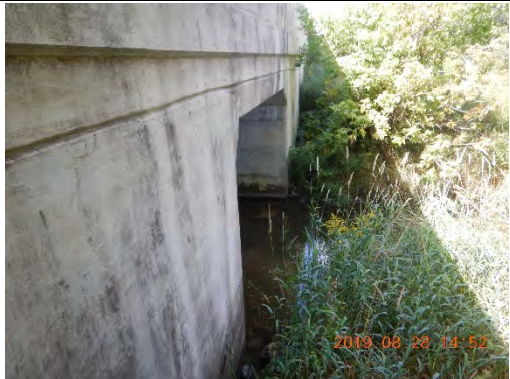
Upstream of Dufferin Street. Fallen tree and manicured lawn were observed.		Upstream of Dufferin Street. No exposed bridge footings.
