Reach WHSL6

Location: Church Street, Lloydtown	Watershed: Humber River	Type of Assessment: Roadside
Valley Type: Unconfined	Land use: Residential	Riparian Coverage: Fragmented trees and grasses
Bankfull Width (m): 5.75	Bankfull Depth (m): 1.08	Bed Substrate: Clay, silt, and sand
RGA Score: N/A	RGA Condition: N/A	RGA Dominant Process: N/A
RSAT Score: N/A	RSAT Condition: N/A	RSAT Limiting Feature: N/A
Down's Channel Evolution: N/A	Notes: Roadside assessment at Church Street and Centre Street. Soft sediment accumulation from downstream pond. No erosion concerns visible from either road crossing.

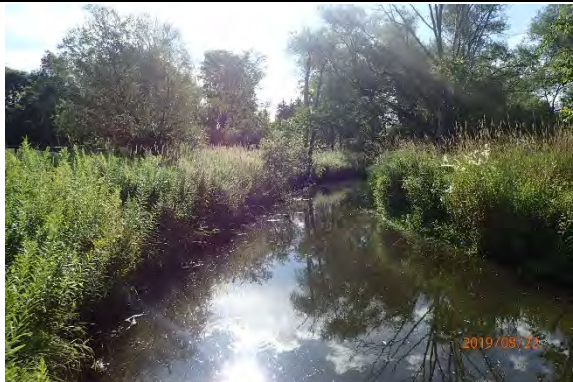
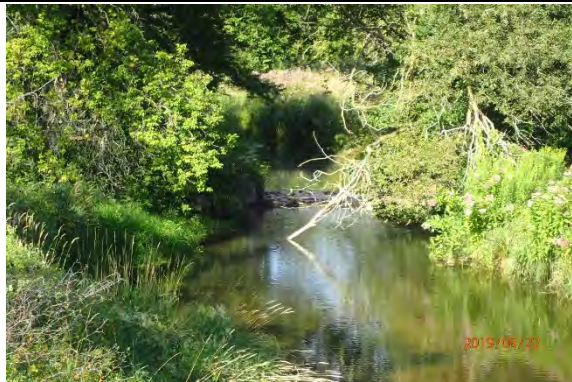
Downstream of Church Street. No riffles were at the downstream extent of the reach.	Upstream of Church Street there was a weir structure adjacent to a residential home.

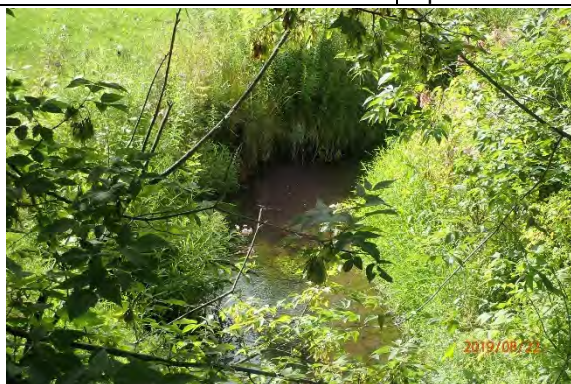
Undercutting visible from crossing upstream of Centre Street.

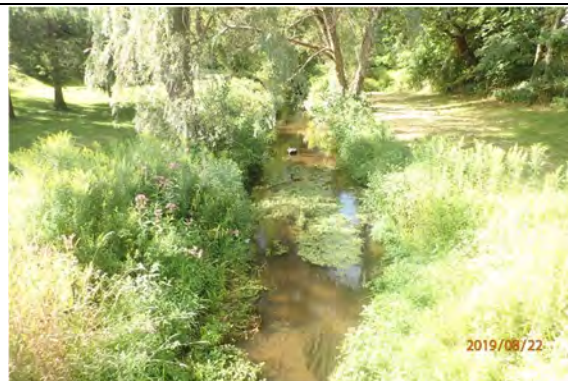
Sedimentation and pooling upstream of the crossing that was caused by the weir structure downstream of Rebellion Way.

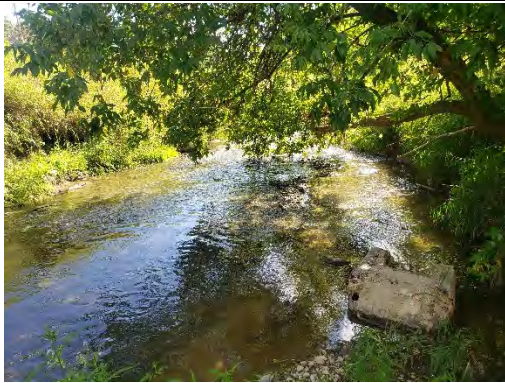
Photograph looking downstream of the bridge at a riffle sequence. Riffles consisted of sand, gravel, and cobble.

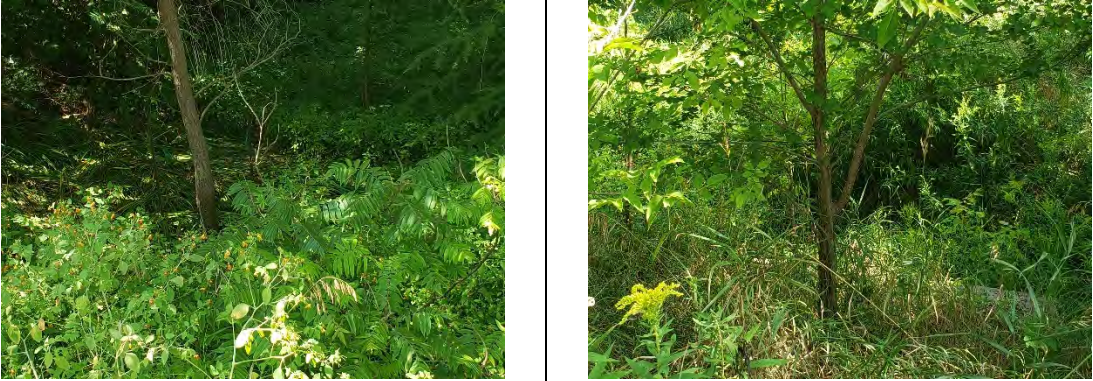
<p>Photograph facing upstream of King Vaughan Road. No water was present at the time of the assessment.</p>		<p>Photograph facing downstream of King Vaughan Road. There was a concrete culvert located at the road crossing.</p>

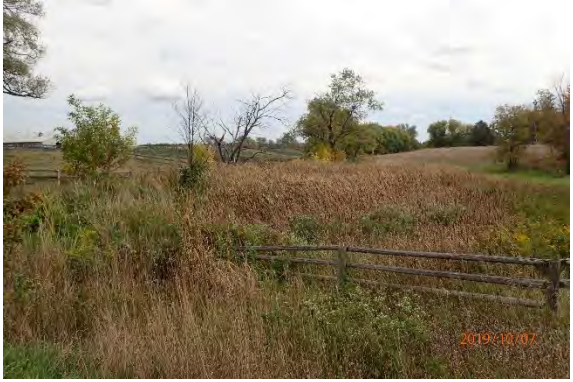
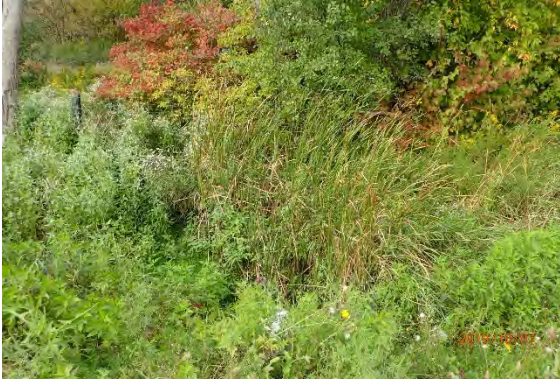
Downstream King Vaughan Road consisted of a swale feature encroached with cattails.	Upstream King Vaughan Road. Feature was forested for this small section of the reach between the two crossings.

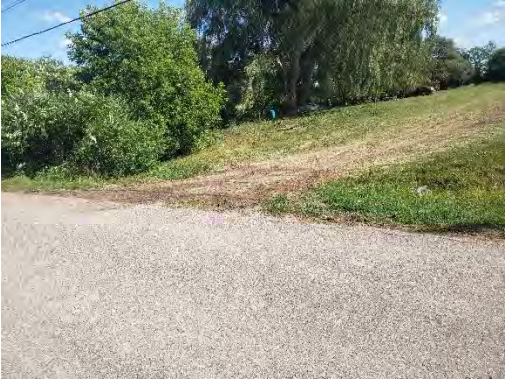
Newly built driveway at the downstream extent of the crossing.	Pipe located under the new driveway at the downstream extent. The pipe outlets parallel to the road into a roadside ditch.

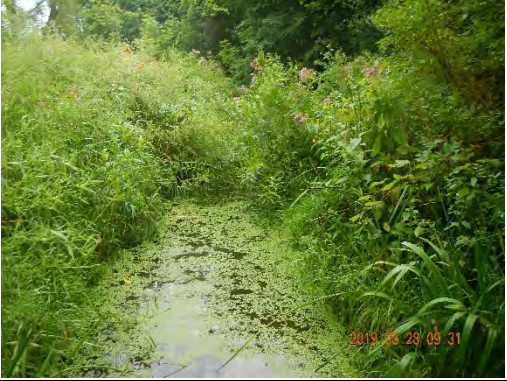
<p>The reach was covered in floating algae at the downstream extent. There was no flow.</p>		<p>Photograph taken near the change from wet to dry conditions along the reach.</p>

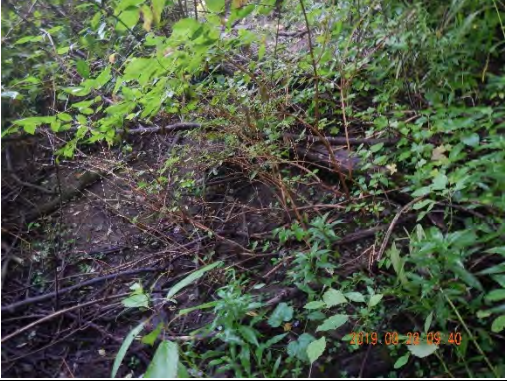
<p>Dry channel bed with vegetation growing along the bed. Bed substrates consisted of silt and sand.</p>		<p>Reach break with a fully vegetated channel bed. The channel was not well defined.</p>

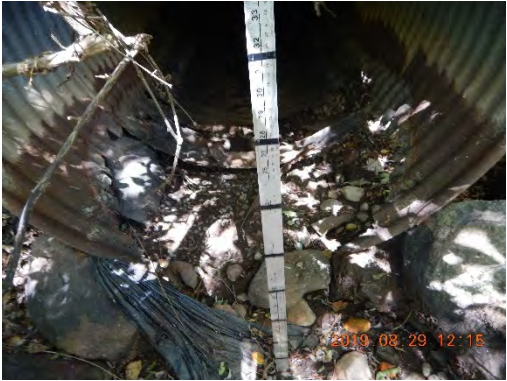
Reach HN2-3c downstream of 15 th Sideroad. The bed was comprised of sand, gravel, cobble, and boulders.	Photograph of the downstream culvert. There CSP at the downstream extent was degraded.

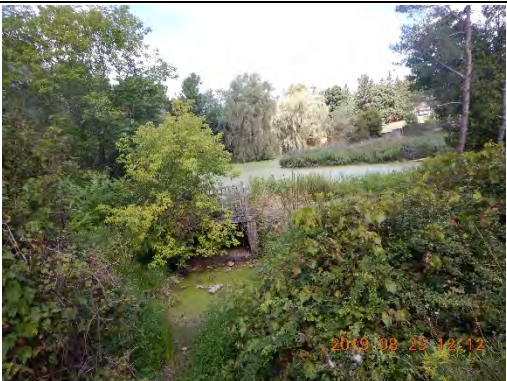
Reach HN2-3c-1 upstream of 15 th Sideroad. There was a small channel between the pond and the CSP.	Photograph of the pond upstream of 15 th Sideroad. The pond was covered in floating algae.

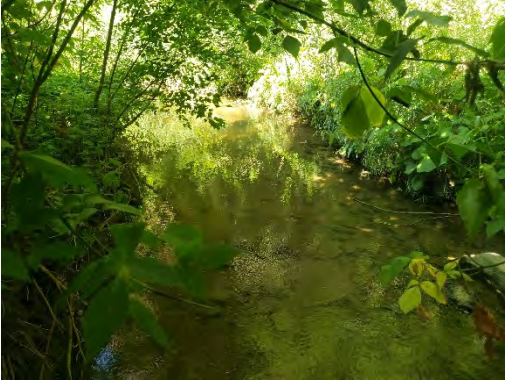
Photograph taken facing upstream from King Road.	Minor undercutting was noted at the downstream extent.

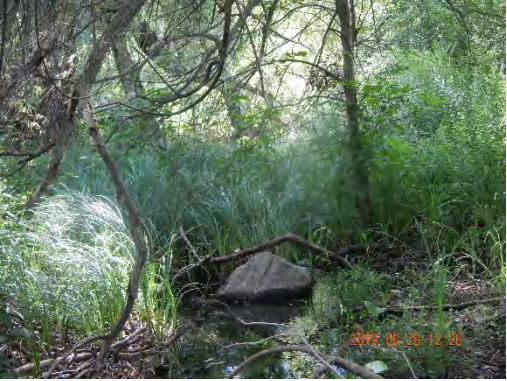
Reach became more encroached with grasses at the upstream extent of the reach.	Photograph taken facing downstream towards a large woody debris jam.

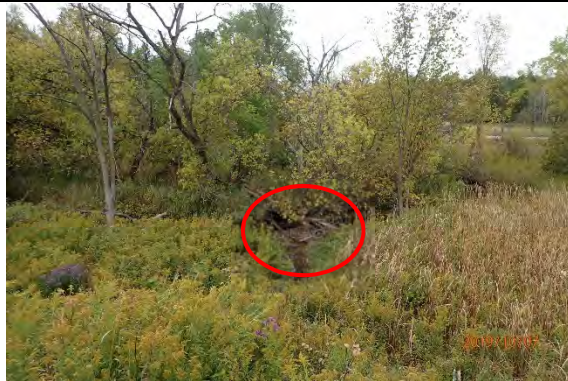
Photograph taken facing downstream of Lloydtown/Aurora Road. The confluence (circle) with a larger tributary was approximately 10 m downstream of the CSP.

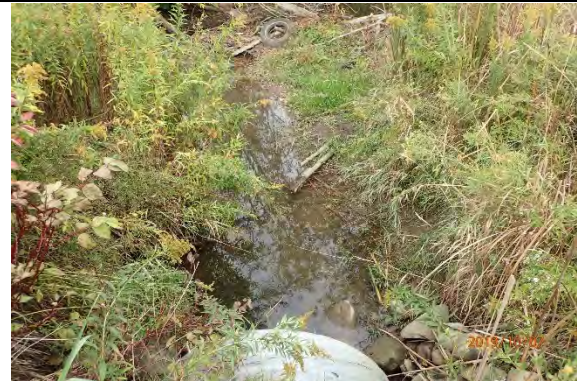
Photograph taken facing downstream of Lloydtown/Aurora Road. Minor bank erosion was noted on both sides of the channel to the confluence.

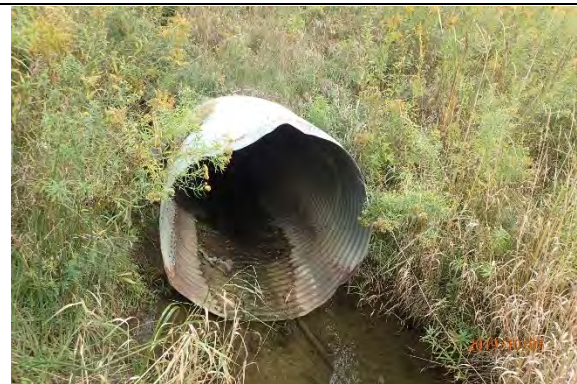
Photograph of the upstream CSP. Erosion was noted surrounding the CSP indicating the crossing may be undersized.

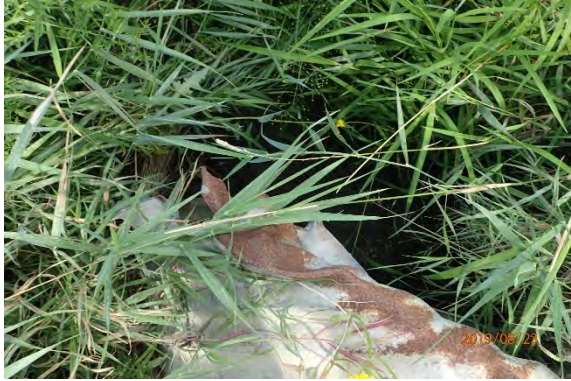
Damage CSP at road crossing. The channel was dry at the time of assessment.		The channel was heavily encroached with grasses, offering little bank definition.

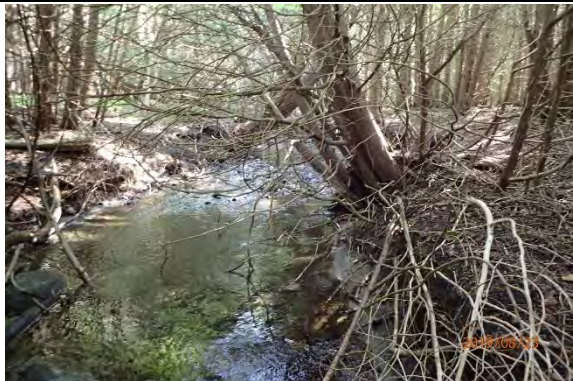
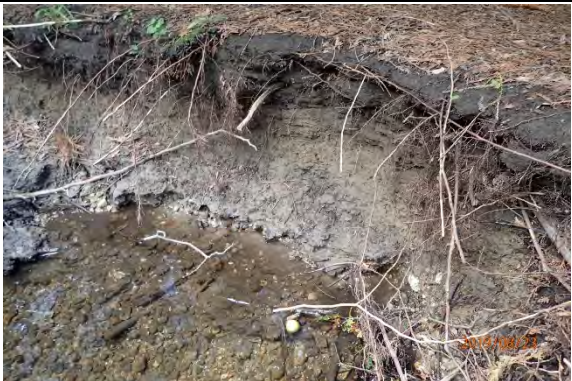
Photograph facing downstream (downstream of Cook Drive). Note leaning trees.	Exposed rootlets and till in an eroded bank.

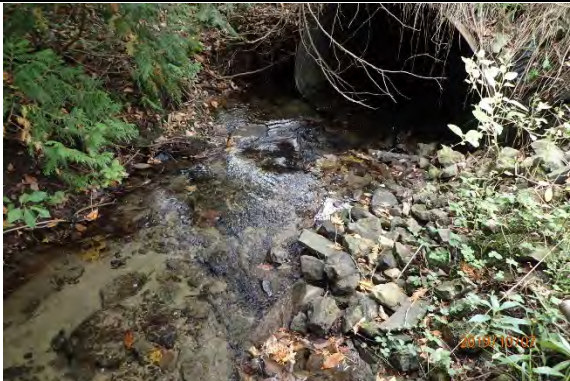
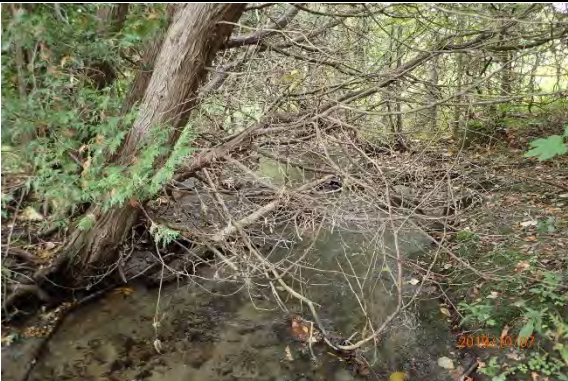
Photograph taken facing downstream towards CSP. Note sandy streak marks in bed indicating aggradation.	Photograph taken facing upstream from crossing. Leaning trees and minor bank erosion were observed.

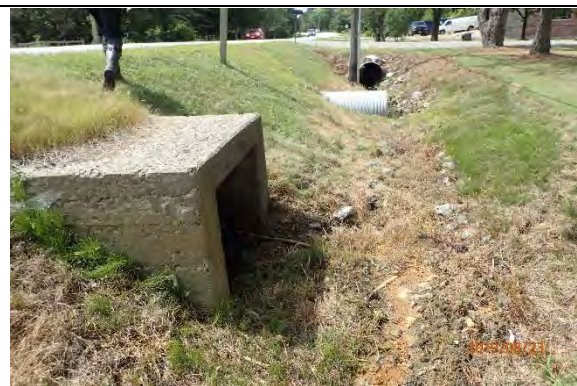
An abandoned box culvert was observed east of the current CSP crossing.

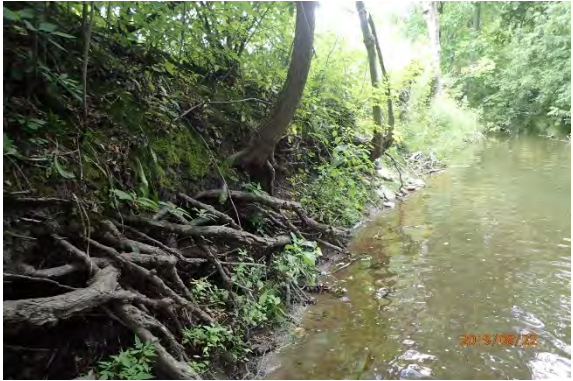
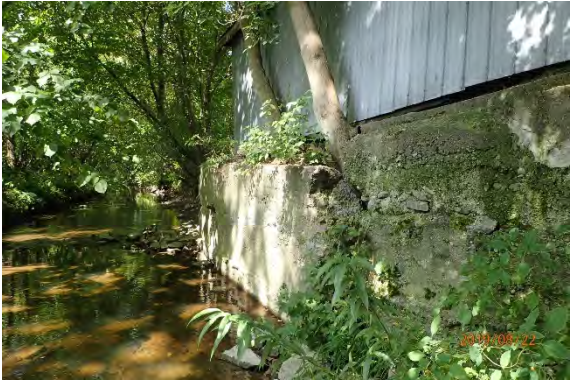
Exposed roots and j-trunk trees along an eroded bank.	Exposed building foundation. Multiple buildings were located close or at top of banks posing as an area of concern.

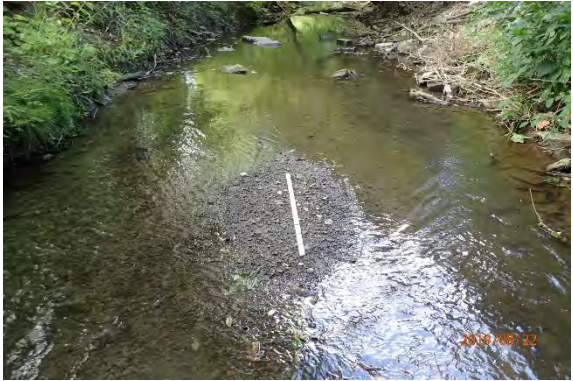
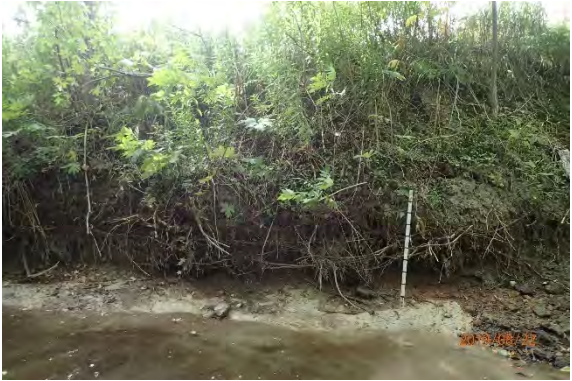
Photograph facing downstream at small medial bar.	Undercutting, exposed till, and exposed tree were observed throughout reach.

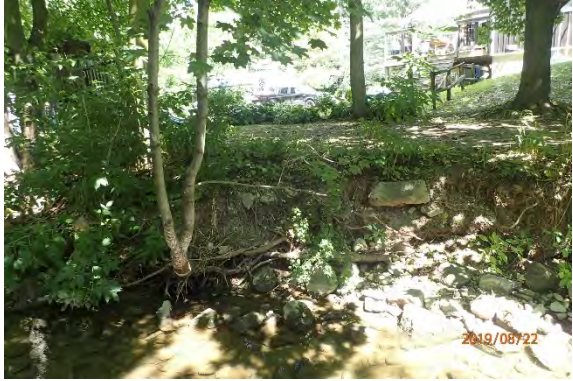
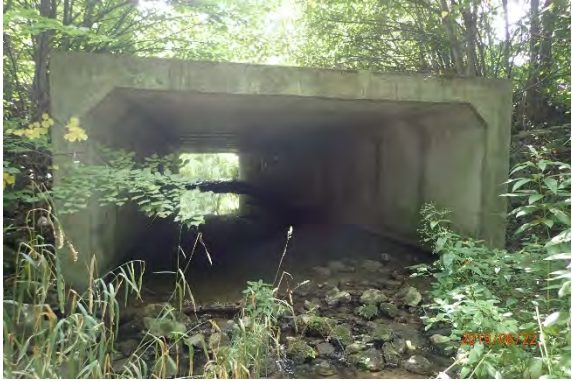
Eroded bank downstream of Main Street near residential house. Lawn manicured to the top of bank.	Closed bottom culvert under Main Street.
