APPENDIX P

Facility Condition Assessments

Component Inspection Report

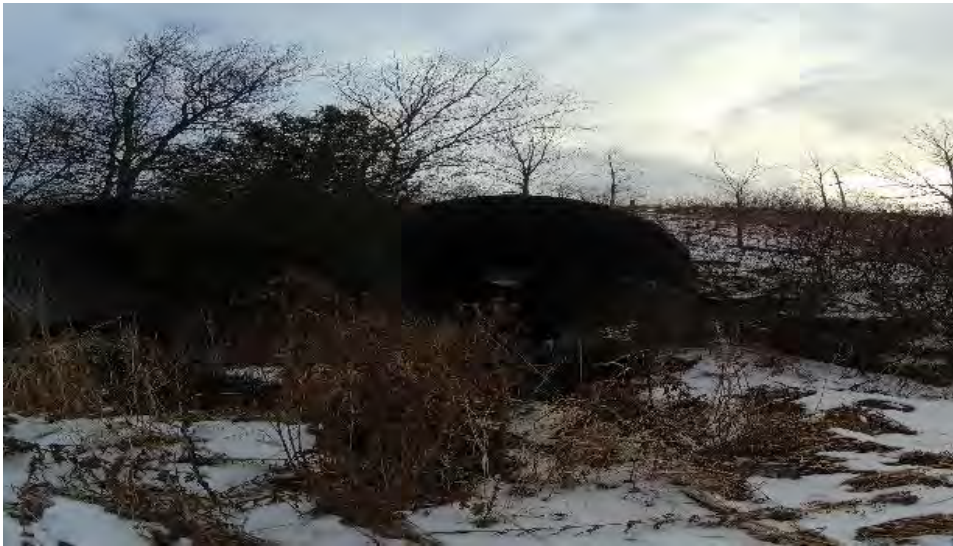
| Component Name: | INLET_01 | Easting: | |

| Comments: | Double CSP Culvert is in good condition at the north side of East Humber Drive. The inlet channel is also in good condition leading to the main stream. | | | | |

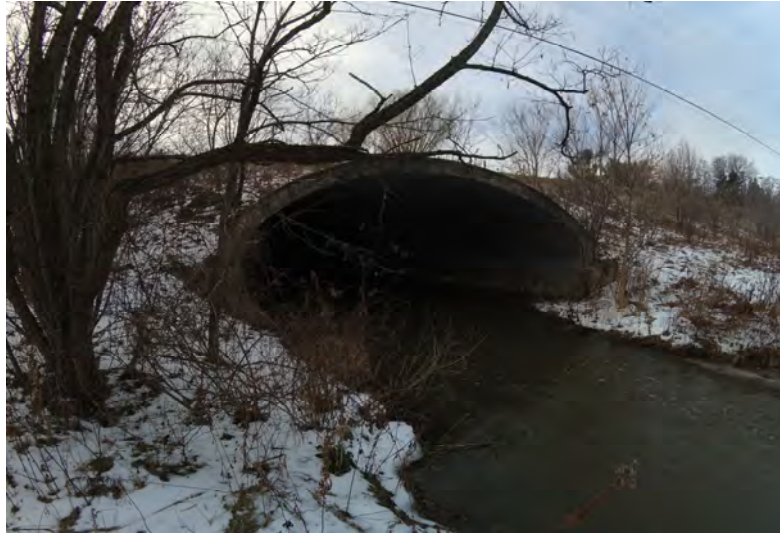
| Component Name: | INLET_02 | Easting: | |

| Comments: | Large Outlet culvert crossing under keele street is in good condition. No obstructions in flow path. | | | | |

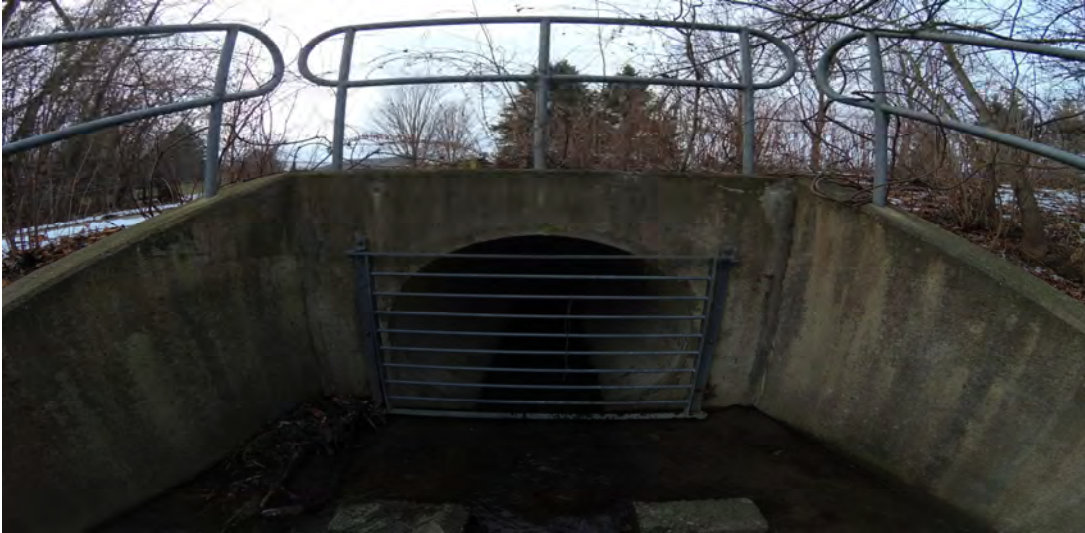
| Component Name: | INLET_01 | Easting: | |

| Comments: | Inlet headwall structure is in excellent condition. No damage around structure. Baffle blocks are in good condition. Grate is in good condition. Graffiti inside pipe. | | | | |

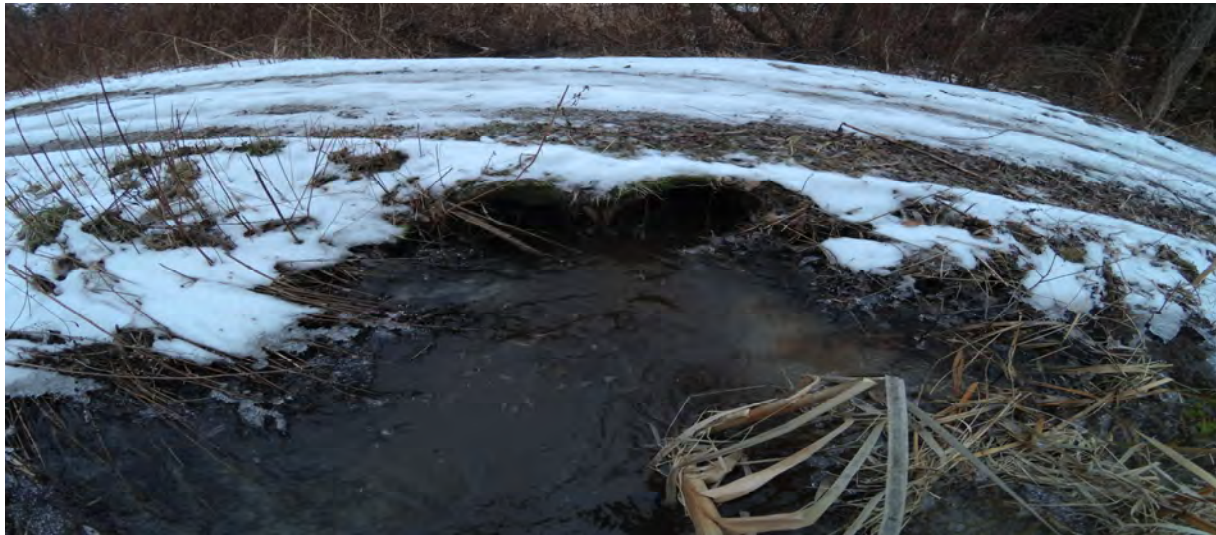
| Component Name: | OUTLET_01 | Easting: | |

| Comments: | First set of double culverts outletting water from facility are in good condition. No significant debris or vegetation cover. Left culvert on outlet side under walking path is slightly dented. | | | | |

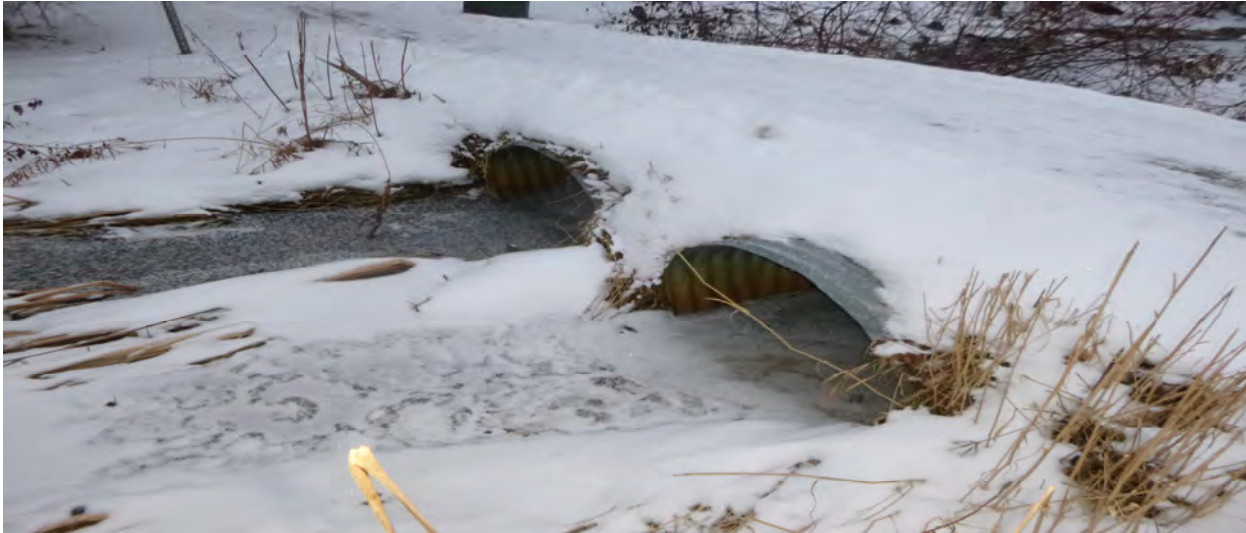
| Component Name: | OUTLET_02 | Easting: | |

| Comments: | First set of double culverts outletting water from facility are in good condition. No significant debris or vegetation cover. | | Inspection Date: 2019-12-10 |

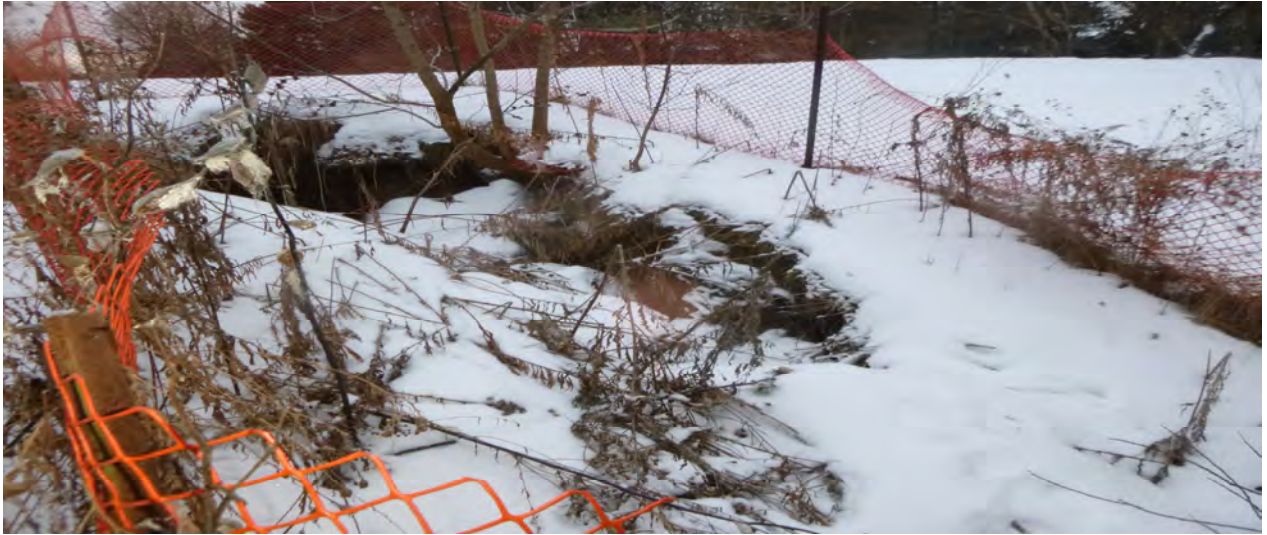
| Component Name: | OUTLET_03 | Easting: | |

| Comments: | Outlet structure from facility has completely failed. Area has been fenced off already. The side walls have caved in completely and area will require complete reconstruction. The culvert in this location is shown to be protected with gabion and wire mesh and is still functioning for flow conveyance | | | | |

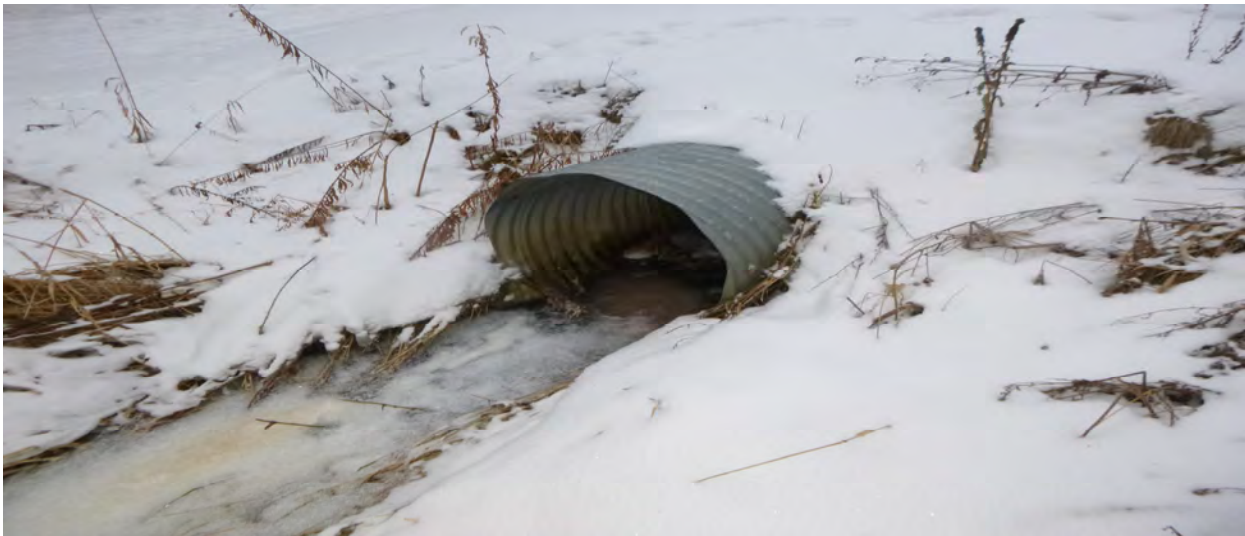
| Component Name: | OUTLET_04 | Easting: | |

| Comments: | Outfall culvert from facility is in good condition. The upstream side failure hasn't affected the condition of the culvert. Downstream flow path is not obstructed. Drainage channel leads to two DICBs, both of which are in good condition. | | | | |

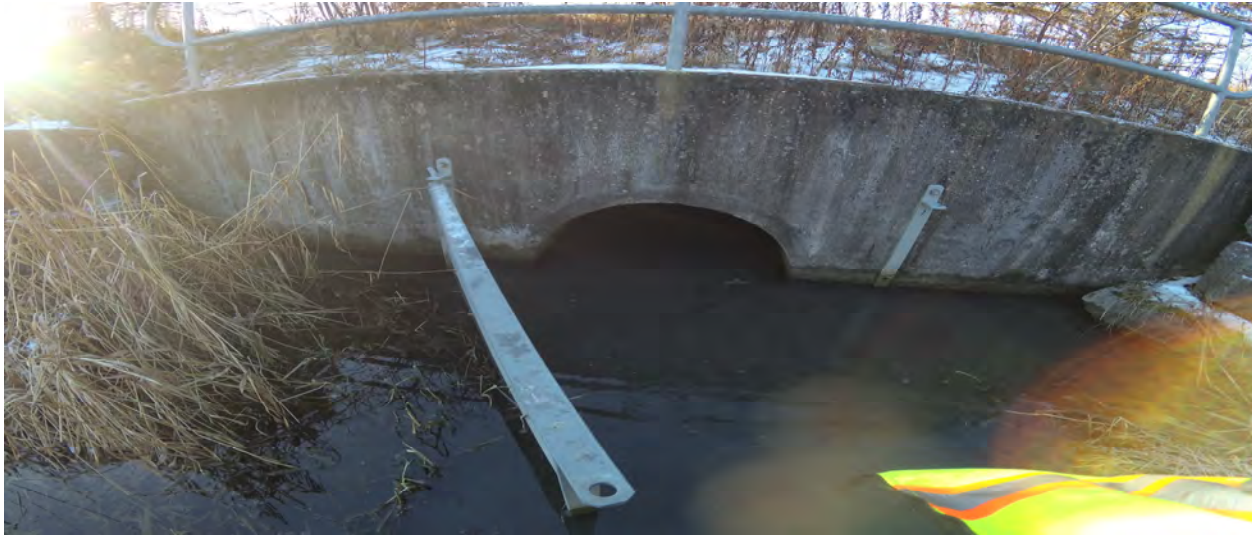
| Component Name: | INLET_01 | Easting: | |

| Comments: | 500mm inlet pipe. Headwall in good condition. Significant sediment build up at inlet. Grate is missing a lock. | | |

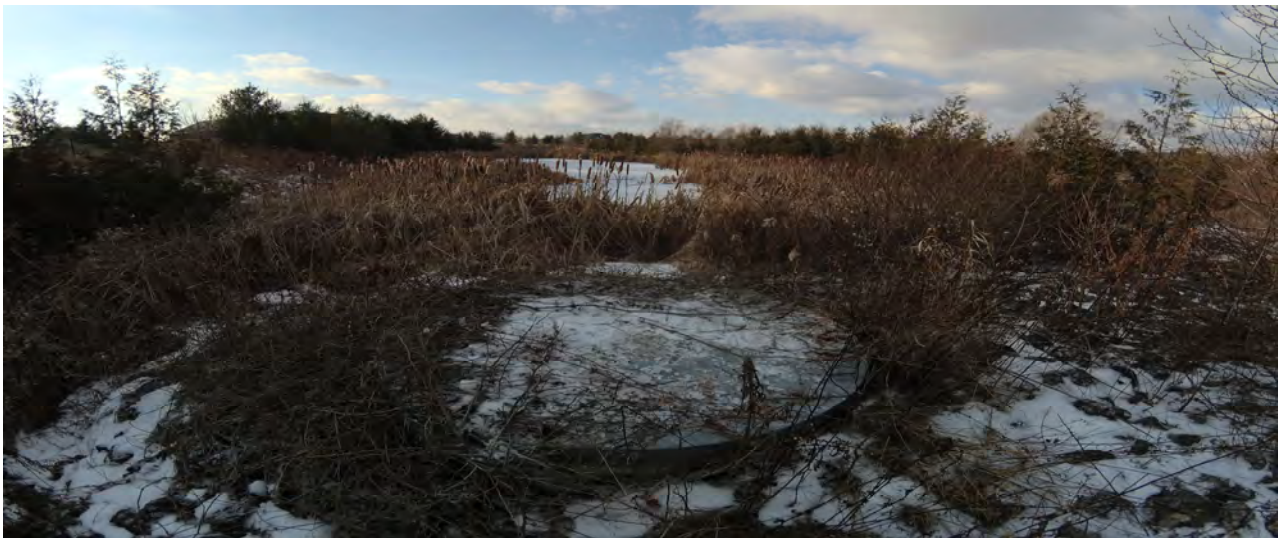
| Component Name: | OUTLET_01 | Easting: | |

Comments: Hickenbottom structure is in decent condition. Outlet pipe is slightly bent. Significant sediment build up in hickenbottom structure.

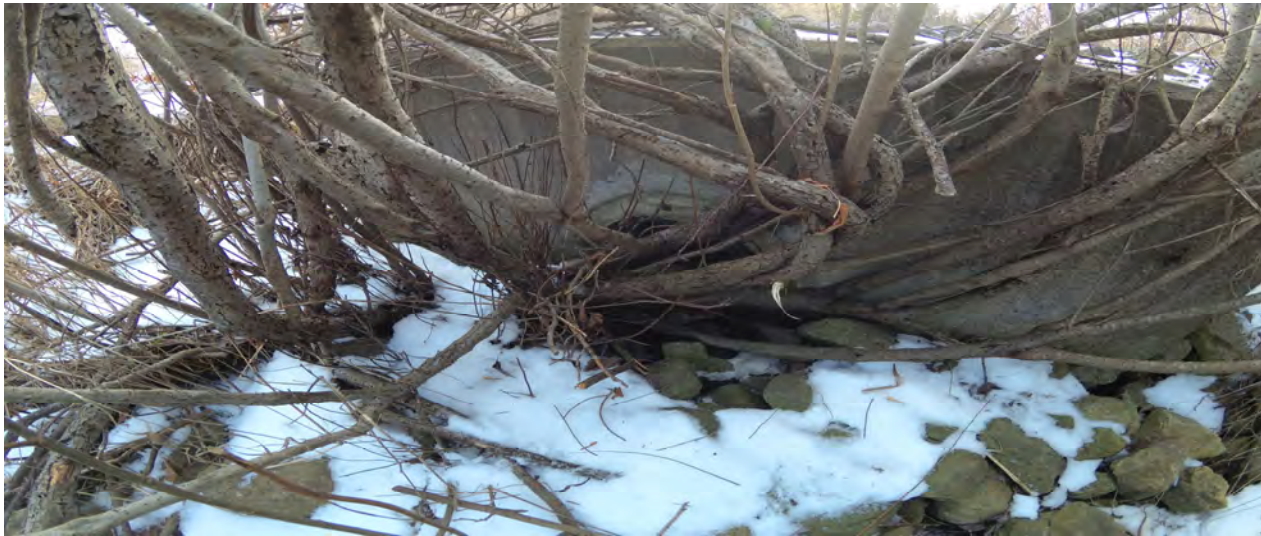
| Component Name: | OUTLET_02 | Easting: | |

Comments: Outlet pipe is in good condition. Tree is blocking the outlet pipe. Slight damage on the bottom right corner of the headwall. Water is leaking out the side of the headwall. Downstream outlet channel is in good condition. Slight erosion at the edges of the channel.

| Facility ID | Component ID | Condition | Maintenance Cost |
|---|---|--|---|
| | Outlet_02 | Tree blocking inlet and concrete headwall is cracked | \$ 2,500.00 |

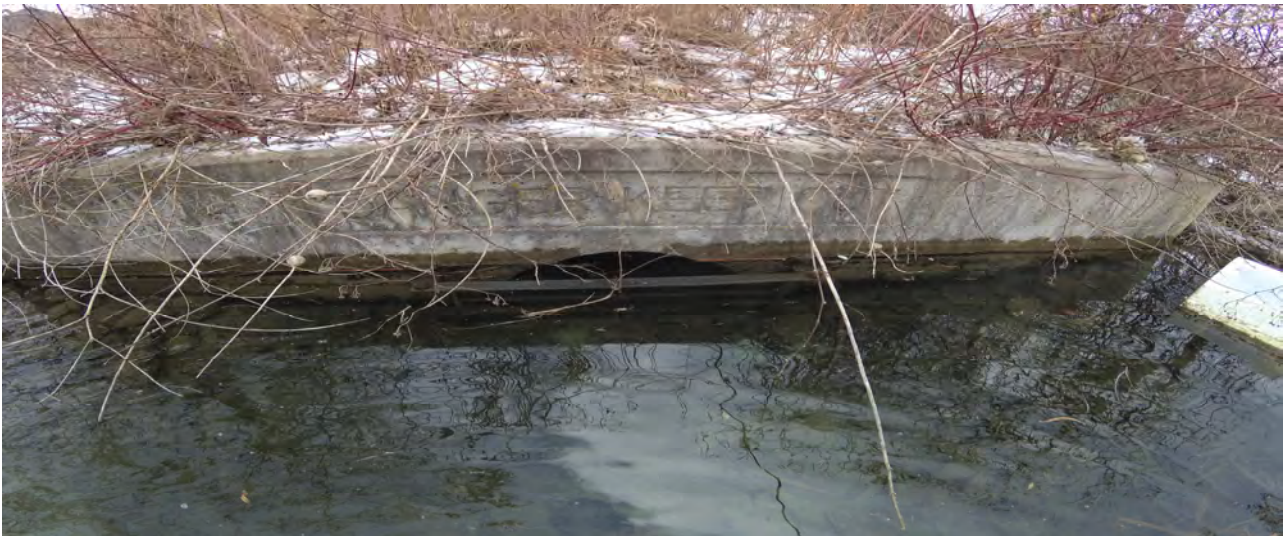
| Component Name: | INLET_01 | Easting: | |

| Comments: | Structurally, the inlet head wall is in good condition. Functionally, the inlet is submerged 90%. There is significant sediment build up at the inlet as well. | | | | |

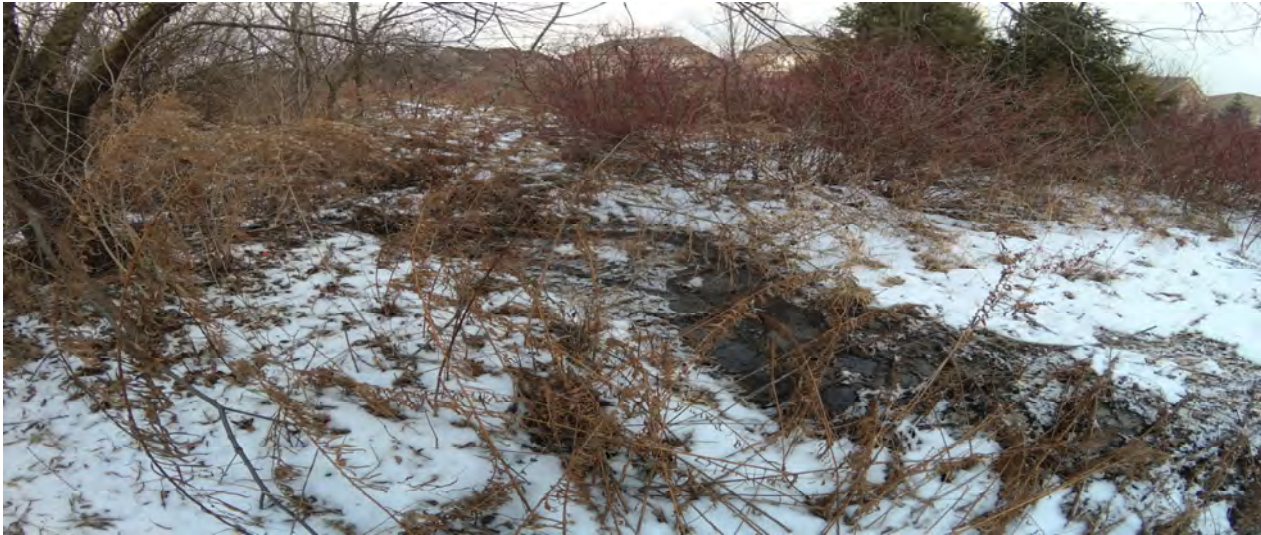
| Component Name: | OUTLET_01 | Easting: | |

| Comments: | The facility does not have a constructed outlet structure. All water flows downstream through a channel located on the east side of the facility and leads to a natural stream flowing east. Overall, the condition of the channel is good. There is some minor erosion along the banks of the outlet channel. | | | | |

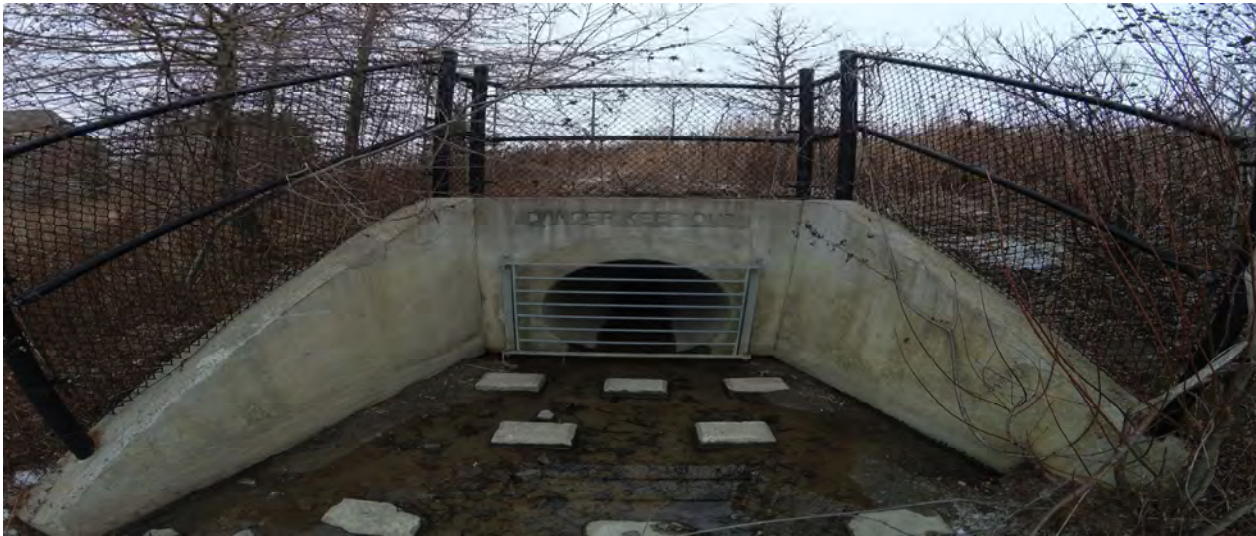
| Component Name: | INLET_01 | Easting: | |

| Comments: | Headwall structure is slightly damaged. Minor damage around bottom corners of headwall by pipe where water is entering the facility. Pipe and grate are in excellent condition. Baffle blocks are in good condition. Baffle on front left side is slightly damaged. Water level is normal and there is no sediment build up. Fence along top of headwall is slightly damaged. Fence is detached from pole connection. | | | | |

| Facility ID | Component ID | Condition | Maintenance Cost |
|---|---|--|---|
| NTPO_0005 | Inlet_01 | Headwall and fence is damaged | \$ 1,500.00 |

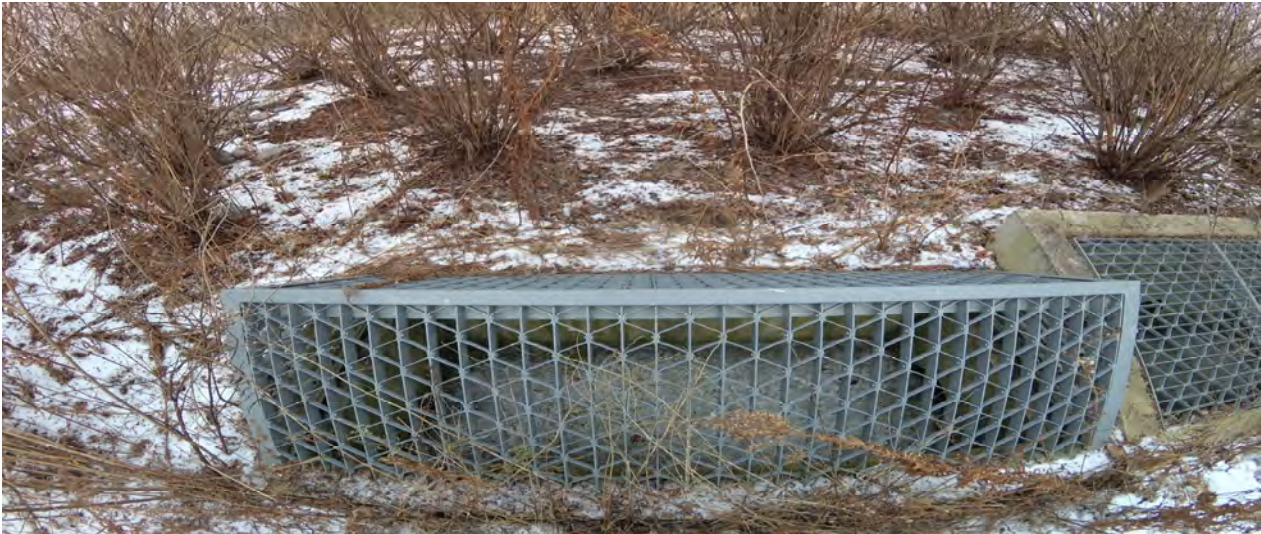
| Component Name: | OUTLET_01 | Easting: | |

| Comments: | Outlet DICB is in good structural condition. No garbage or debris build up in DICBs. Water level is just below orifice pipe. | | | | |

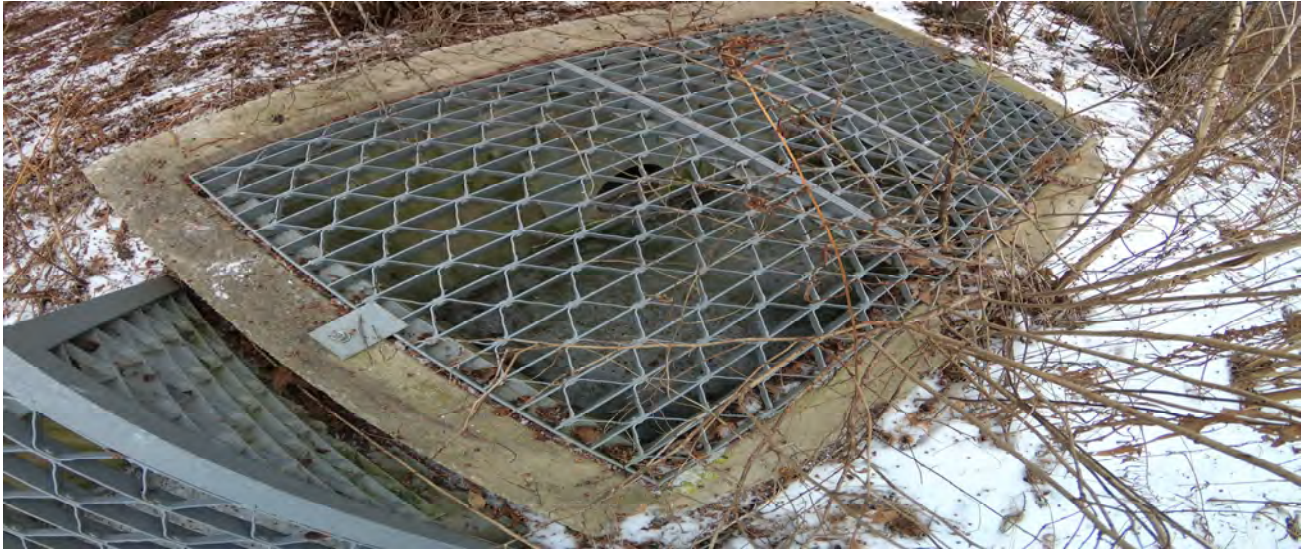
| Comments: | Overflow DICBs are in good structural condition. No garbage or debris build up on or around structure. Standing water (frozen). | | | | |

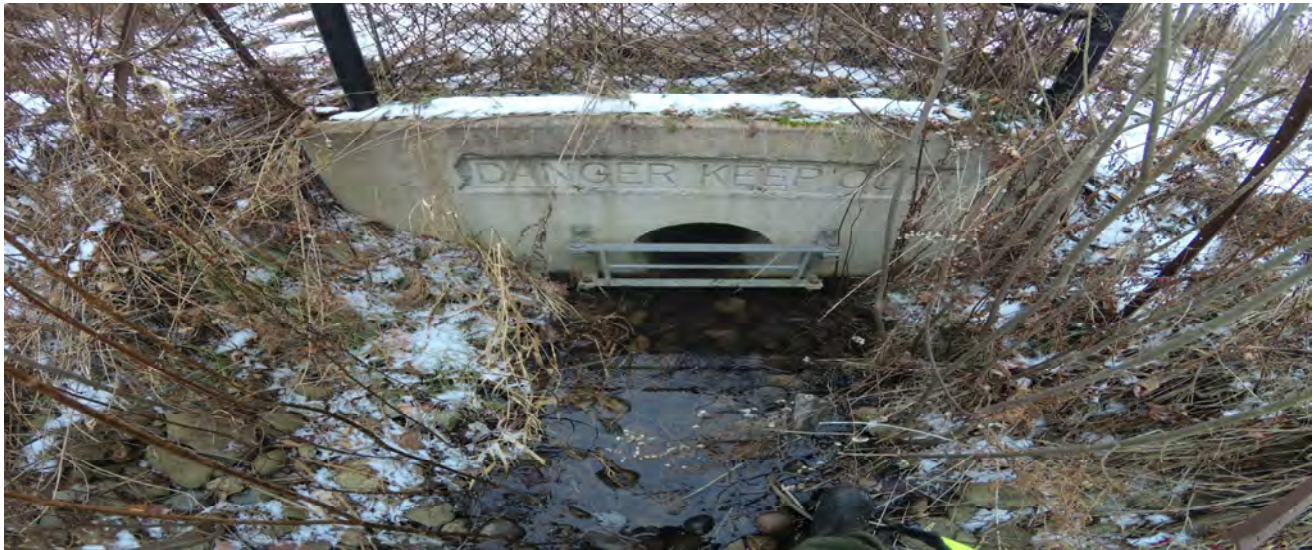
| Comments: | Manhole outlet structure is in good structural condition. No debris build up and all pipes are in excellent condition. | | | | |

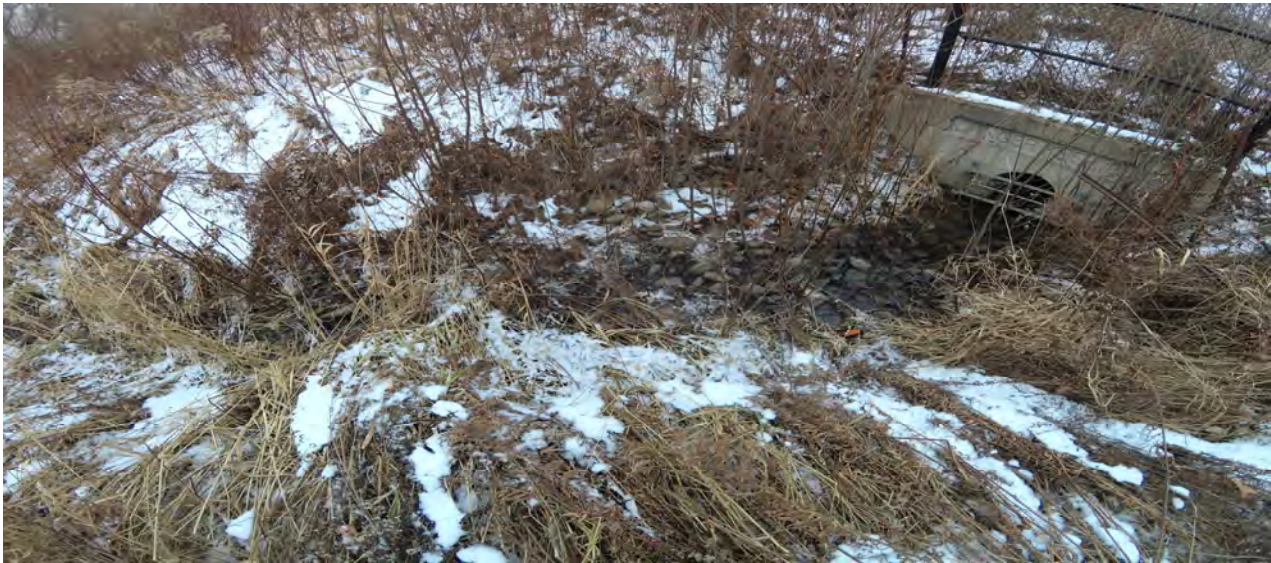
| Comments: | Outfall structure into stream is in good condition. Grate is in good condition. Water level is at normal level. Slight erosion around outfall channel. | | | | |

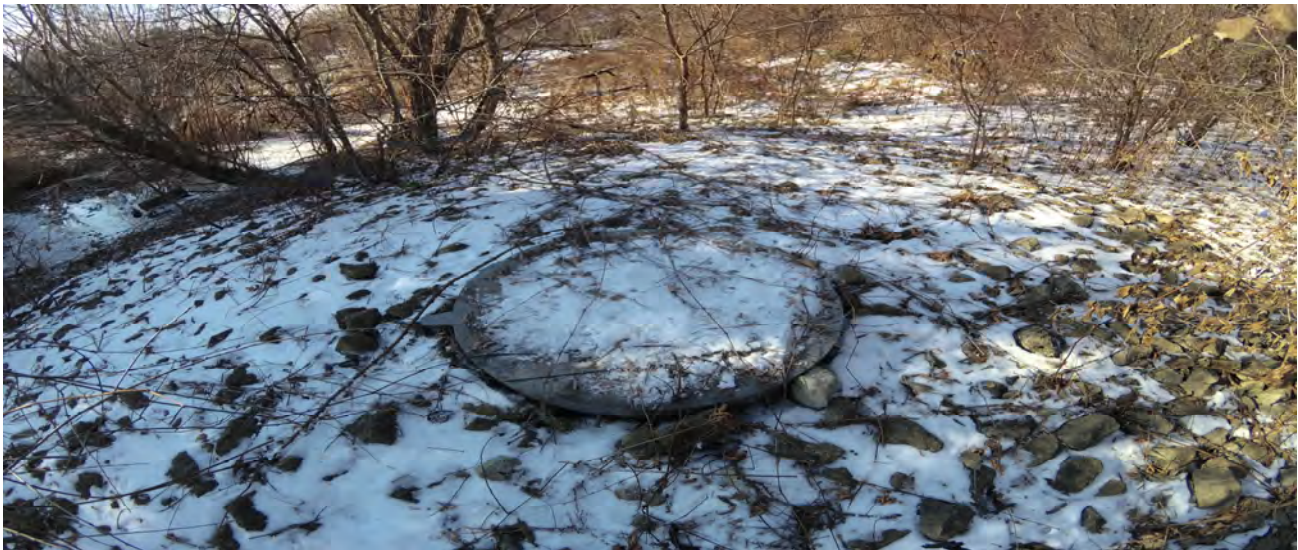
| Comments: | Hickenbottom strucutre is in decent condition. Outlet pipe is slightly bent. Significant sediment build up in hickenbottom structure. | | | | |

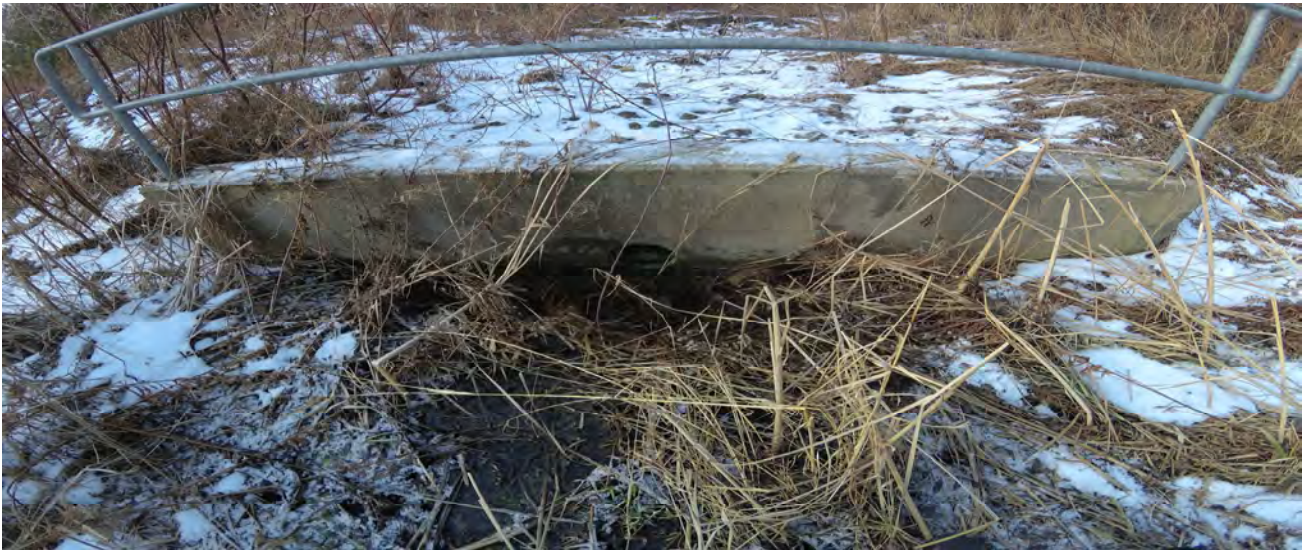
| Comments: | Outlet pipe is in good condition. Tree is blocking the outlet pipe. Slight damage on the bottom right corner of the headwall. Water is leaking out the side of the headwall. Downstream outlet channel is in good condition. Slight erosion at the edges of the channel. | | | | |

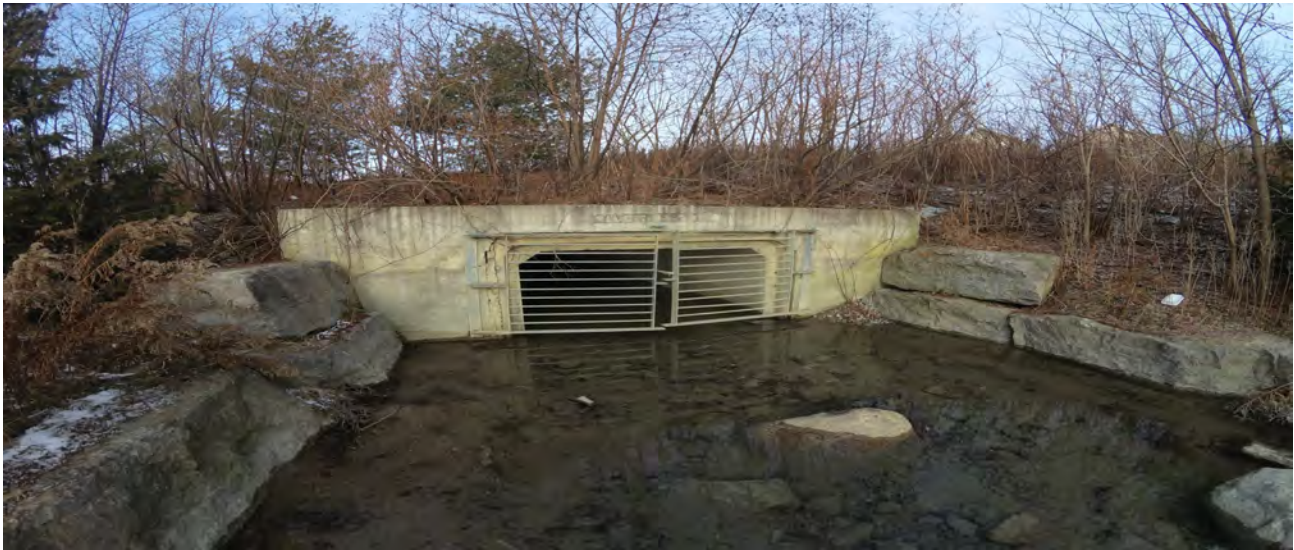
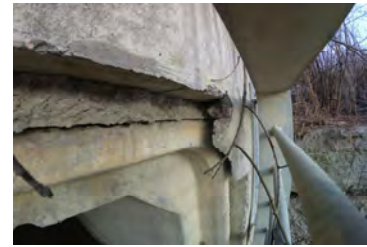
Comments: Overall, the inlet structure is in good condition. There is some structural damage around the perimeter of the inlet pipe. The concrete is cracking in some places and is damaged. Would require some parging to fix the damage. No sediment build up around inlet structure.

| Facility ID | Component ID | Condition | Maintenance Cost |
|---|---|--|---|
| NTPO_0009 | Inlet_01 | Crack in pipe | \$ 1,500.00 |

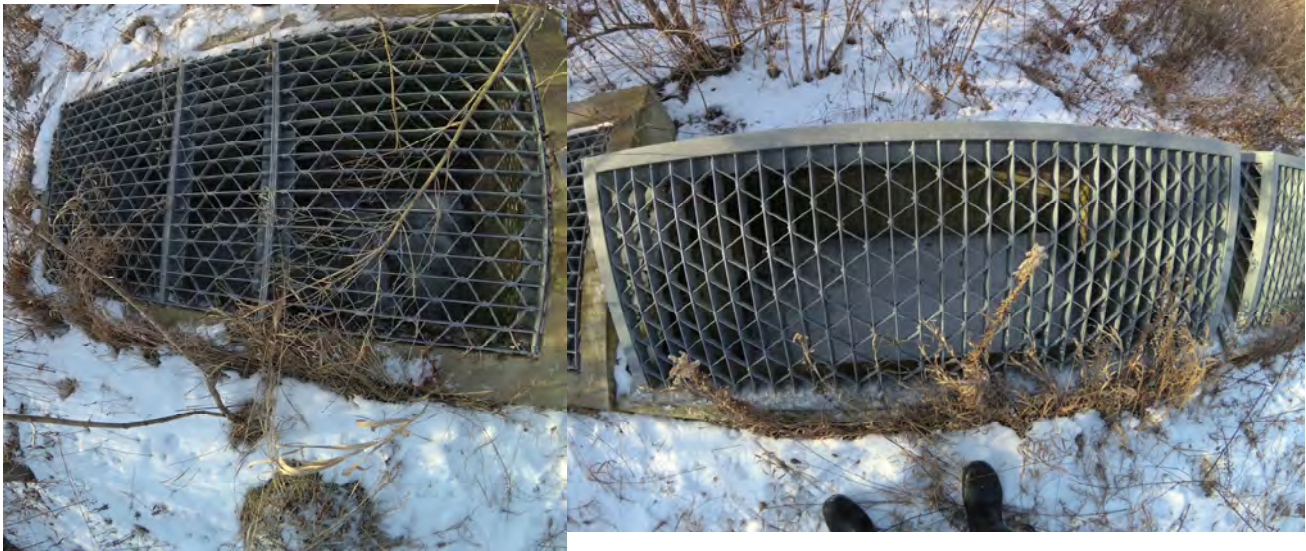
| Comments: | The outlet and overflow DICBs are in good condition. Standing water in the DICBs. No debris or vegetation covering the DICBs | | | | |

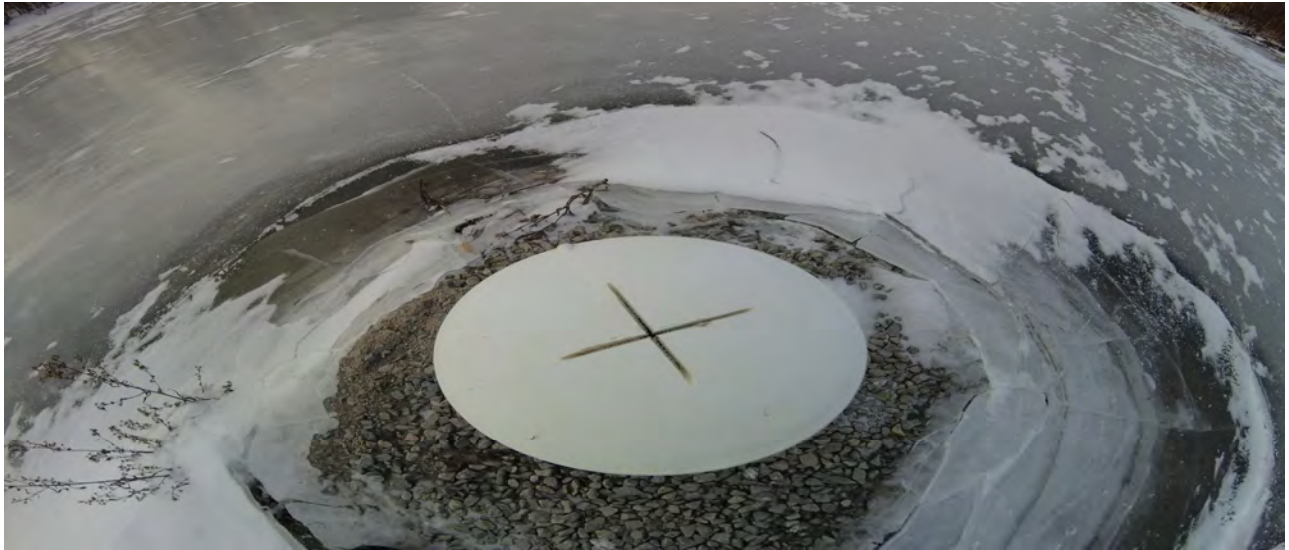
| Comments: | Outlet control maintenance hole structure is in good condition. There is no debris build up and no flow obstructions. | | | | |

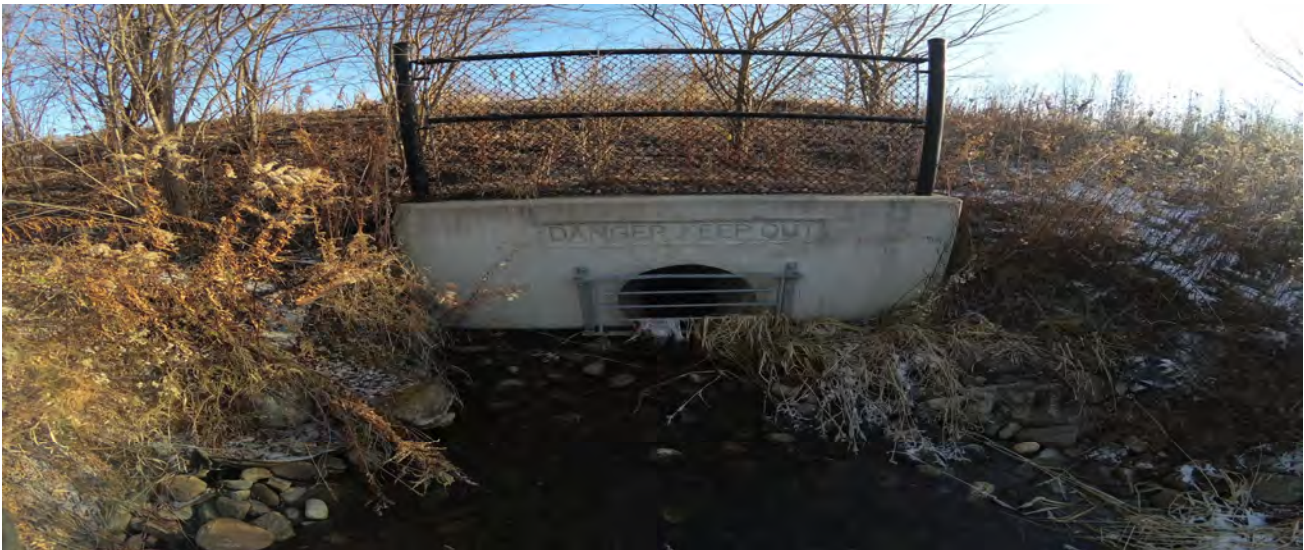
| Comments: | The overall structural condition of the outfall headwall structure is good. There is a minor crack on the bottom left side of the outfall pipe. Minor ragging caught on the outfall grate. Minor vegetation growth in front of outfall structure. | | | | |

| Facility ID | Component ID | Condition | Maintenance Cost |
|---|---|--|---|
| | Outlet_03 | Crack in pipe | \$ 1,500.00 |
