TOWNSHIP OF KING

10 YEAR PAVING STRATEGY AND PAVEMENT MANAGEMENT PLAN FINAL REPORT (REVISED)

NOVEMBER 26, 2020

PROJECT NO.: 19M-01017-05
DATE: NOVEMBER 26, 2020

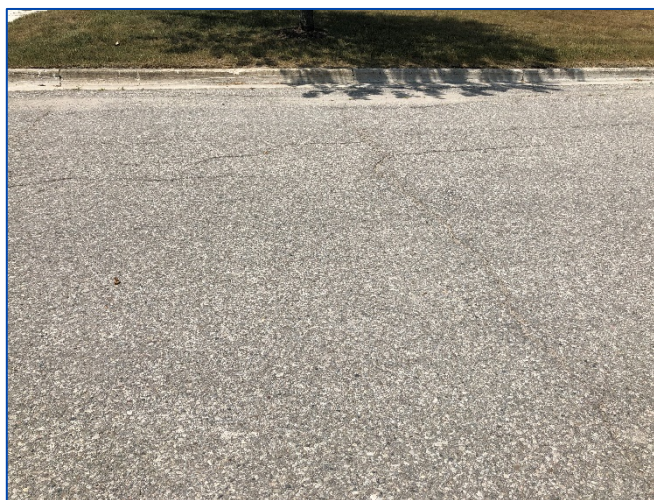
Ravelling and loss of coarse aggregates is a surficial distress that appears as though the pavement surface is breaking up into small pock-marks as aggregate particles are lost from the surface. This type of distress have a variety of possible causes including lack of bond and poor adhesion between the aggregates and asphalt binder, fracturing or disintegration of the aggregates from repeated freezing and thawing action, insufficient asphalt content, asphalt hardening due to aging and poor compaction or construction practices. An example of ravelling and aggregate loss is presented in Figure 4.1.

Figure 4.1: Moderate Ravelling – Russell Snider Drive, Nobleton (Section No. 2116)

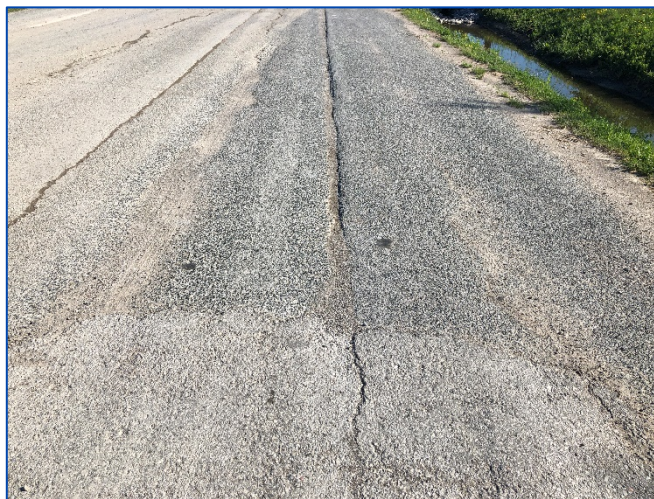
Deformations in the asphalt pavement such as wheel-track rutting are longitudinal depressions left in the wheel-path after repeated load applications. Rutting results from densification and permanent deformation under the load, combined with displacement of pavement materials. Possible causes of rutting include poorly-compacted pavement structural layers, unstable granular layers or asphalt mixes, or an overstressed subgrade.

Pavement distortion was another type of deformation that was observed, which typically results from settlement slope failure, and/or frost heaving. Distortions may take the form of dishing, bumps, dips, tenting, stepping at cracks which creates a rougher driving surface for vehicles. An example of wheel-track rutting is presented in Figure 4.2.

Figure 4.2: Wheel-Track Rutting – Magnum Drive, Schomberg (Section No. 3002)

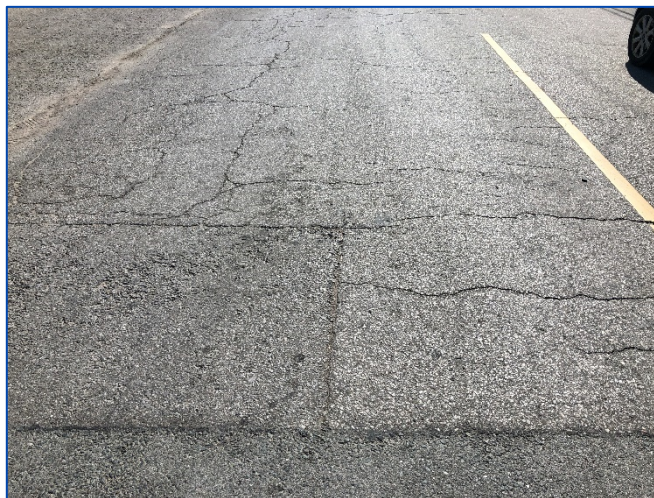
Pavement cracks which follow a course approximately parallel to the direction of travel. Cracks situated at or near the centre of the wheel tracks are considered to be wheel-track longitudinal cracking, centerline longitudinal cracks are situated at or near the centerline of the roadway, and mid-lane cracks are typically at or near the middle of the lane between the wheel-tracks. Longitudinal cracks may be caused by heavy traffic loading, frost action, and poor construction (particularly at the longitudinal construction joint). An example of longitudinal cracking is presented in Figure 4.3.

Figure 4.3: Longitudinal and Transverse Cracking – Old King Road, Nobleton (Section No. 2000)

A type of pavement cracking which follows a course approximately at right angles to the pavement centreline. Full transverse cracks extending across the full width of the road tend to be regularly spaced along the length of the road, while cracks that extends half or part-way occur at shorter distances. Natural shrinkage caused by low temperatures, the susceptibility of the asphalt to high temperatures and frost action may produce transverse cracks.

Another common source of transverse cracking are reflection cracks. This is when cracks in the lower layers of the asphalt gradually reflect through the surface layer to the top of the pavement, and typically occurs on roadways following a “shave and pave” where the milling depth was not deep enough to fully remove the existing cracks. Reflection cracking is also common in composite pavements where a layer of asphalt has been paved over concrete slabs. The movement between slabs at the joints will cause the asphalt above to crack through to the surface at these locations. An example of transverse cracking is presented in Figure 4.3.

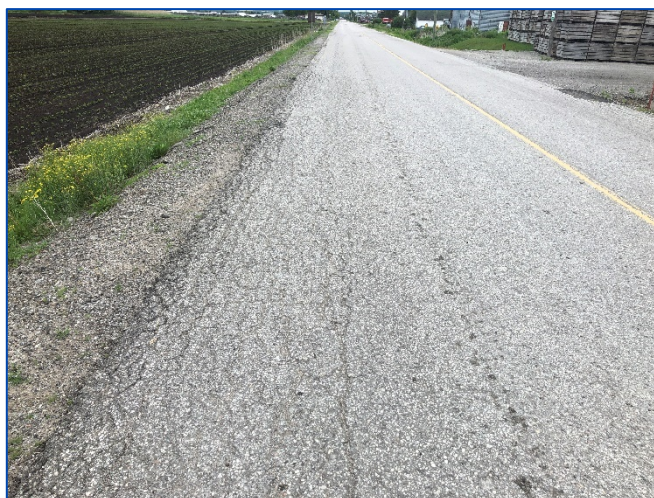
Cracks that are parallel to and generally within 30 cm of the roadway’s edge of pavement, and are either fairly continuous or consists of crescent-shaped crack patterns in a wave formation. On some thin asphalt surfaces, pavement edge cracking progressively encroaches onto the outer wheel-tracks through the middle of the lane or further. Pavement edge cracking are generally a result of insufficient bearing support and/or excessive traffic loading at the pavement edge (due to inadequate pavement width or substandard geometry), or poor drainage at the pavement edge and shoulder. An example of pavement edge cracking is presented in Figure 4.4.

Figure 4.4: Pavement Edge Cracking – Strawberry Lane (Section No. 307)

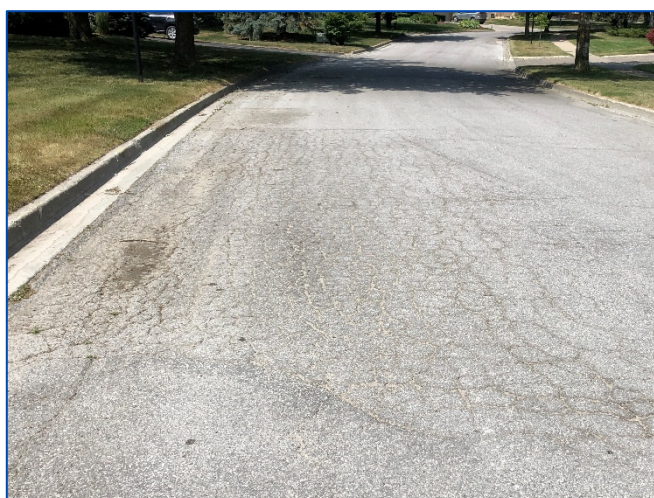
This type of pavement cracking forms a network of polygon blocks resembling the skin of an alligator. The block size, which can range from a few millimetres to about a metre, is indicative of the level (depth) at which failure is taking place. Alligator cracking is often accompanied by large depressions together with lateral movement of the pavement edge outwards and upwards resulting in water-ponding during rains.

Alligator cracking is caused by the inability of a part of the pavement structure to support the traffic loads. Other types of cracking such as transverse and longitudinal may allow surface water to infiltrate the pavement structure and weaken the granular or subgrade support. Therefore, alligator cracking is considered the final stage of crack development and is often an indicator of pavement failure. An example of alligator cracking is presented in Figure 4.5.

Figure 4.5: Alligator Cracking – Robb Drive, Nobleton (Section No. 2084)

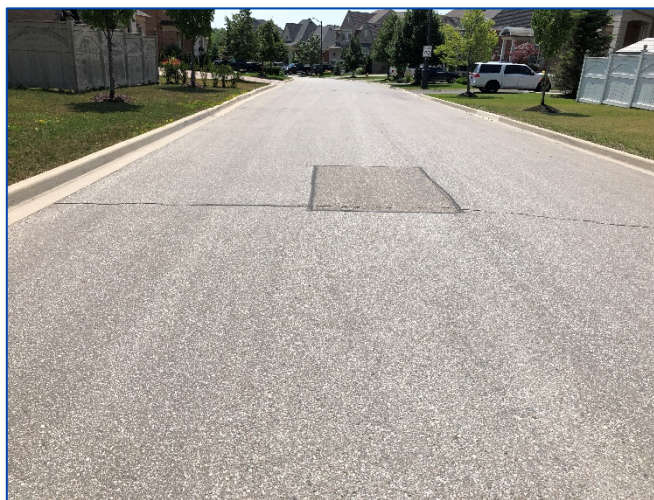
Patching is the placing and spreading of premixed asphaltic materials to repair potholes, bumps, depressions, alligator cracking, wheel-track rutting, distortions and other pavement distresses. Deteriorated patches are a concern as it may produce a rough driving surface. Pavement patching may also involve removing the existing pavement via saw-cutting prior to patching, and it is common for cracks to develop and spread at these saw-cut joints. If these joints are not sealed, water and moisture will also penetrate the pavement and increase the rate of pavement deterioration. Improper or inadequate compaction during placement of the patch may further result in settlement or raised grades of the patched area, this will result in water-ponding during rains and an uneven driving surface. An example of asphalt patching is presented in Figure 4.6.

Figure 4.6: Pavement Patch – Blue Beech Trail, Nobleton (Section No. 2137)

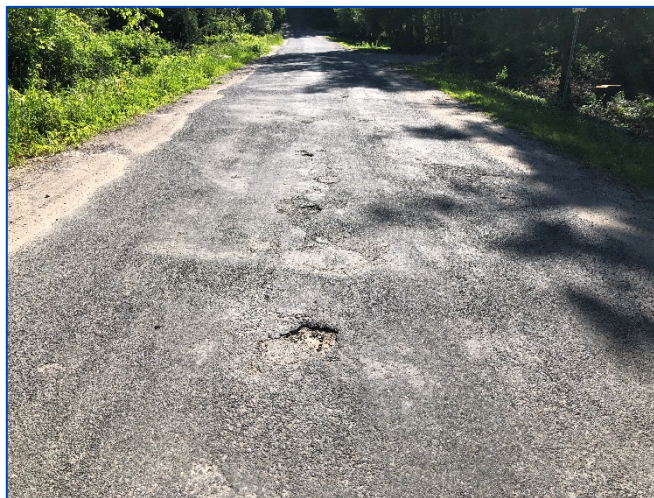
Ravelling and loss of coarse aggregates on surface-treated pavements is similar to as on asphalt paved roads, and is when aggregate particles are lost from the surface treatment due to poor bonding or adhesion between the aggregates and asphalt emulsion, fracturing or disintegration of the aggregates or insufficient asphalt content in the emulsion.

Potholes are bowl-shaped depressions in the pavement surface that penetrates through the surface-treatment layer into the underlying base course, typically with sharp edges and vertical sides. As surface-treatments are usually composed of thin layers, it is susceptible to potholing where chunks of the pavement become dislodged by traffic after the surface-treatment has cracked. An example of surface-treated defects is presented in Figure 4.7.

Figure 4.7: Ravelling and Aggregate Loss, Potholes – 16th Sideroad between Bathurst Street and West End (Section No. 21)

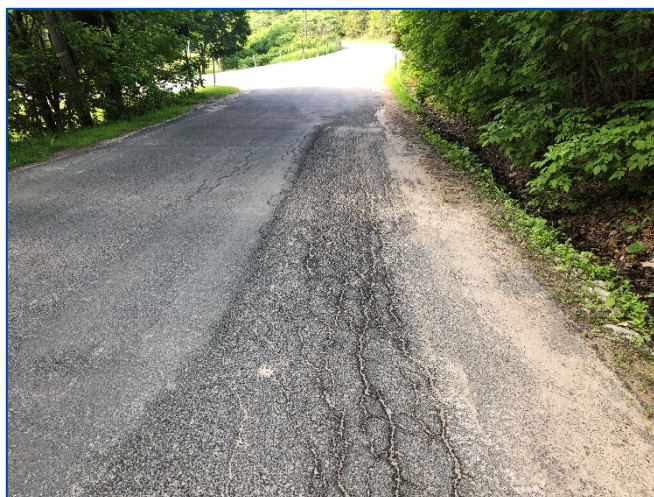
Rutting and distortion on surface-treated roads are similar to those on asphalt-paved roads, as previously outlined. Rutting results from permanent deformation of the pavement under load, due to insufficient strength in the surface-treated pavement, granular layers, subgrade or some combination of all the layers. As with asphalt pavements, distortions on surface-treated pavements results from settlement slope failure, and/or frost heaving. Distortions may take the form of dishing, bumps, dips, tenting, stepping at cracks which creates a rougher driving surface for vehicles.

Rippling are regular transverse undulations on the pavement surface, consisting of closely-spaced, alternate valleys and crest of singular or multiple waves or humps located transversely or longitudinally on the road surface. An example of surface-treated deformations is presented in Figure 4.81.

Figure 4.8: Surface-Treated Pavement Distortion – Lorne Avenue, Kettleby (Section No. 109)

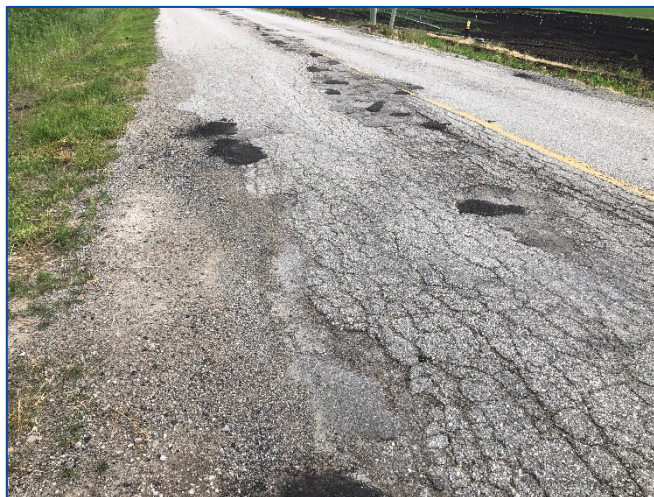
Longitudinal cracks on surface-treated roads are parallel to the direction of travel and can be located near the centerline of the roadway, in the middle of the lane between the wheel-tracks or on the wheel cracks. Causes of longitudinal cracking include but are not limited to, traffic loading, frost action and poor construction. Conversely, transfer cracks run at right angles to the road's direction of travel and are a result of temperature changes (heating and cooling), frost action and reflection cracking.

Alligator cracking on surface-treated pavements also form a network of polygon blocks similar to the skin of an alligator with depressions. Alligator cracking are produced due to insufficient strength or support in the pavement structure to accommodate the traffic loads on the road. Longitudinal and transverse cracking may develop into alligator cracking as they continue to deteriorate and allow water to infiltration into the base or subgrade material, thereby further weakening the pavement structure and leading to failure. An example of these cracking types is presented in Figure 4.9.

Figure 4.9: Alligator Cracking on Surface-Treated – Wist Road (Section No. 287)

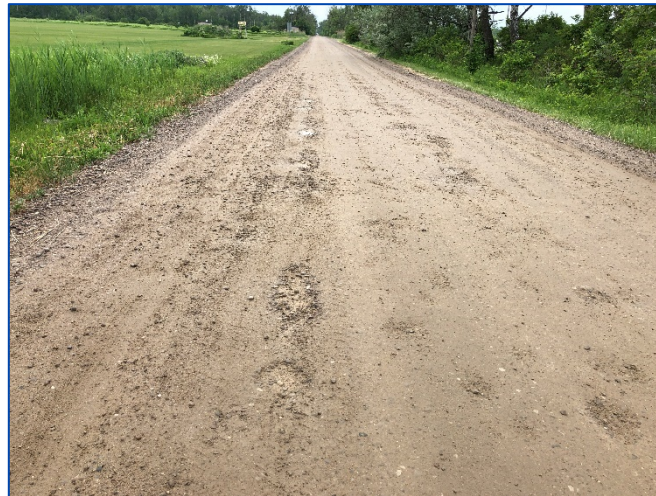
Loose gravel is when the gravel surface is loosely compacted with the gravel in wind-rows along the centre of the road, alongside the wheel-track or along the shoulder parallel to the direction of traffic. Loose gravel is a result of insufficient compaction during construction or placement, and traffic action segregating coarse aggregates from the fine particles and then moves loosened aggregates away from the wheel-tracks.

Potholes in gravel roads are bowl-shaped depressions in the road surface, and are produced by a combination of excessive moisture, traffic action, frost action and inadequate structural strength in the roadway.

Breakups are distresses where the subgrade soils have punched through the gravel surface, usually with the broken surficial area surrounded by depression or dishing type of distortion. Breakups are most likely to occur at the wheel-tracks where any inadequacies in structural strength is exacerbated by the traffic loading. Other causes include poor drainage and frost action. An example of these surface defects is presented in Figure 4.10.

Figure 4.10: Potholes, Loose Gravel and Breakups – Toll Road (Section No. 345)

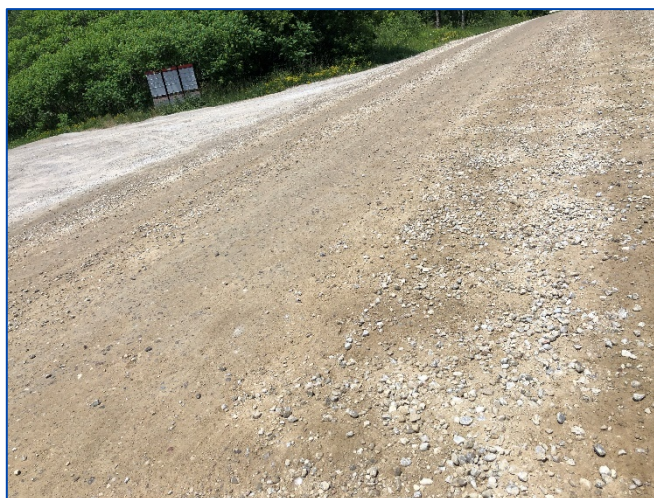
Washboard is a series of closely-spaced crests and valleys which resembles a “washboard” surface, and always occurs with the ripples perpendicular to the direction of travel and are more pronounced at the wheel-tracks. This type of distress may be caused by traffic loading combined with loose gravel, areas of acceleration and deceleration such as curves, downhill or uphill and at intersections, and insufficient pavement structural strength.

Rutting in gravel roads is similar to rutting in paved roads, and are surface depressions in the wheel-track. As with paved roads, gravel road rutting is a product of inadequate structural strength due to design or deterioration.

Distortion is any deviation of the gravel road surface from its original shape other than rutting or washboard, and usually takes the form of dishing, bumps or dips that creates a rougher driving surface. As distortion can take many forms, it can be caused by a variety of factors such as differential frost heaving and settlement, poor drainage, lack of subgrade support or embankment slope failure. An example of these surface deformations is presented in Figure 4.11.

Figure 4.11: Washboard and Rutting – Concession Road 7 (Section No. 233)

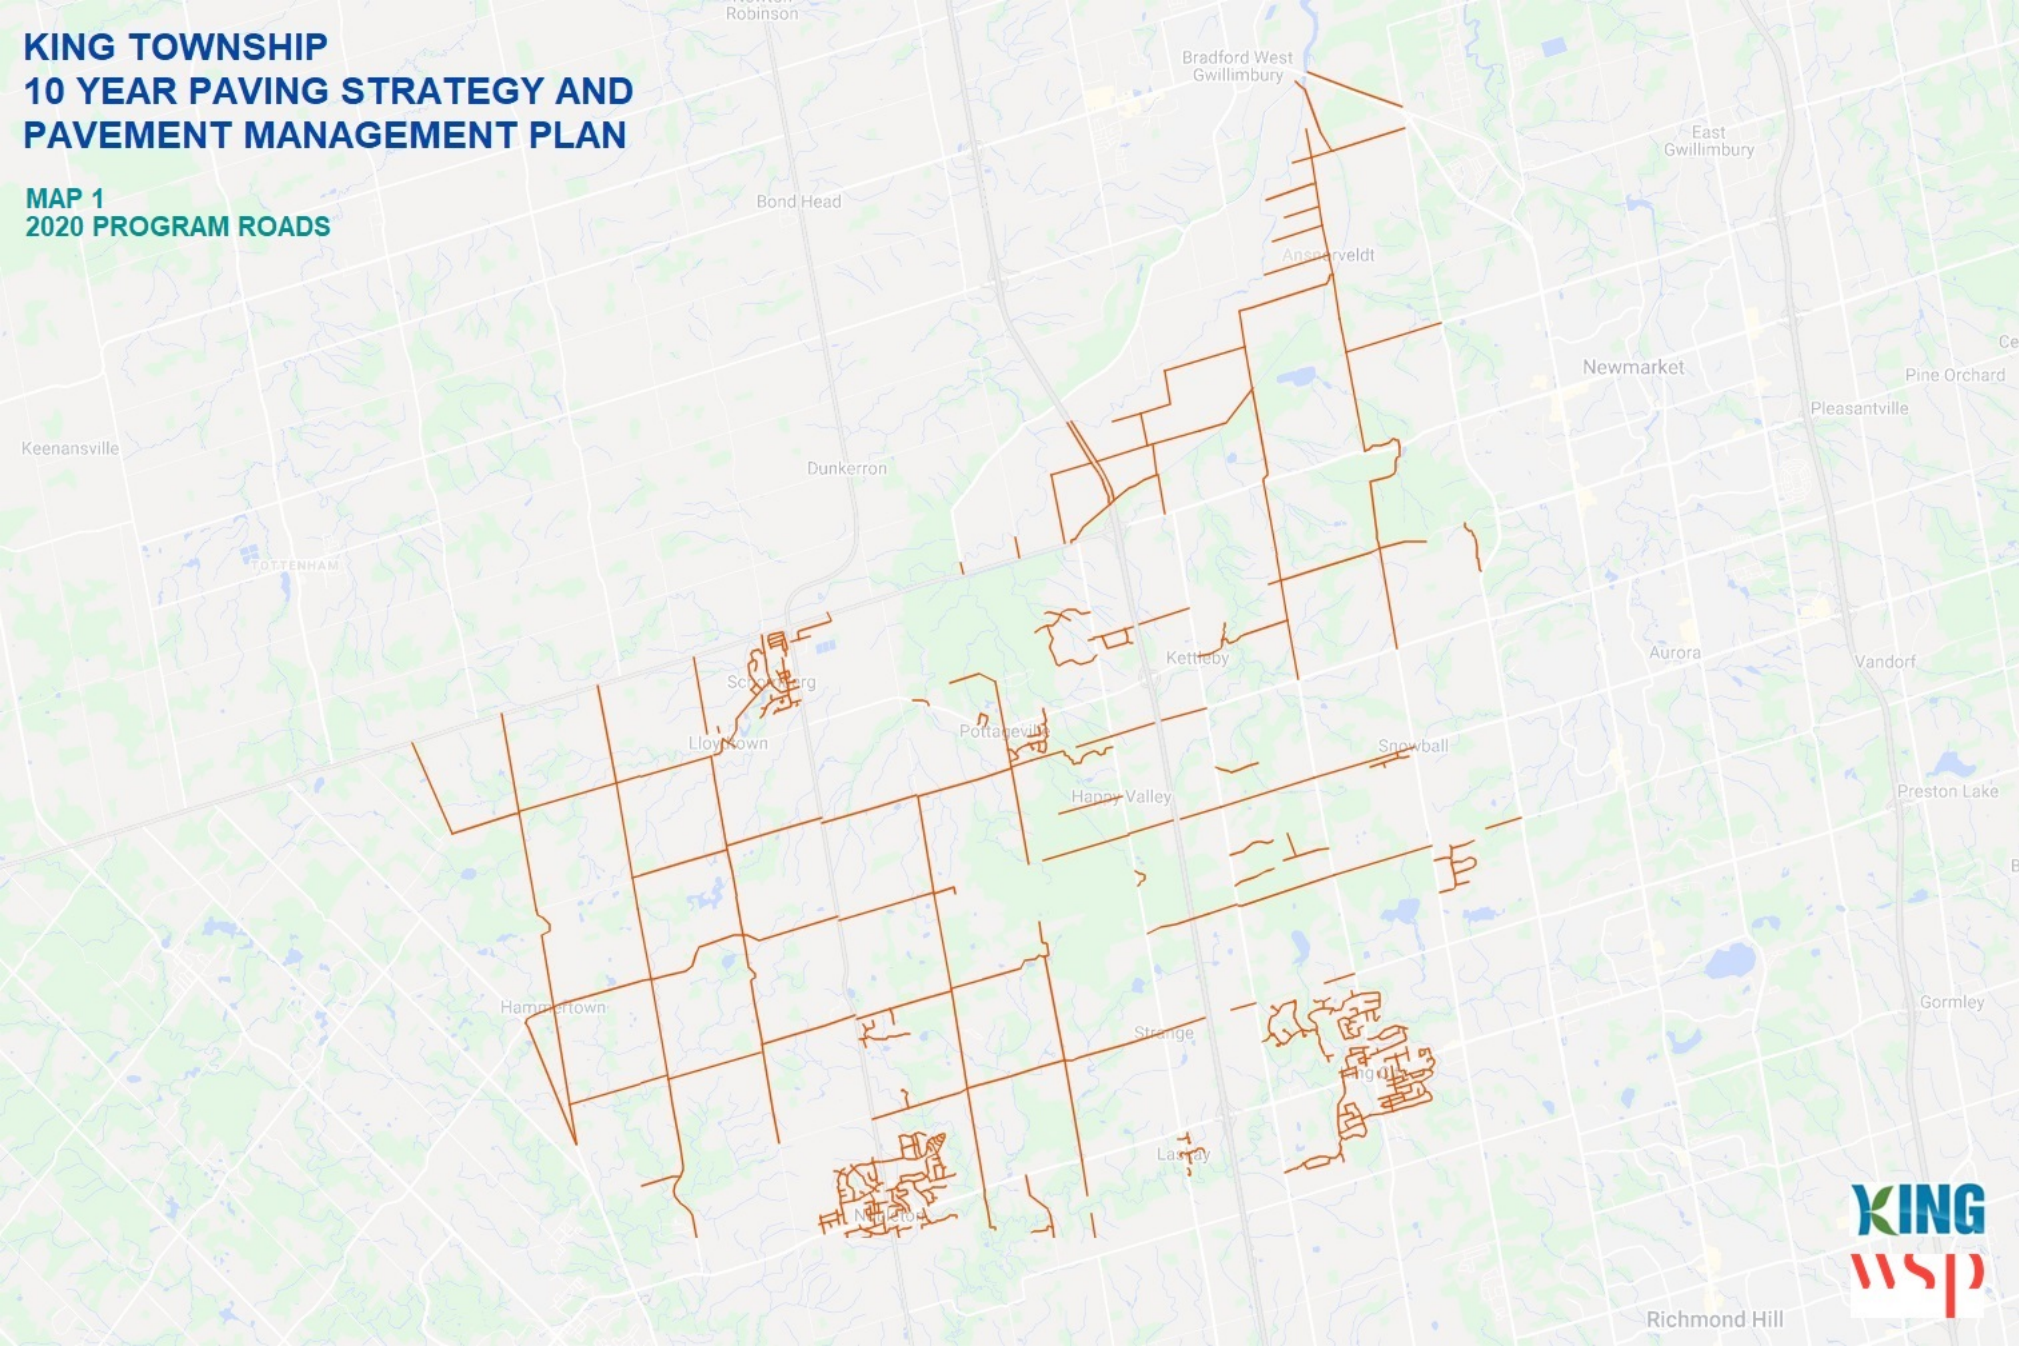
MAP 1
2020 PROGRAM ROADS
