APPENDIX K

Reach Summaries

Township of King
Comprehensive Stormwater Management Plan
Reach Delineation, Crossing and Extent Assessed
Figure K-1: Ansnorveldt

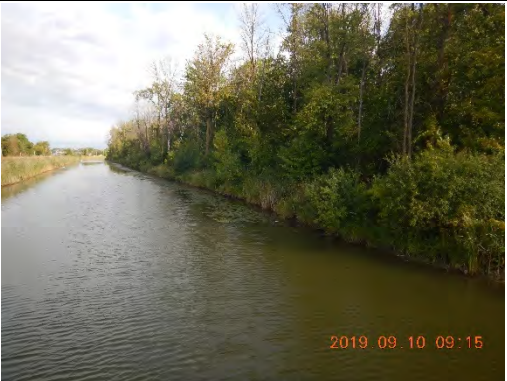
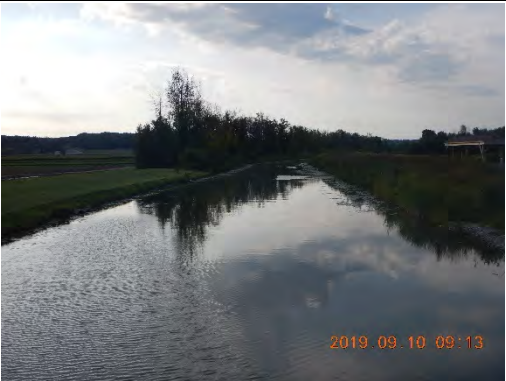
Reach WHG1

Downstream of bridge crossing at Graham Sideroad.		Upstream of bridge crossing at Graham Sideroad.

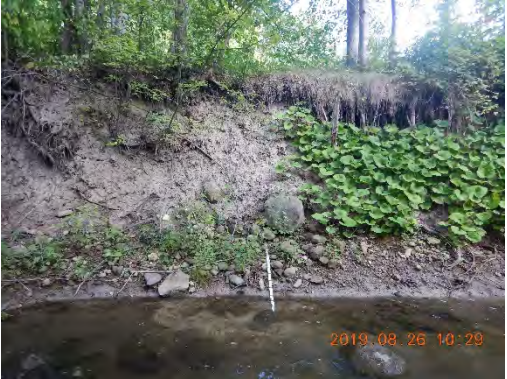
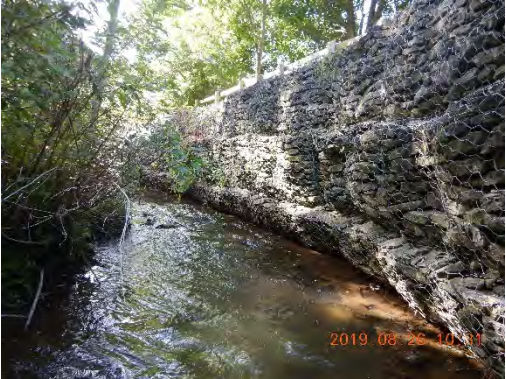
Reach WHK1

Location: Kettleby Road, Kettleby	Watershed: West Holland River	Type of Assessment: Partial Reach
Valley Type: Confined	Land use: Park	Riparian Coverage: Fragmented trees and manicured lawns
Bankfull Width (m): 4.98	Bankfull Depth (m): 0.65	Bed Substrate: Silt, sand, gravel, cobble, boulder, and till
RGA Score: 0.31	RGA Condition: In Transition/Stress	RGA Dominant Process: Evidence of Aggradation
RSAT Score: 28	RSAT Condition: Good	RSAT Limiting Feature: Riparian Habitat Conditions
Down's Channel Evolution: 'M' – lateral migration	Notes: Siltation in pools, lobate bar, valley wall contacts, old cribwall, thalweg out of alignment, and gabion near road was not degraded but was leaning towards channel.

<p>Valley wall contact where vegetation has begun to re-grow along the banks.</p>		<p>Gabion supporting the bank beside a road. Note the gabion is leaning towards channel.</p>

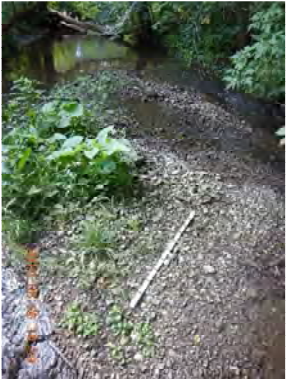
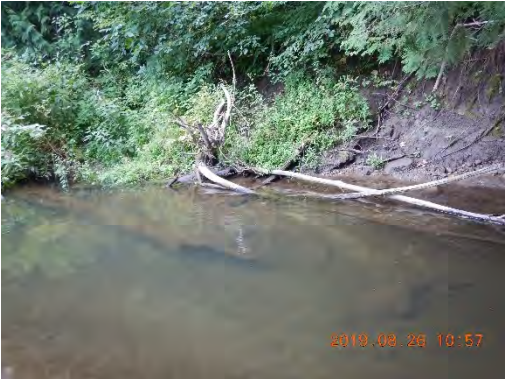
<p>Medial bar located in the middle of the channel. Note the vegetation growing on the bar.</p>		<p>Woody debris located within the channel bed and bank. Note the siltation within the pool.</p>

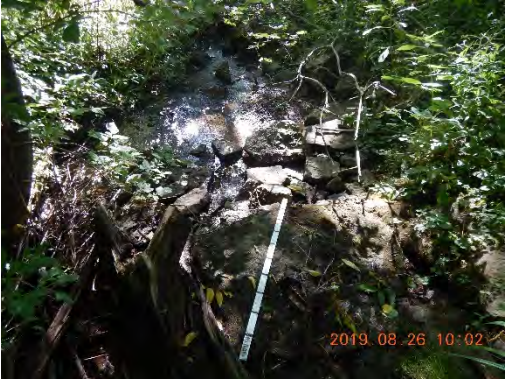
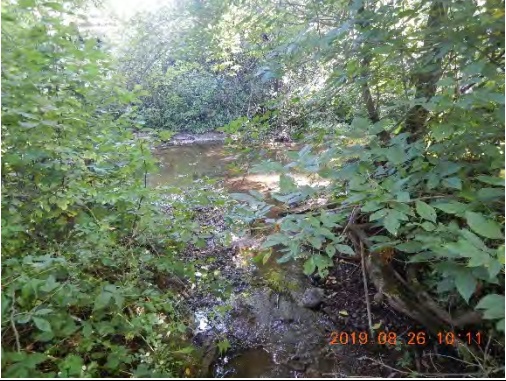
Reach WHK1-1

Valley wall contact along the reach near the downstream extent.		Photograph taken facing downstream towards confluence with reach WHK1 .

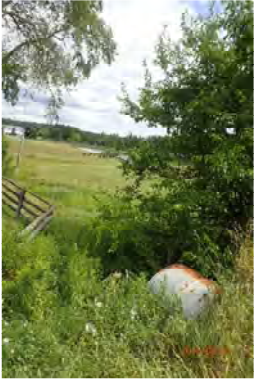
Reach WHK2-3

A wetland feature with no defined channel was observed upstream of the crossing.		Photograph facing upstream towards an agricultural field from where the reach originates.

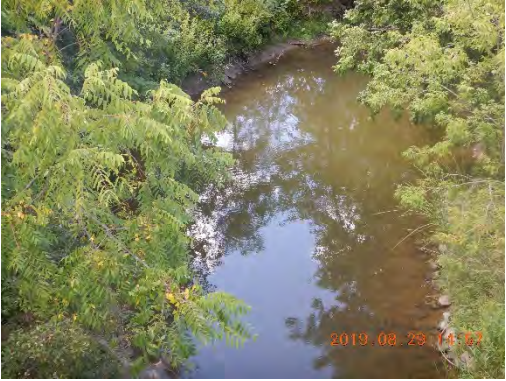
Reach HK1

<p>Photograph facing upstream of Jane Street. Note beaver dam and a riffle sequence flowed under the bridge.</p>		<p>Photograph facing downstream of Jane Street. There was a pool upstream of the bridge with some siltation.</p>

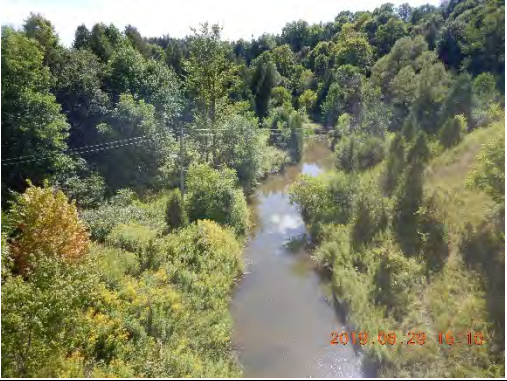
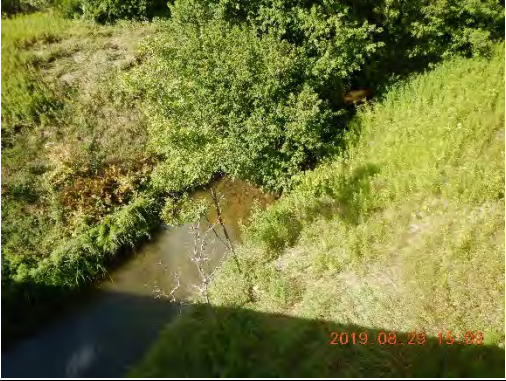
<p>Upstream of King Road the channel flowed through a forest. The reach flowed from Jane Street to King Road.</p>		<p>Downstream of King Road. The reach was partially forested downstream of King Road.</p>

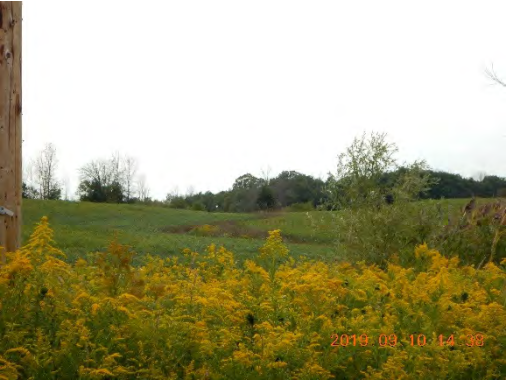
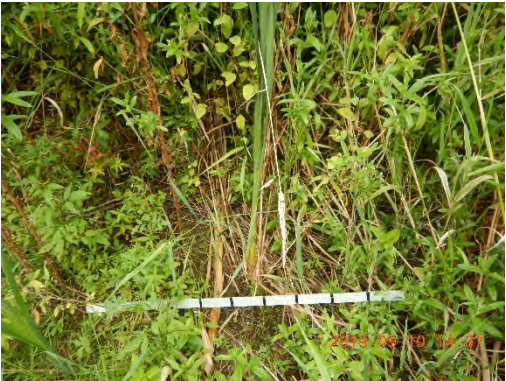
Reach HK1-2b upstream from Jane Street. Reach consisted of a swale flowing through an active agricultural field.		Reach HK1-2b upstream of Jane Street. The reach was heavily encroached with grasses.

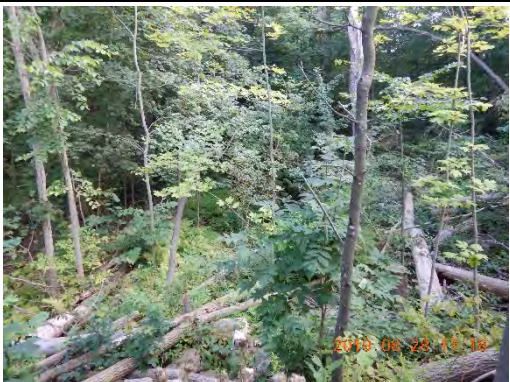
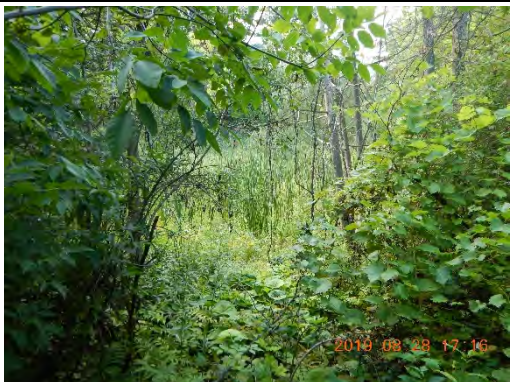
Reach HK1-3

Reach HK1-2 downstream of Kingscross Drive. The reach was not accessible or visible from the road.		Upstream of Kingscross Drive. Feature consisted of a wetland.

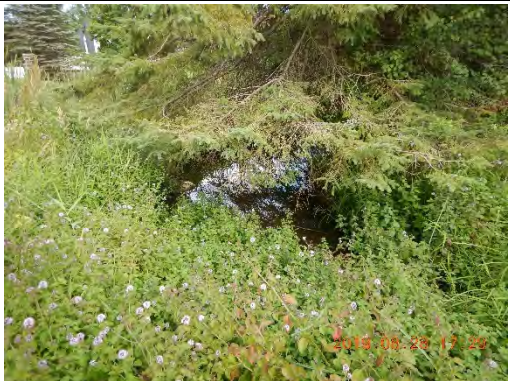
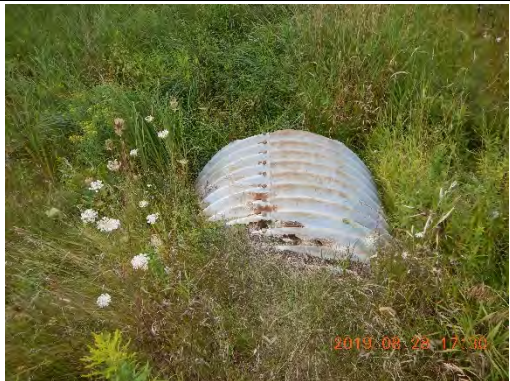
Downstream of Kingsworth Drive, the channel had water but was still poorly defined.		CSP upstream of Kingsworth Drive. There was no defined channel and was heavily encroached with grasses.

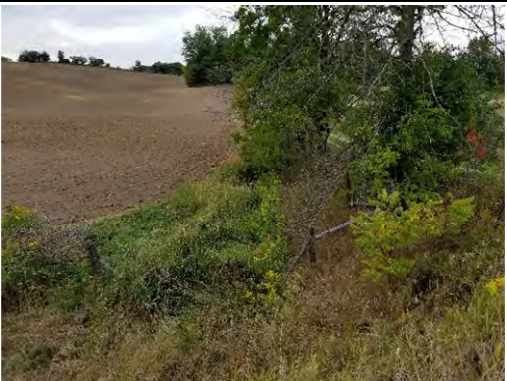
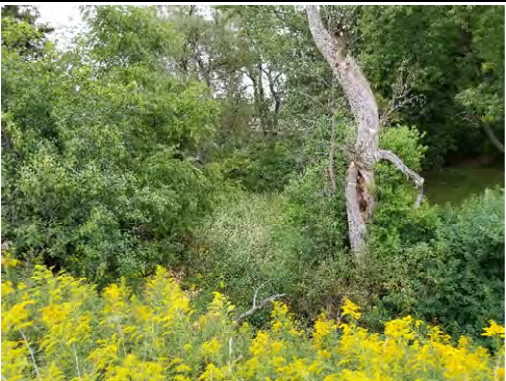
Reach HK1-3a

Upstream of Jane Street, there was no defined feature within the active agricultural field.		Downstream of Jane Street, the channel was more heavily vegetated.

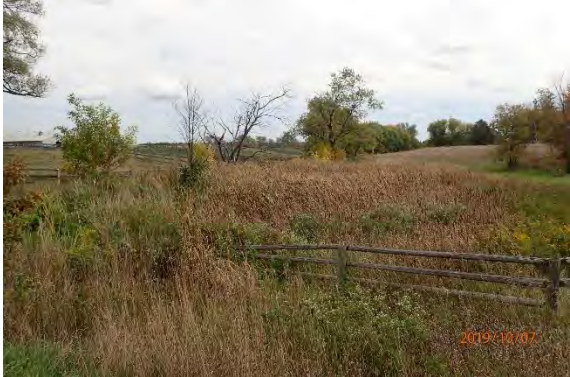
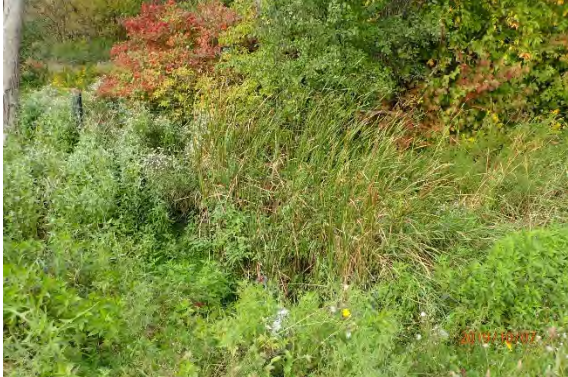
Reach HN1-4

Downstream King Vaughan Road consisted of a swale feature encroached with cattails.		Upstream King Vaughan Road. Feature was forested for this small section of the reach between the two crossings.

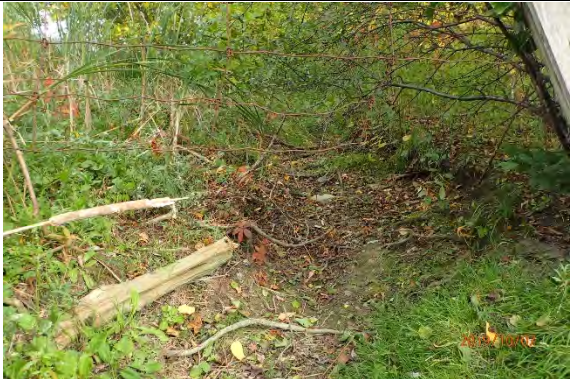
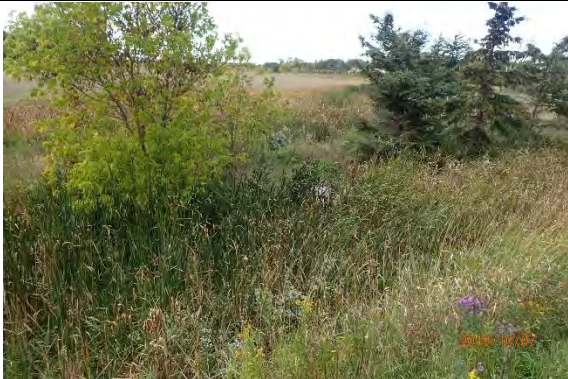
Downstream HWY 27 the channel was defined within the small section between the two crossings.		Upstream HWY 27 consisted of a swale feature encroached with cattails.

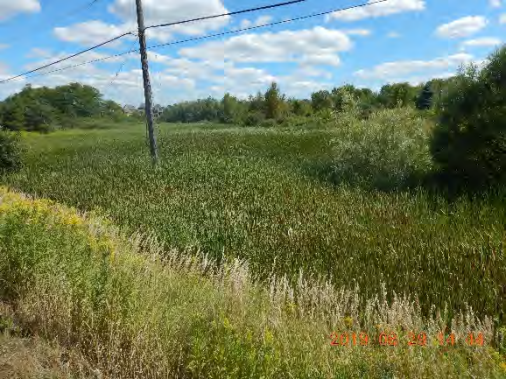
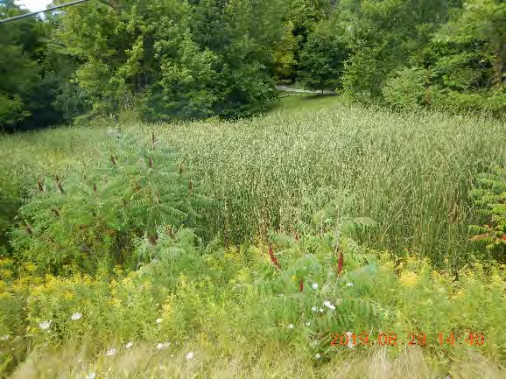
Reach HK2-1 and Reach HK2-2

Reach HK2-2 upstream of King Road. Wetland feature.		Reach HK2-1 downstream of King Road. Wetland feature.

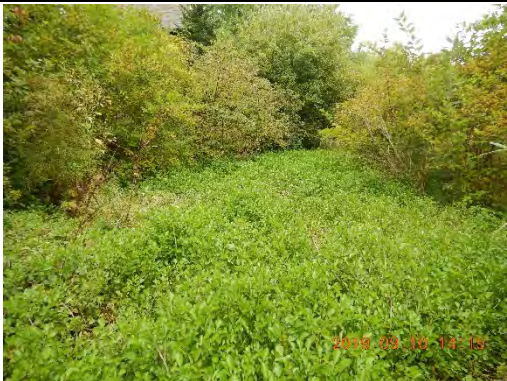
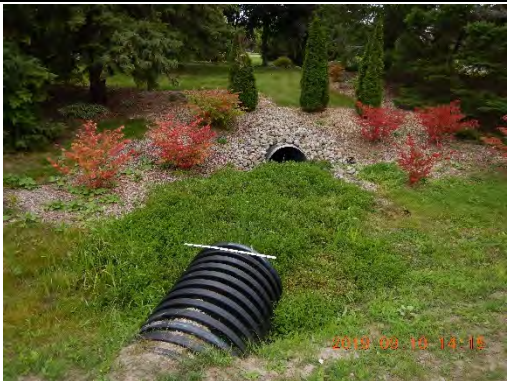
Reach HK2-3

</div></div>		
Downstream of Jane Street the reach flowed through a poorly defined and heavily encroached swale.		The reach was piped upstream of the road crossing and diverted under the road into a CPP.

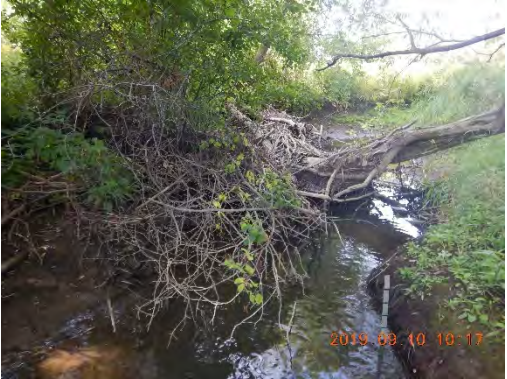
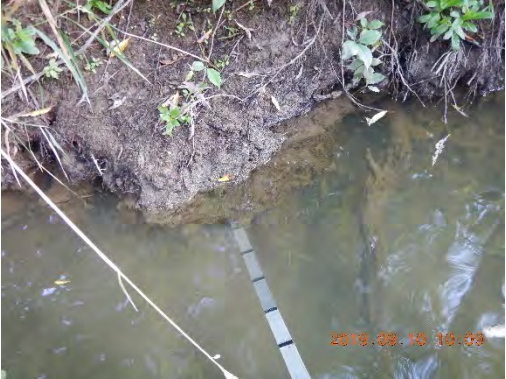
Reach HK3

Location: Martin Street, King City	Watershed: Humber River	Type of Assessment: Partial reach
Valley Type: Unconfined	Land use: Park and forest	Riparian Coverage: Continuous trees and grasses
Bankfull Width (m): 4.50	Bankfull Depth (m): 1.17	Bed Substrate: Clay, silt, sand, gravel, and exposed till
RGA Score: 0.36	RGA Condition: In Transition/ Stress	RGA Dominant Process: Evidence of Degradation & Widening
RSAT Score: 26.5	RSAT Condition: Good	RSAT Limiting Feature: Physical Instream Habitat
Down's Channel Evolution: 'E' – enlarging	Notes: Reach assessed at upstream extent. Observations include elevated storm sewer outlet, fall and leaning trees, and the thalweg was out of alignment.

<p>Photograph facing upstream of a fallen tree narrowing the width of the channel.</p>		<p>Exposed till in the channel.</p>

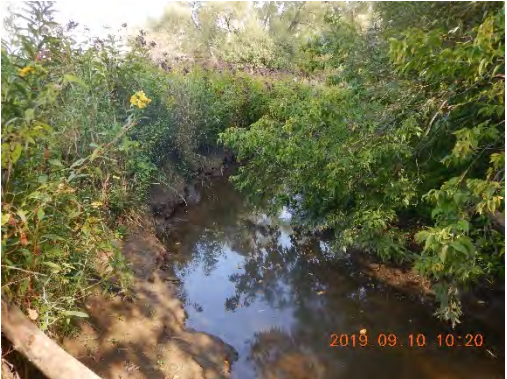
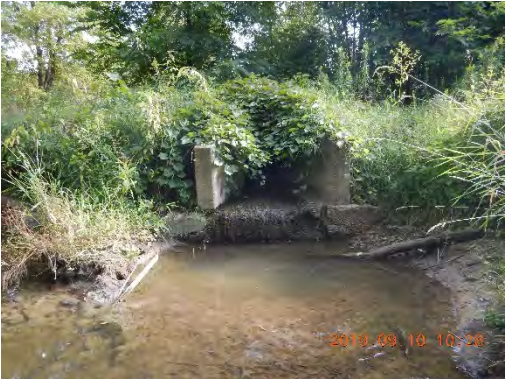
<p>Bank erosion occurring on the outer bank through a meander bend.</p>		<p>Elevated storm water outlet with small scour pool.</p>

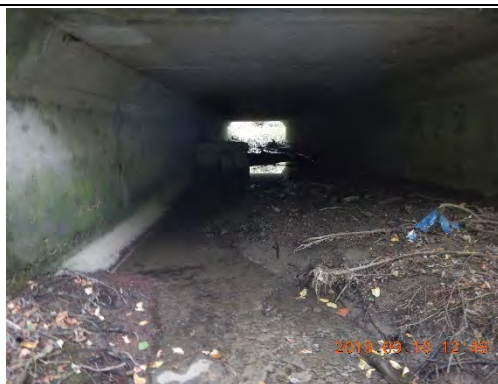
Reach HK3-1

Culvert under Martin Street. There were no bridge footings exposed.

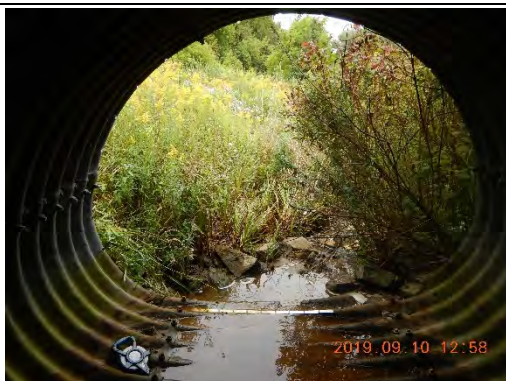
Downstream of King Road. There was iron staining downstream of the CSP. The CSP was elevated but there was no scour pool.

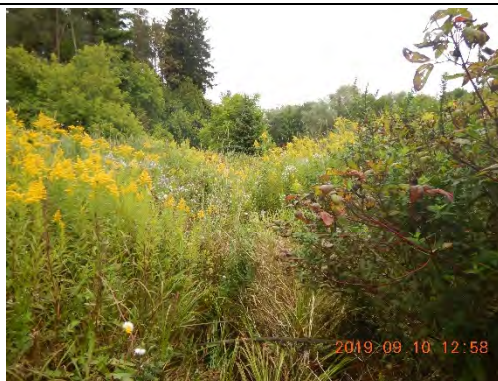
Downstream of King Road. Channel was more confined at upstream extent of reach near King Road.

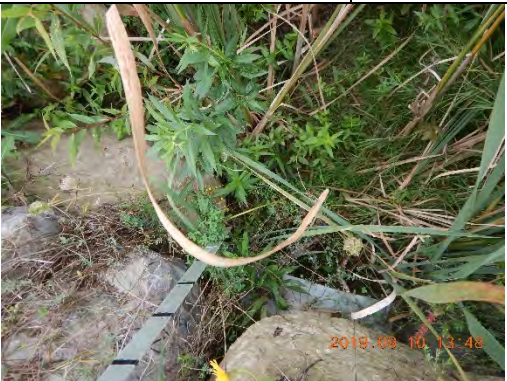
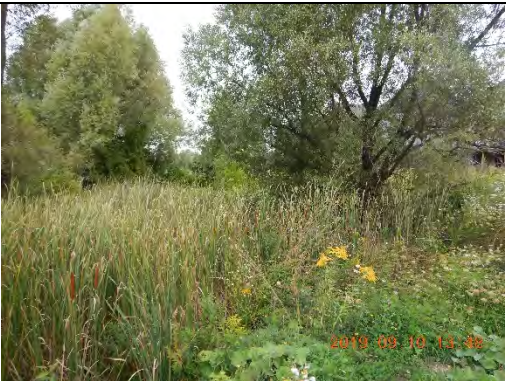
Reach HK3-2a

CSP at trail crossing. There was no defined flow path and the channel was dry at time of assessment.		View of wetland feature from trail crossing.

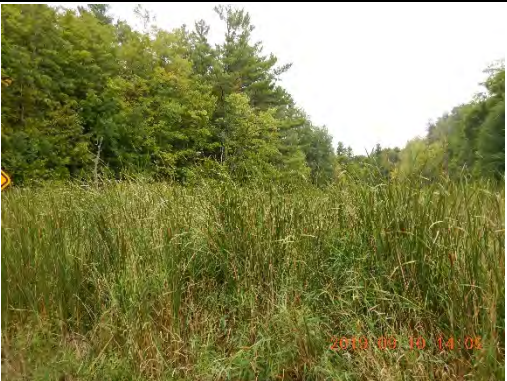
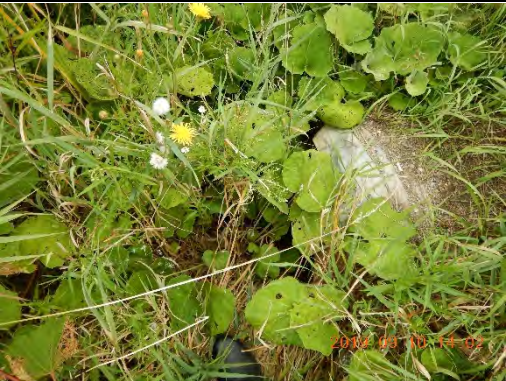
Reach HK3-3

Upstream of King Vaughan Road. The reach consisted of a wetland feature with no defined channel both upstream and downstream of the road crossing.		Photograph of the CSP at the downstream side of King Vaughan Road.

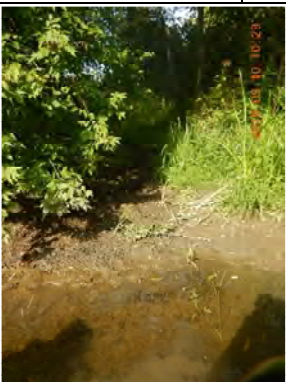
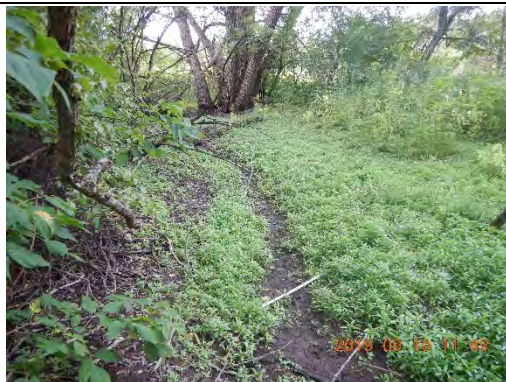
Confluence of reach with HK4 . Reach HK3-4 had a saturated bed at the downstream but was dry.		The downstream extent of the reach was more defined. There were scattered trees at the downstream extent.

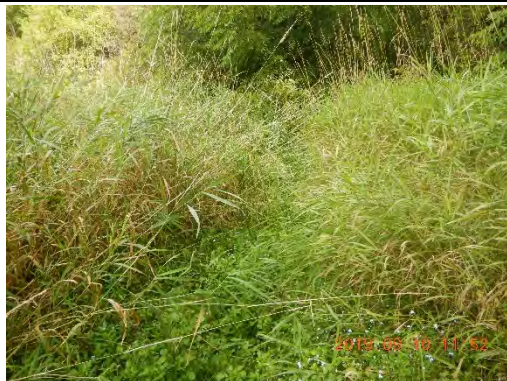
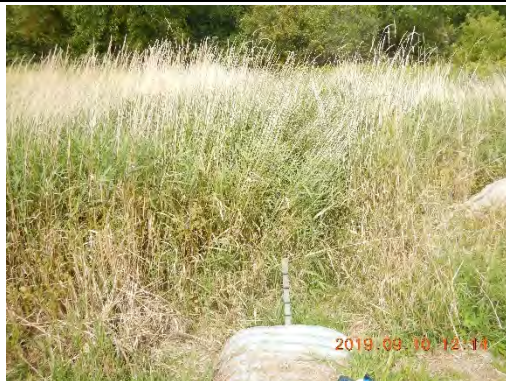
Further upstream from the confluence the reach became undefined.		CSP at trail crossing mid-reach. The channel was undefined upstream and downstream of the trail.

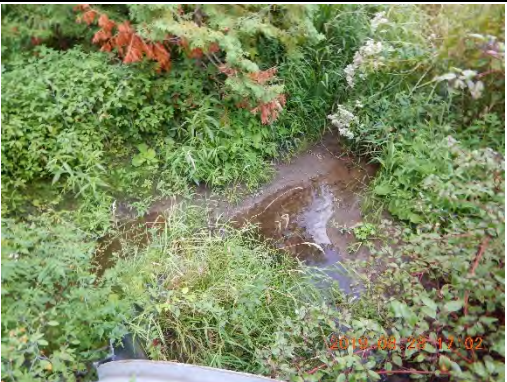
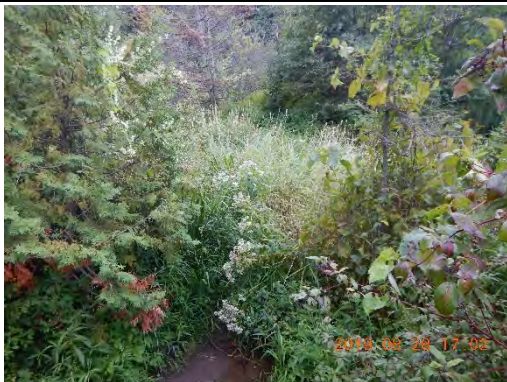
Reach HK3-5

Downstream of road crossing. The reach had flowing water at time of assessment.		Photograph taken facing downstream from Kingscross Drive.

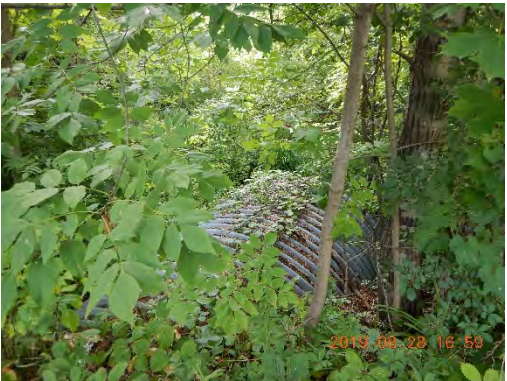
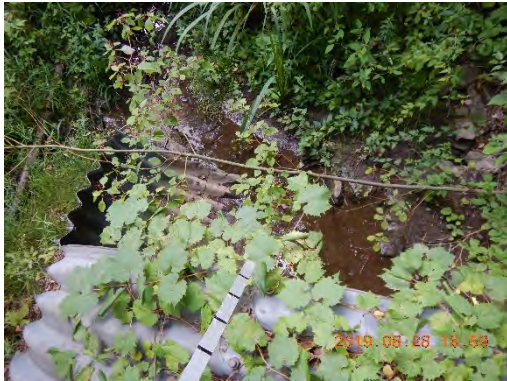
Photograph taken facing upstream from Kingscross Drive. The reach flowed through a forest.		Upstream of Kingscross Drive. Small defined channel with minor bank erosion.

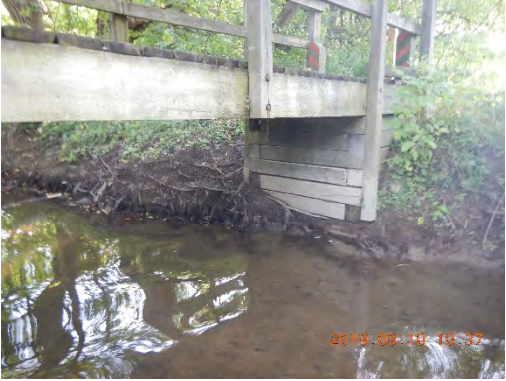
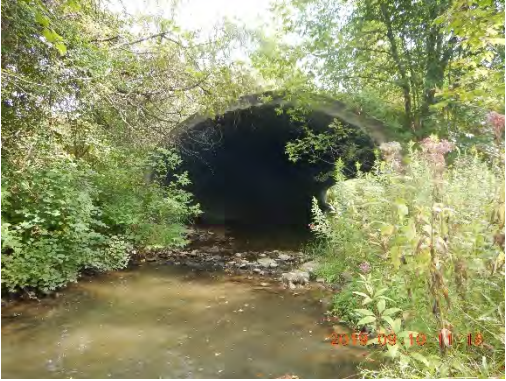
Reach HK4

Location: Norman Drive and Keele Street, King City	Watershed: Humber River	Type of Assessment: Full reach
Valley Type: Partially confined	Land use: Park and residential	Riparian Coverage: Fragmented trees and grasses
Bankfull Width (m): 4.55	Bankfull Depth (m): 0.79	Bed Substrate: Clay, silt, sand, gravel, cobble, boulder, and till
RGA Score: 0.20	RGA Condition: In regime	RGA Dominant Process: Evidence and Widening
RSAT Score: 27	RSAT Condition: Good	RSAT Limiting Feature: Riparian Habitat Conditions
Down's Channel Evolution: 'M' – lateral migration	Notes: Observations include exposed roots, leaning trees and fences, chutes, leaning fence, old gabion basket intact, and siltation in pools. Erosion concerns at this reach.

Photograph taken facing erosion along the left bank and leaning fence at the back of a residential property.		Photograph taken facing upstream towards Keele Street crossing.

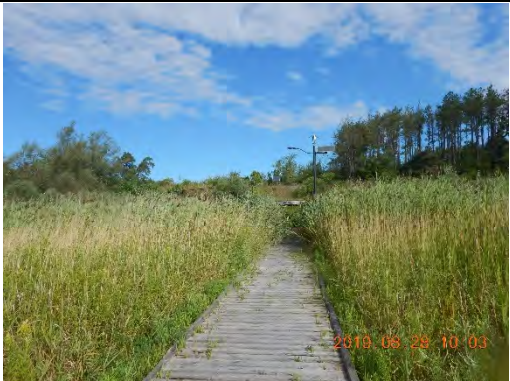
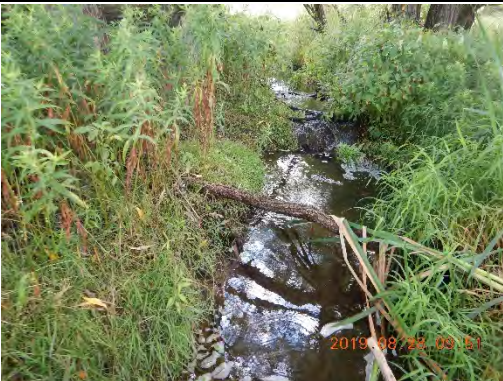
Reach HK4-2

Wetland feature at the downstream extent near rail crossing with no defined channel. Photograph taken along the trail crossing.		Downstream of King Road, the channel was more defined near willow trees. Note the woody debris and rooted knickpoint in channel.

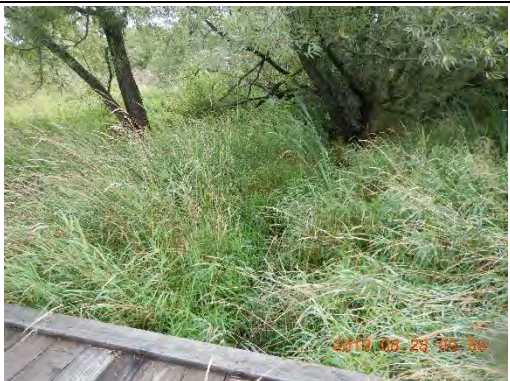
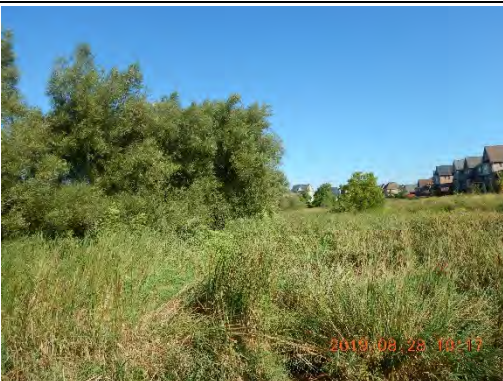
The reach lost definition again downstream of willow trees.		Upstream of King Road, the reach had no definition and was a wetland. Channel was dry with few pockets of standing water.

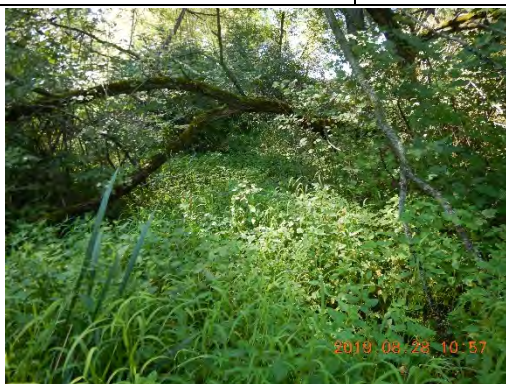
Reach HK4-2a

Downstream extent of the reach near the confluence. The reach consisted of a wetland feature.

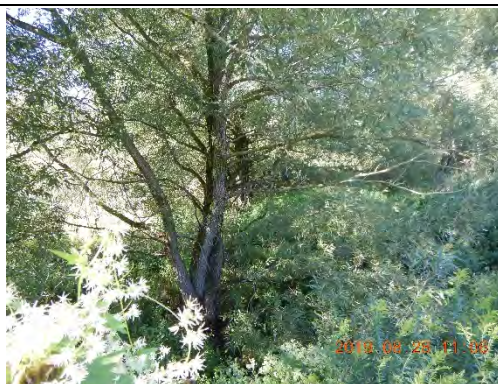
Downstream of Spring Hill Drive. The reach remained undefined. Riparian vegetation consisted of trees and grasses.

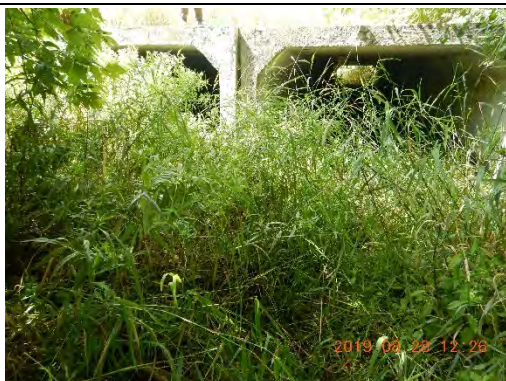
There were two box culverts under Dufferin Street. The culvert had no water flowing at time of assessment. One culvert was open bottom and the other was closed bottom.

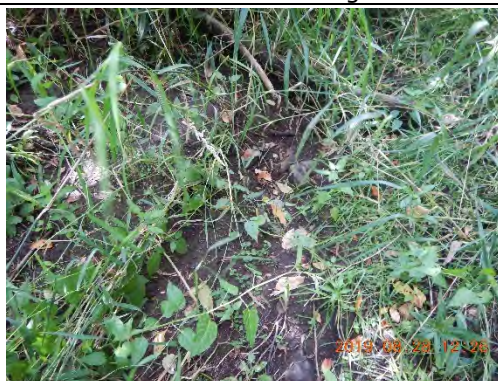
Upstream of Dufferin Street there was a small flow path approximately 0.30 m wide. The path had grasses growing on the bed and was dry at the time of assessment.

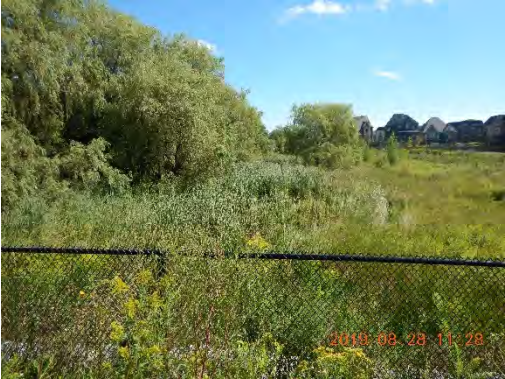
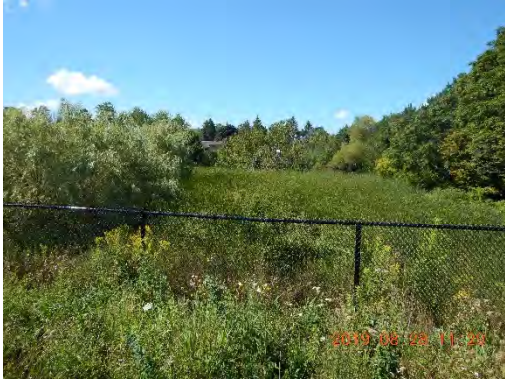
Reach HK4-3

Downstream of Lavender Valley Road. The reach was a wetland feature with no defined channel.		Upstream of Lavender Valley Road.

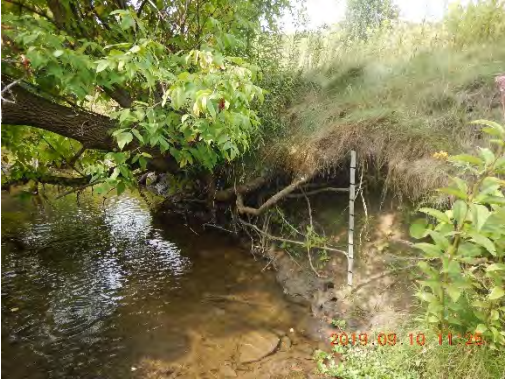
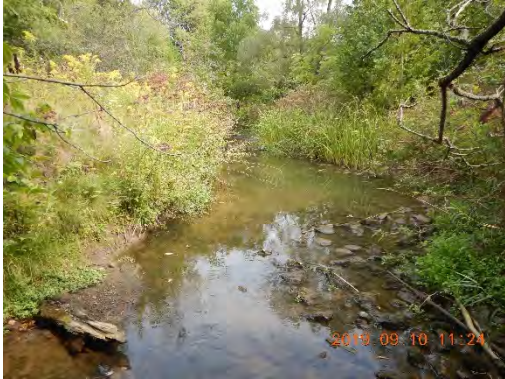
Reach HK5

Photograph taken facing downstream. Leaning tree and eroded break near downstream reach break.		Rip rap was noted in riffles and siltation was noted in pools.

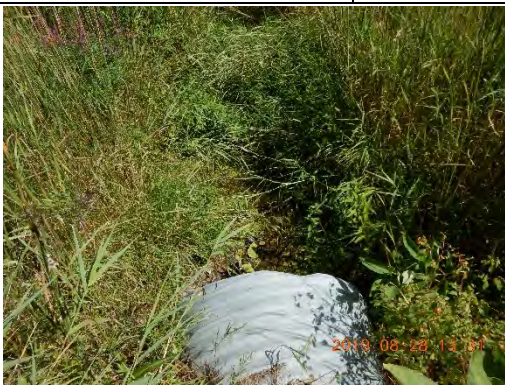
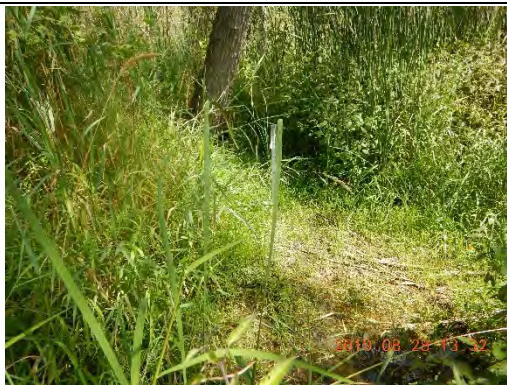
Reach HK5-2

</div></div>		
Downstream of Keele Street. There was not water flowing through the pipe.		No channel definition and high vegetation encroachment downstream of Keele Street.

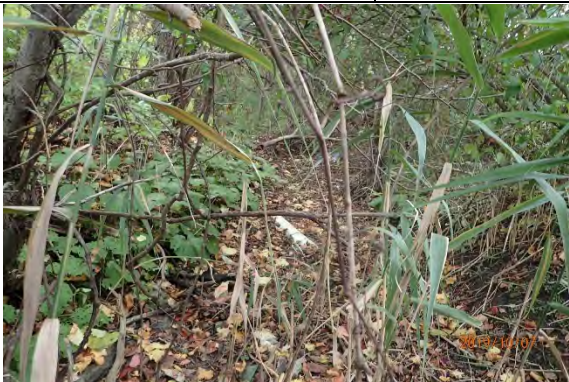
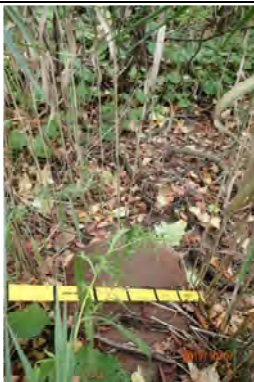
Reach HK5-2b and Reach HK5-2c

Reach HK5-2b downstream of 15 th Sideroad. A defined channel was present within the woodlot.	Reach HK5-2b downstream of 15 th Sideroad. Feature was dry at the time of assessment.

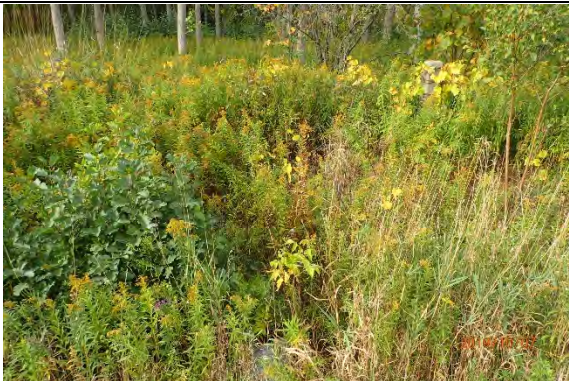
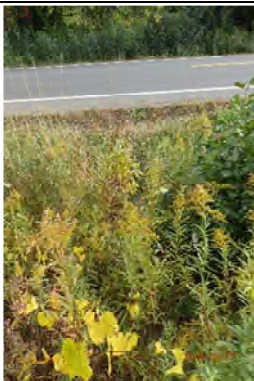
Reach HK5-2c upstream of 15 th Sideroad. No flowpaths were observed from the northern property.	Reach HK5-2c upstream 15 th Sideroad consisted of a roadside ditch.

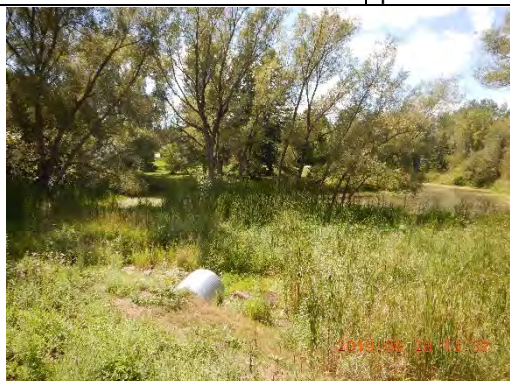
Reach HK5-3

Photograph upstream of Keel Street. Note large pond on residential property.

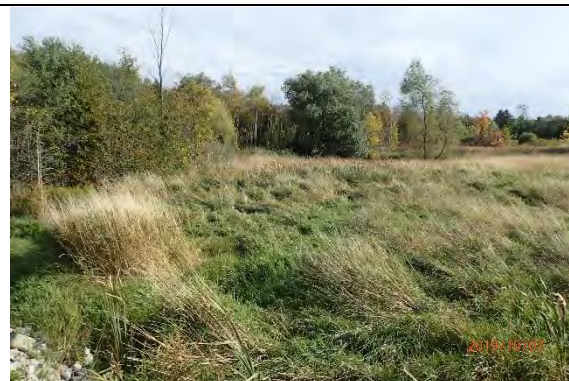
Photograph downstream of 15th Sideroad.

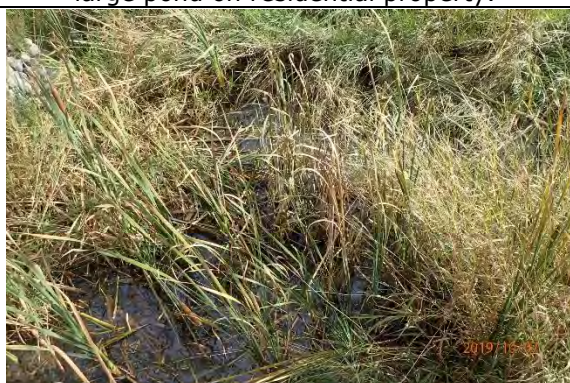
Photograph downstream of 15th Sideroad. A poorly defined swale feature with standing water was noted.

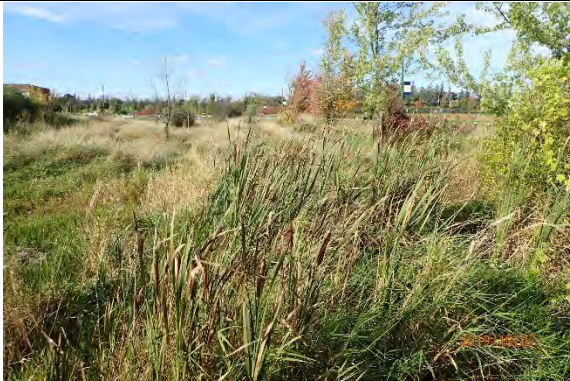
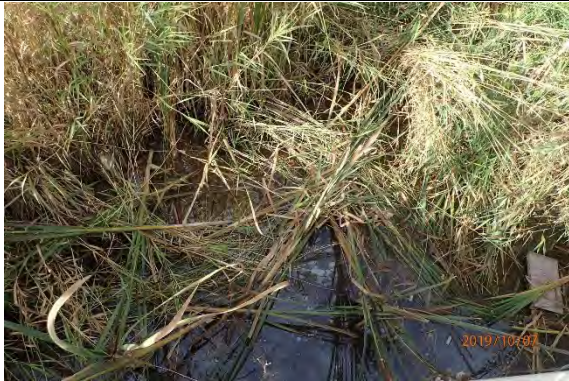
Reach HK5-4

Location: 15 th Sideroad, King City	Watershed: Humber River	Type of Assessment: Roadside
Valley Type: Unconfined	Land use: Residential and Institutional	Riparian Coverage: Continuous grasses
Bankfull Width (m): N/A	Bankfull Depth (m): N/A	Bed Substrate: Clay and silt
RGA Score: N/A	RGA Condition: N/A	RGA Dominant Process: N/A
RSAT Score: N/A	RSAT Condition: N/A	RSAT Limiting Feature: N/A
Down's Channel Evolution: 'S' - stable	Notes: Roadside assessment at 15 th Sideroad. The reach consisted of a straightened swale feature through a school property.

Photograph upstream of 15 th Sideroad. Straight swale feature was observed.		Standing water was present within the poorly defined swale.

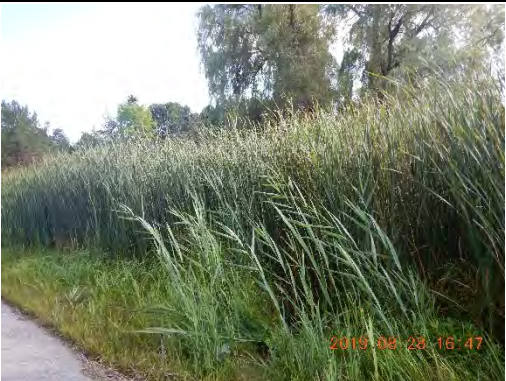
Reach HK5-3a

Location: Lockhart Lane, King City	Watershed: Humber River	Type of Assessment: Roadside
Valley Type: Unconfined	Land use: Residential	Riparian Coverage: Continuous grasses and trees
Bankfull Width (m): N/A	Bankfull Depth (m): N/A	Bed Substrate: N/A
RGA Score: N/A	RGA Condition: N/A	RGA Dominant Process: N/A
RSAT Score: N/A	RSAT Condition: N/A	RSAT Limiting Feature: N/A
Down's Channel Evolution: 'S' – stable	Notes: Roadside assessment at Lockhart Lane. Reach consisted of a wetland feature. CPP completely submerged on both sides of crossing.

Downstream of Lockhart Lane. The CPP was submerged.		Wetland feature upstream of Lockhart Lane.

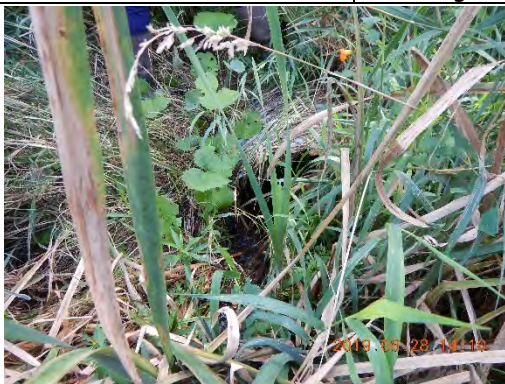
Reach **HK6-2a** was downstream of 15th Sideroad. The channel was undefined.

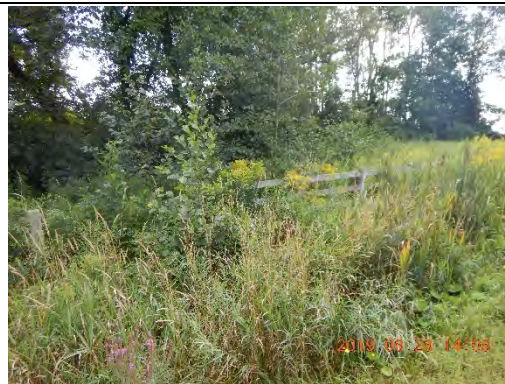
Downstream of 15th Sideroad, reach **HK6-2a** consisted of a wetland feature.

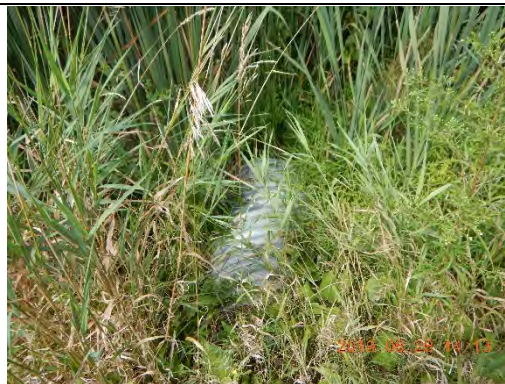
Reach **HK6-2b** was an undefined wetland feature with lots of cattails.

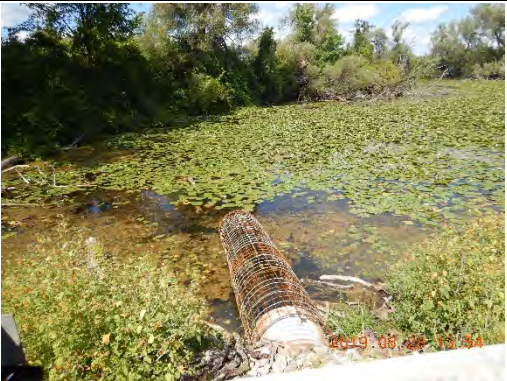
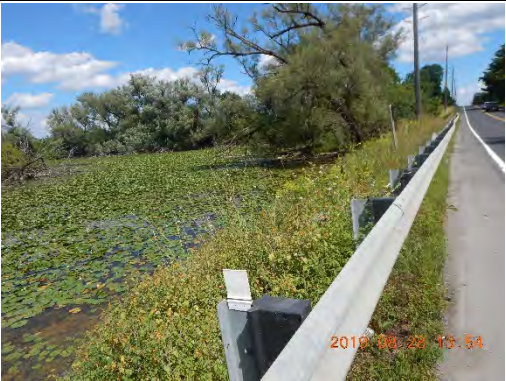
Reach HK6-4 was upstream of 15 th Sideroad. The reach was the downstream end of Lake Seneca. Note the beaver cage.		The pond upstream of 15 th Sideroad (reach HK6-4).

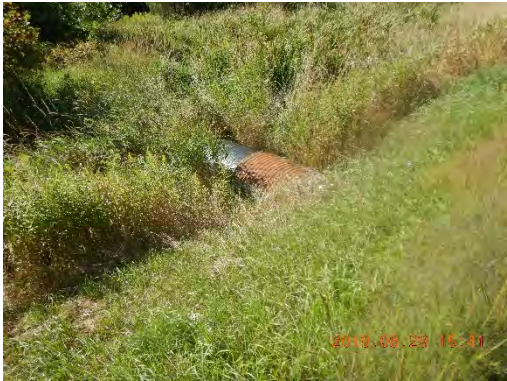
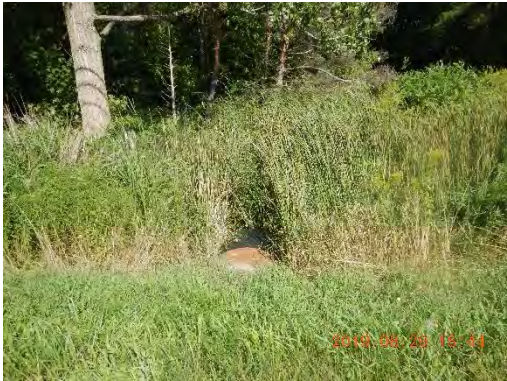
Reach HK8

Location: Jane Street, King City	Watershed: Humber River	Type of Assessment: Roadside
Valley Type: Unconfined	Land use: Agricultural and residential	Riparian Coverage: Continuous trees and grasses
Bankfull Width (m): N/A	Bankfull Depth (m): N/A	Bed Substrate: N/A
RGA Score: N/A	RGA Condition: N/A	RGA Dominant Process: N/A
RSAT Score: N/A	RSAT Condition: N/A	RSAT Limiting Feature: N/A
Down's Channel Evolution: N/A	Notes: Roadside assessment at Jane Street. The channel was dry and not well defined.	
<div><div>

<p>2019.06.23 15:44</p></div></div>		
<div><div>Downstream of Jane Street. There was a CPP inside a CSP.</div><div>Upstream of Jane Street. The channel had little definition both upstream and downstream.</div></div>

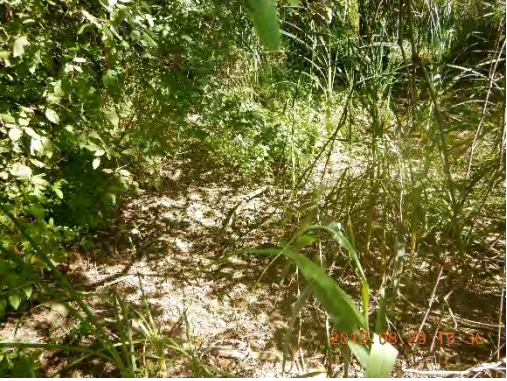
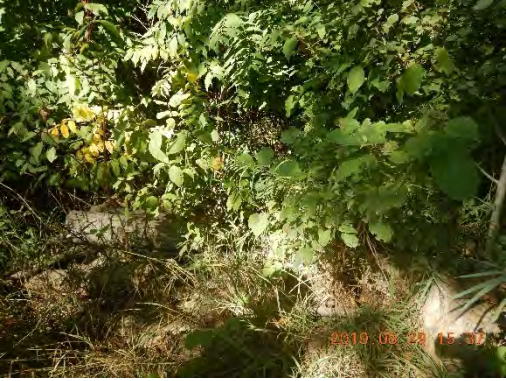
Reach HK8-1

Location: Summit Farm Road, King City	Watershed: Humber River	Type of Assessment: Roadside
Valley Type: Unconfined	Land use: Residential	Riparian Coverage: Fragmented trees and grasses
Bankfull Width (m): N/A	Bankfull Depth (m): N/A	Bed Substrate: N/A
RGA Score: N/A	RGA Condition: N/A	RGA Dominant Process: N/A
RSAT Score: N/A	RSAT Condition: N/A	RSAT Limiting Feature: N/A
Down's Channel Evolution: N/A	Notes: Roadside assessment at Summit Farm Road. The channel was dry and not well defined.

No defined channel downstream of Summit Farm Road.		No defined channel upstream of Summit Farm Road.

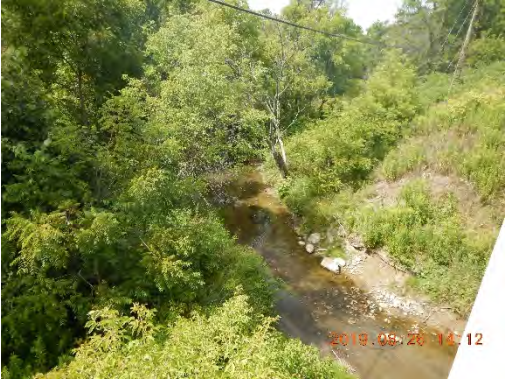
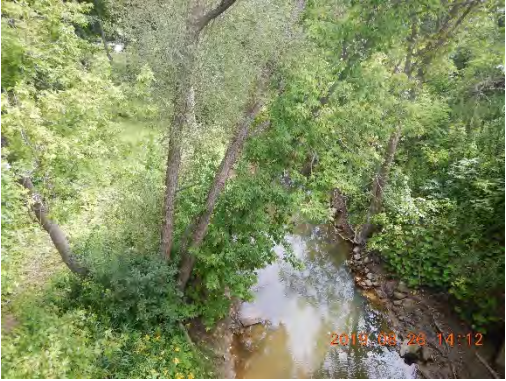
Reach HL1 and Reach HL2

Reach HL1 downstream of Weston Road.		Reach HL2 upstream of Weston Road. Note manicured lawns to the top of bank.

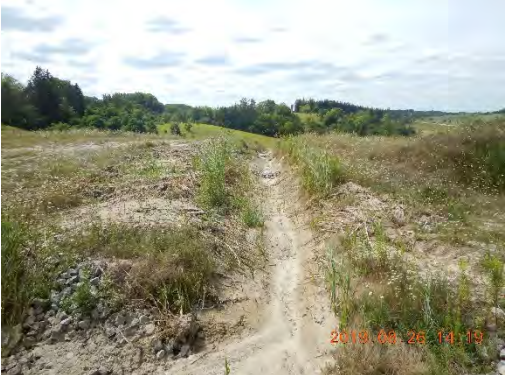
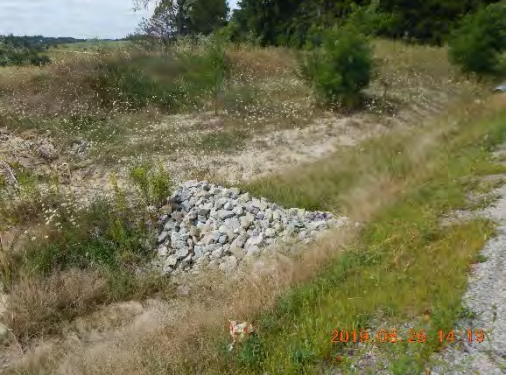
Location: Weston Road, Laskay	Watershed: Humber River	Type of Assessment: Roadside
Valley Type: Unconfined	Land use: Residential (construction)	Riparian Coverage: Fragmented grasses
Bankfull Width (m): N/A	Bankfull Depth (m): N/A	Bed Substrate: Clay and silt
RGA Score: N/A	RGA Condition: N/A	RGA Dominant Process: N/A
RSAT Score: N/A	RSAT Condition: N/A	RSAT Limiting Feature: N/A
Down's Channel Evolution: N/A	Notes: Roadside assessment at Weston Road. The reach was fed by the roadside ditches. Rock check dams were noted along the reach and roadside ditches. Reach HL1-2a had been previously straightened.

Photograph taken facing downstream from Weston Road. Reach had been straightened. Note rock check dam further down the reach.		Reach was fed by roadside ditches on the west side of Weston Road. Rock check dams were also present within the roadside ditches.

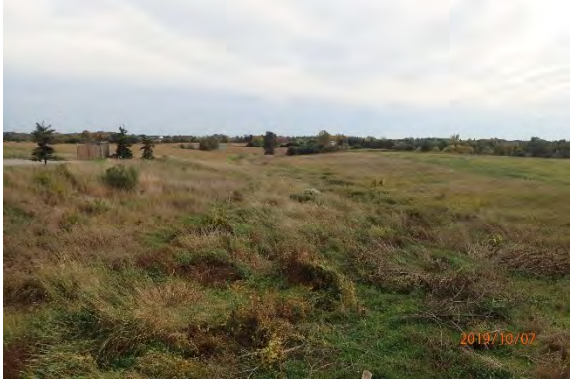
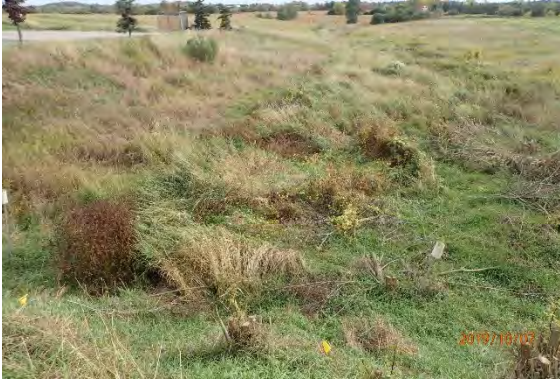
Reach HL2-2a downstream of King Road. The riparian zone was wide within the shallow valley.		Reach HL2-2a downstream of King Road was poorly defined swale feature with moderate vegetation encroachment.

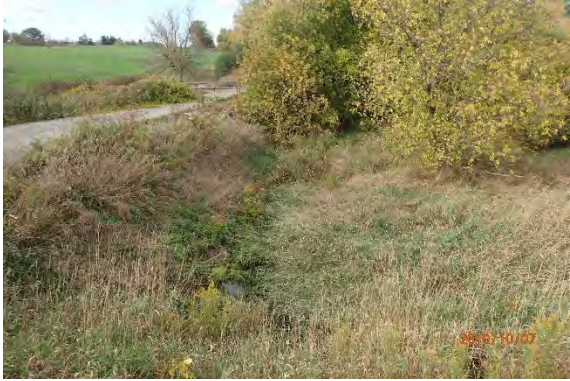
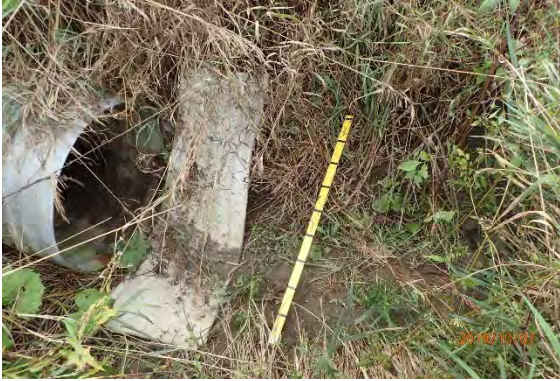
Reach HL2-2b upstream of King Road. There reach was moderately entrenched from the adjacent driveway.		Reach HL2-2b upstream of King Road. The reach has more channel definition than downstream.

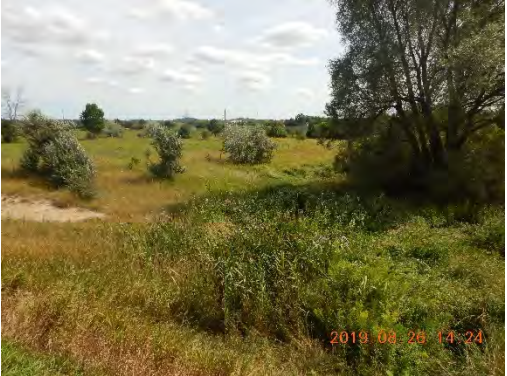
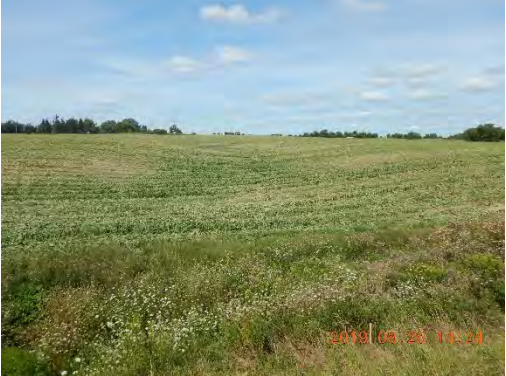
Reach HL2-3 and Reach HL2-4

Location: King Road, Laskay	Watershed: Humber River	Type of Assessment: Roadside
Valley Type: Unconfined	Land use: Agricultural and residential	Riparian Coverage: (HL2-3) Continuous trees and grasses
Bankfull Width (m): N/A	Bankfull Depth (m): N/A	Bed Substrate: N/A
RGA Score: N/A	RGA Condition: N/A	RGA Dominant Process: N/A
RSAT Score: N/A	RSAT Condition: N/A	RSAT Limiting Feature: N/A
Down's Channel Evolution: 'S' – stable	Notes: Roadside assessment at King Road. Reach HL2-3 was downstream of King Road. Reach HL2-3 consisted of a swale feature. Reach HL2-4 was upstream of King Road. Reach HL2-4 was a poorly defined swale with no riparian vegetation.

Reach HL2-3 downstream of King Road. The feature was present, with no defined banks.		Reach HL2-4 was upstream of King Road. Poorly defined swale feature within active agricultural field.
