Reach WHSL6

Location: Church Street, Lloydtown	Watershed: Humber River	Type of Assessment: Roadside
Valley Type: Unconfined	Land use: Residential	Riparian Coverage: Fragmented trees and grasses
Bankfull Width (m): 5.75	Bankfull Depth (m): 1.08	Bed Substrate: Clay, silt, and sand
RGA Score: N/A	RGA Condition: N/A	RGA Dominant Process: N/A
RSAT Score: N/A	RSAT Condition: N/A	RSAT Limiting Feature: N/A
Down's Channel Evolution: N/A	Notes: Roadside assessment at Church Street and Centre Street. Soft sediment accumulation from downstream pond. No erosion concerns visible from either road crossing.

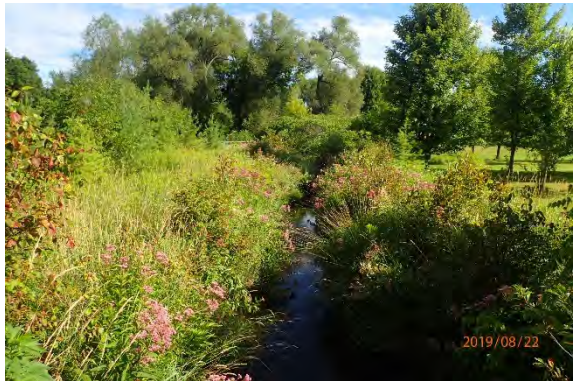
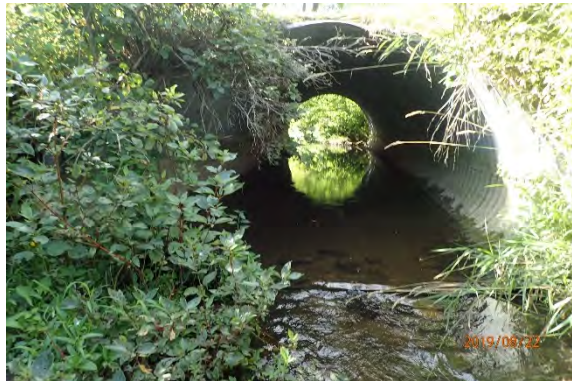
Photograph taken facing downstream from Centre Street. Channel was narrower with a few riffles present compared to Church Street.	Photograph taken facing upstream towards 3 m CSP at Centre Street. No erosion concerns upstream or downstream of the crossing.

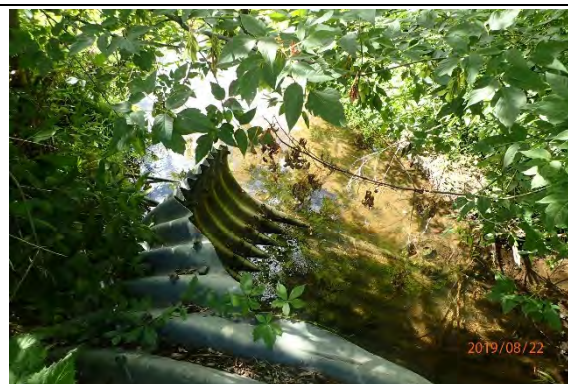
The CSP upstream of Centre Street was misaligned with channel creating a possible concern.

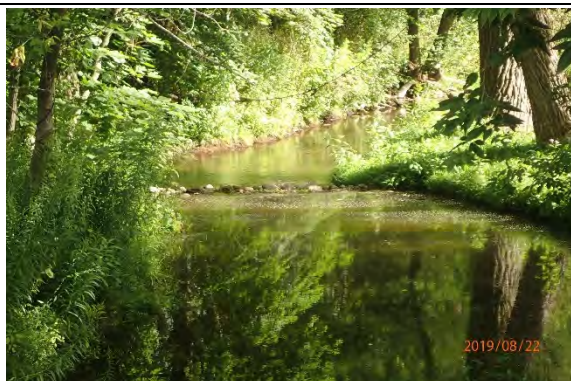
Downstream of Rebellion Way, a cobble stone weir structure was causing sedimentation and pooling upstream.

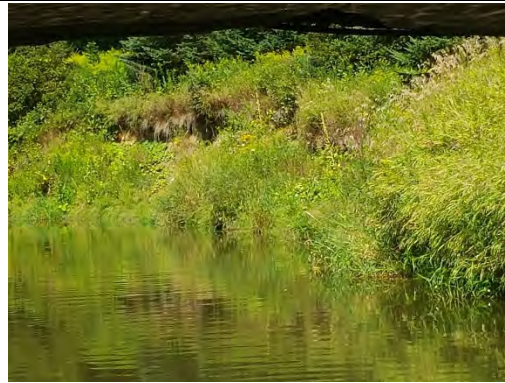
Photograph looking upstream at a vegetated bank where a slump had previously occurred.

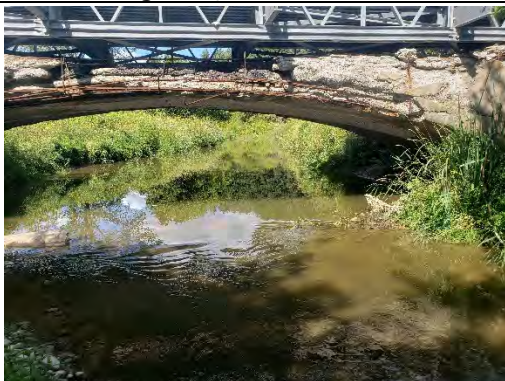
Newly renovated bridge crossing at King Vaughan Road. Photograph is looking upstream.

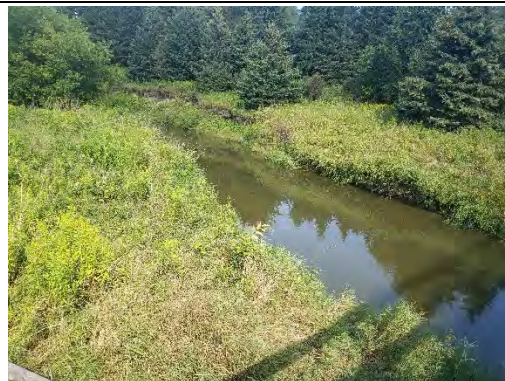
Upstream extent of the bridge crossing. Riparian vegetation consisted of fragmented grasses and trees.

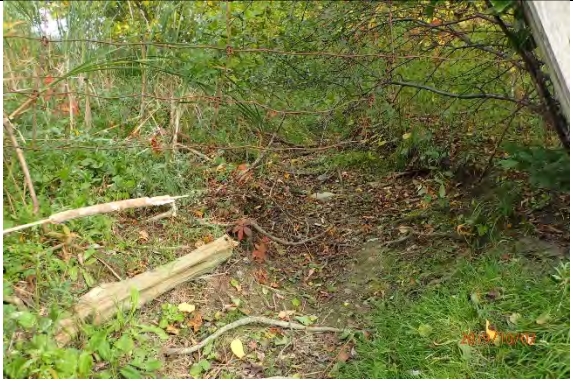
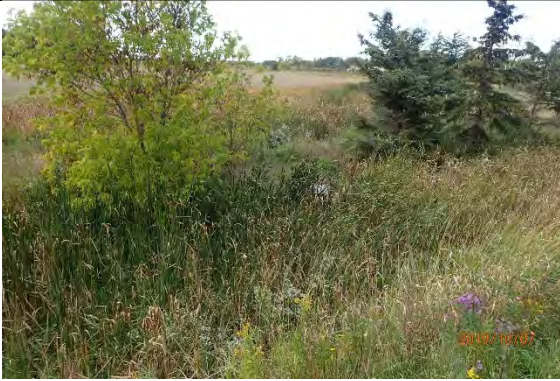
Downstream HWY 27 the channel was defined within the small section between the two crossings.	Upstream HWY27 consisted of a swale feature encroached with cattails.

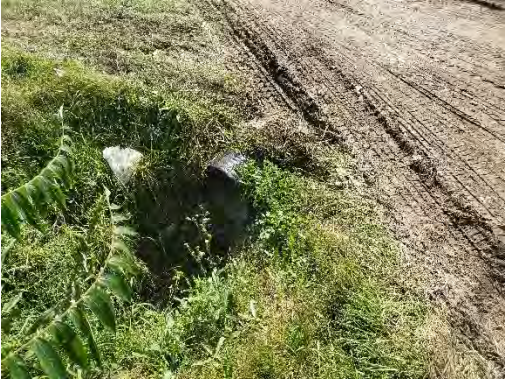
Newly built driveway at the downstream extent of the crossing.	Pipe located under the new driveway at the downstream extent. The pipe outlets parallel to the road into a roadside ditch.

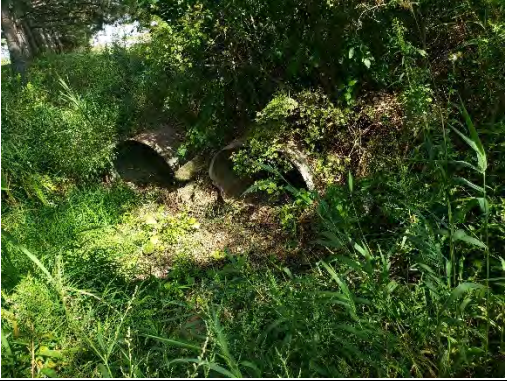
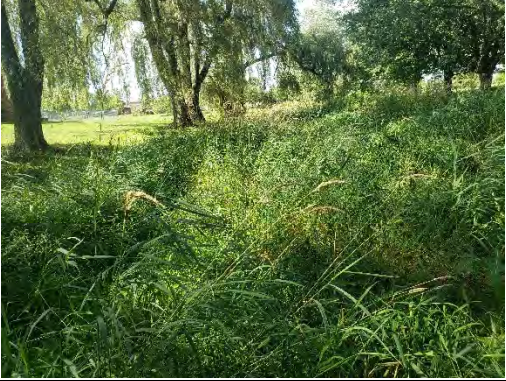
Double concrete steel pipes at the upstream extent of the crossing. The channel was dry at the time of the assessment.	Photograph looking upstream at the dry channel. Grasses were growing in the channel.

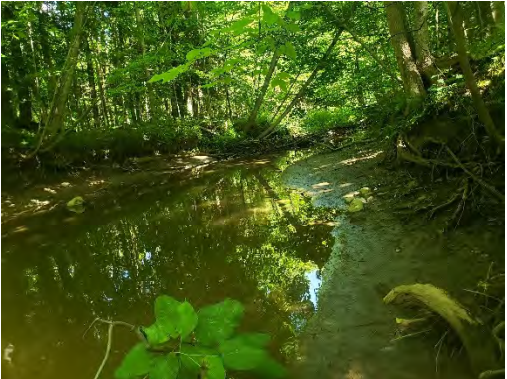
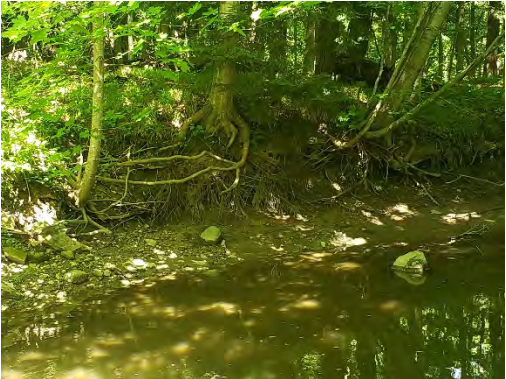
Photograph looking downstream of reach HN2 . Note the leaning trees and the exposed roots.	Exposed roots, j-trunk trees, leaning trees, and undercutting present downstream of the crossing.

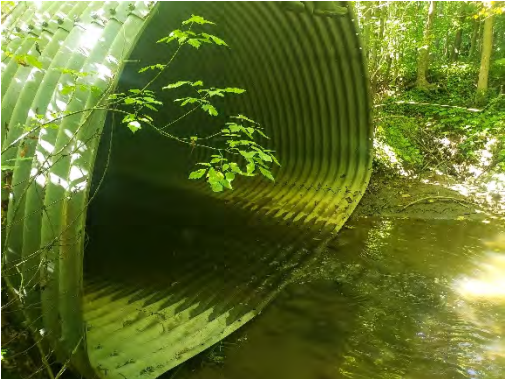
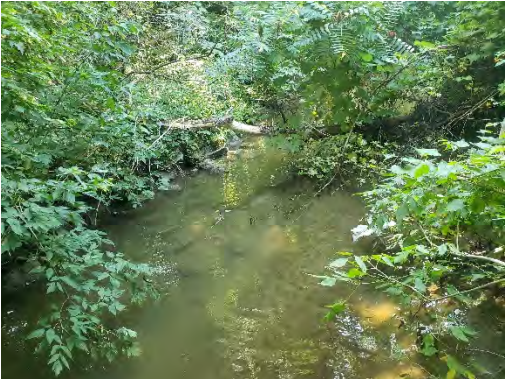
Culvert at the downstream extent of 8 th Concession.	Photograph taken upstream of the crossing at 8 th Concession. Upstream was narrower with sedimentation within the channel bed.

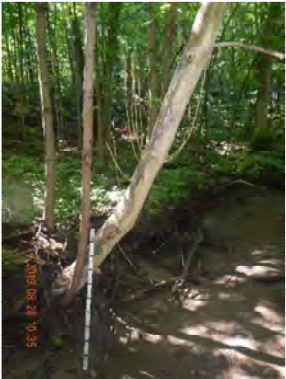
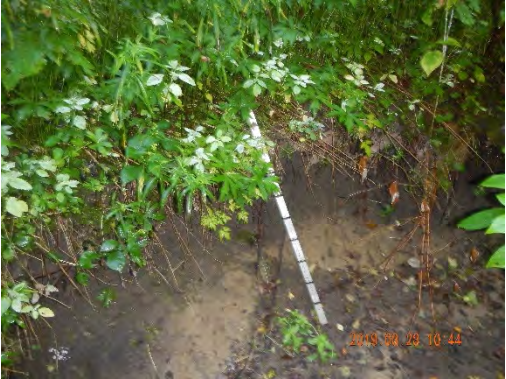
Leaning and j-trunk trees that were present along the reach. Note the exposed roots.		Exposed till located along the channel bank.

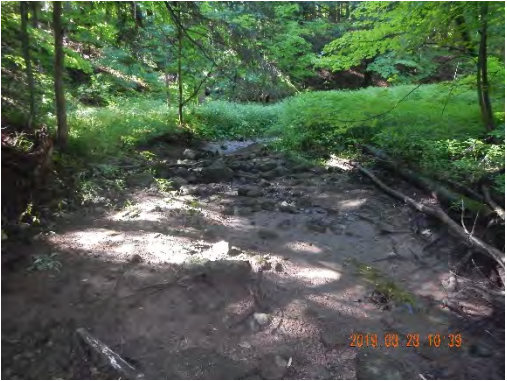
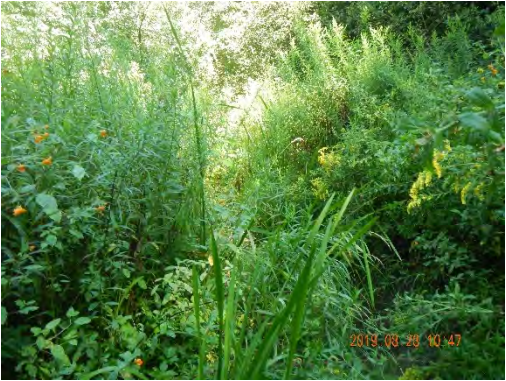
Cobbles and boulders were present within the channel. Note the woody debris located along the banks.		Upstream extent of the reach which became narrower, and heavily vegetated with grasses.

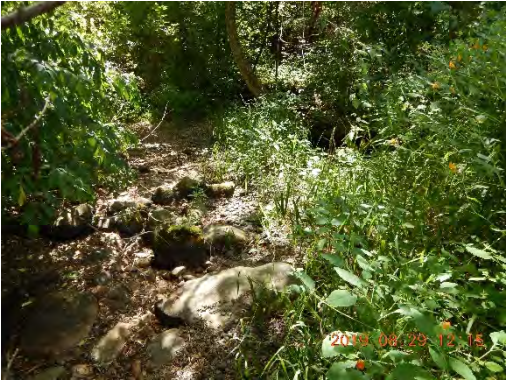
Reach HN2-3c downstream of 15 th Sideroad. The bed was comprised of sand, gravel, cobble, and boulders.	Photograph of the downstream culvert. There CSP at the downstream extent was degraded.

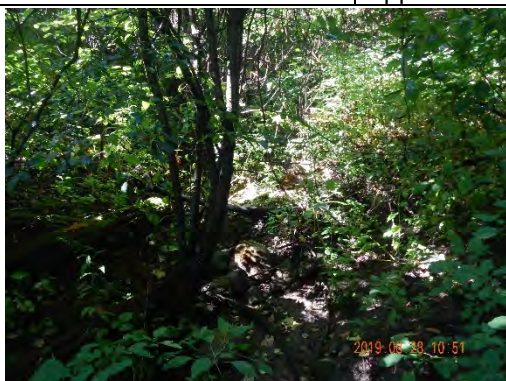
Downstream extent of the reach with cobbles and boulders present in channel. Note the vegetation growing within the channel.

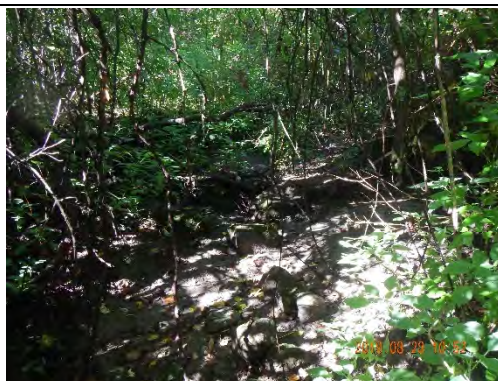
Woody debris present within the channel.

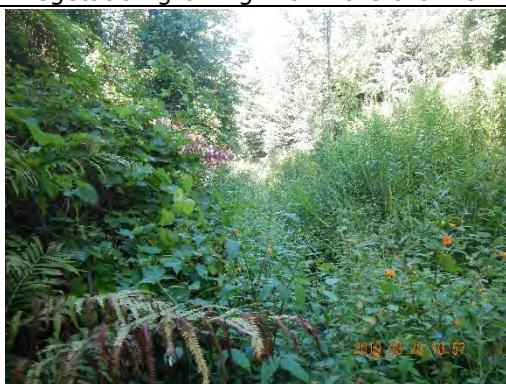
Portion of the reach directly upstream of the forested section. The channel became encroached and narrower with smaller grain sizes along the bed.

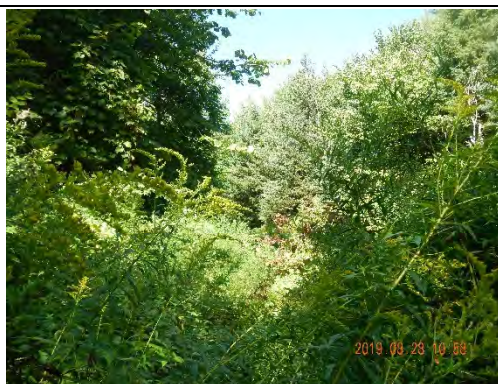
Upstream extent of the reach. The channel was still dry, narrow, moderately encroached with vegetation.

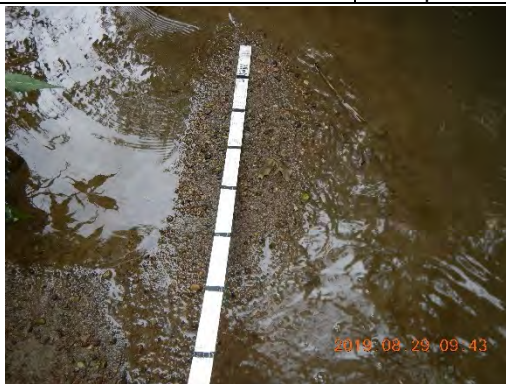
Medial bar present at the upstream extent of the reach.

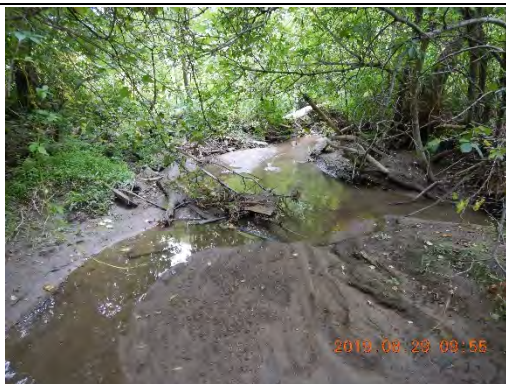
Photograph looking downstream at sand deposits within the channel.

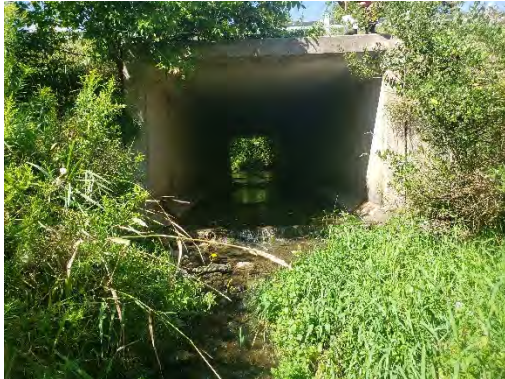
Photograph facing upstream at the downstream extent of the road crossing. Channel bed was lower than the box culvert.

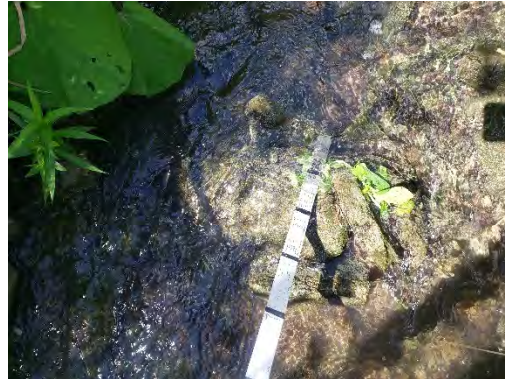
Riffle sequence downstream of the crossing. Riffle substrate consisted of sand, gravel, and cobble.

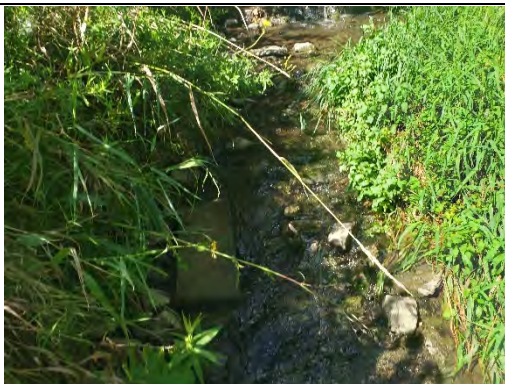
Photograph taken facing upstream. Bank undercutting measured to 0.05 m.

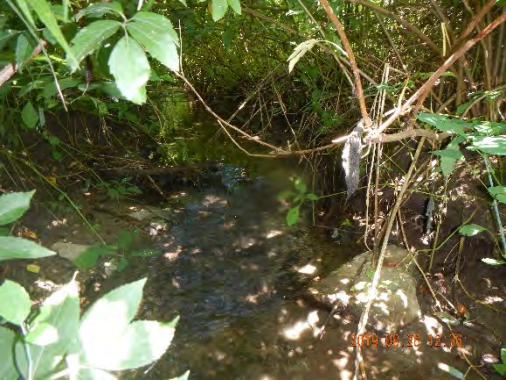
Photograph taken facing upstream from King Road.	Minor undercutting was noted at the downstream extent.

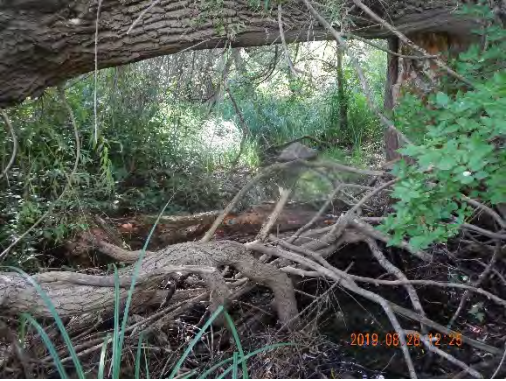
Reach became more encroached with grasses at the upstream extent of the reach.	Photograph taken facing downstream towards a large woody debris jam.

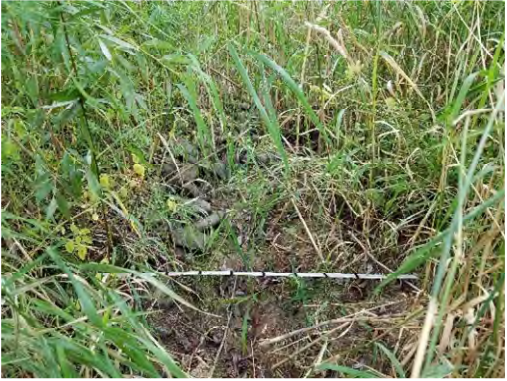
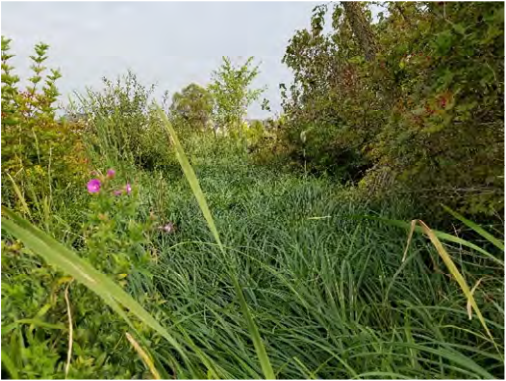
Photograph upstream of Parkheights Trail. Presence of rounded cobble indicate a possible natural channel design.	Photograph taken upstream of Parkheights Trail. Reach heavily encroached with grasses.

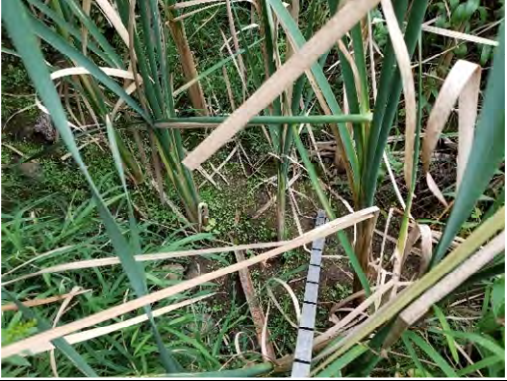
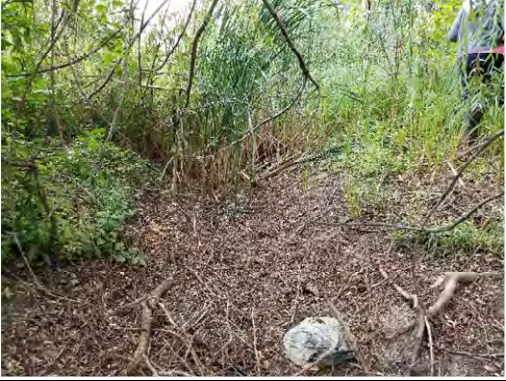
Photograph showing cattails and vegetation growing in channel upstream of Fairmont Ridge Trail.	Photograph taken near pond outlet. The channel was not well defined.

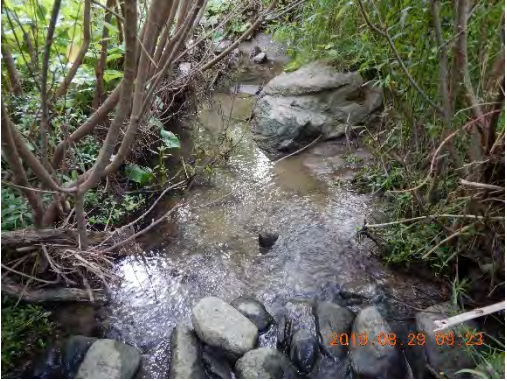
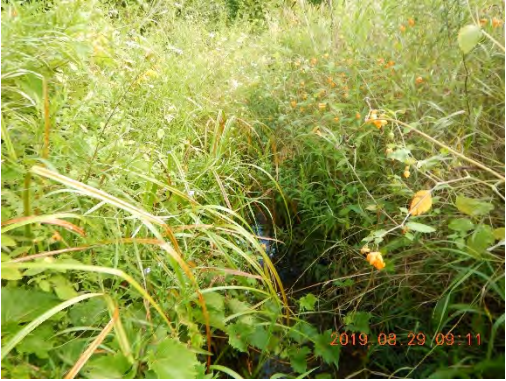
Boulder and large cobbles located within a riffle at the downstream extent of the reach.	The downstream extent of the reach was overgrown with vegetation.

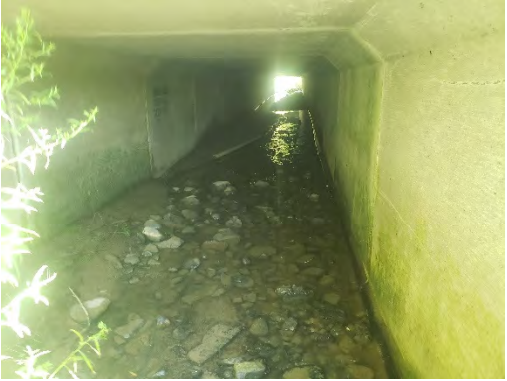
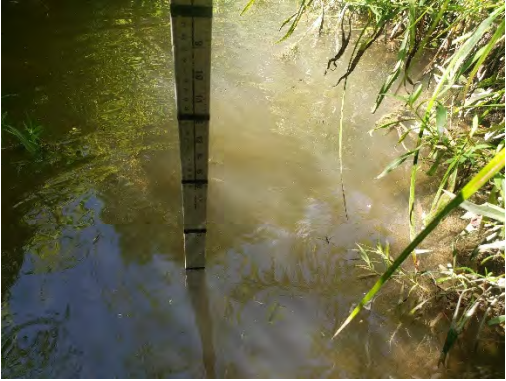
Culvert under Woodhill Avenue. Substrates consisted of cobble, gravel and sand.	Pool upstream of Woodhill Ave. Pool wetted depth was 0.30 m and pool bankfull depth was 0.65 m.

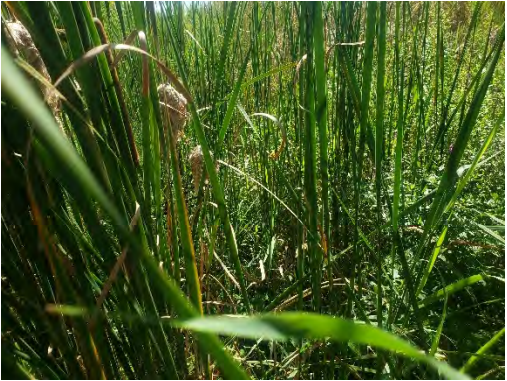
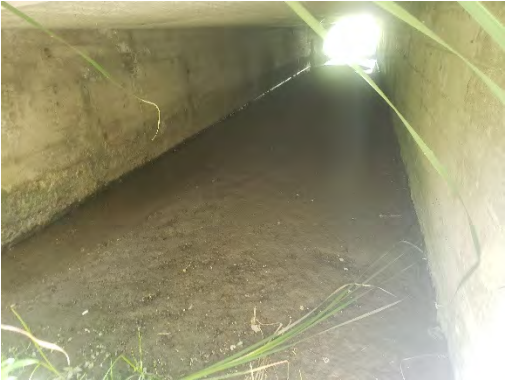
Downstream of culvert at King Road. Channel was not well defined.	Photograph taken facing upstream through box culvert under King Road.

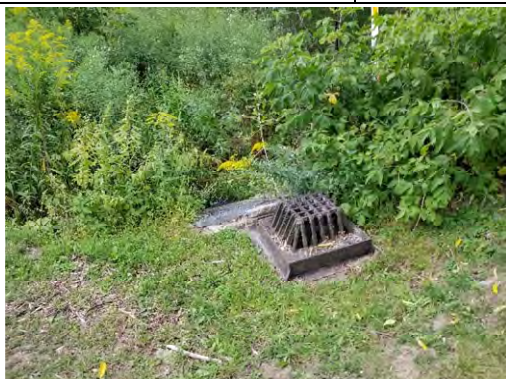
Reach **HN4-4** flowed into a catch basin. Reach **HN4-3** is piped to downstream of HWY 27.

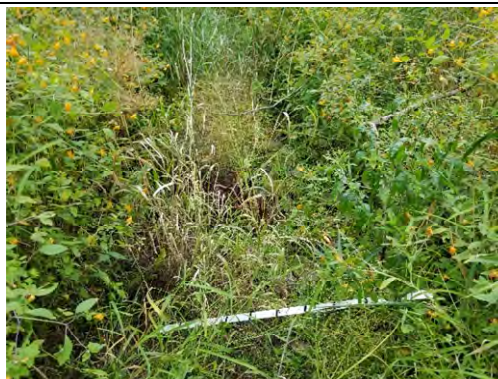
Photograph taken facing downstream. Reach was moderately encroached. The bed consisted of rounded river stone.

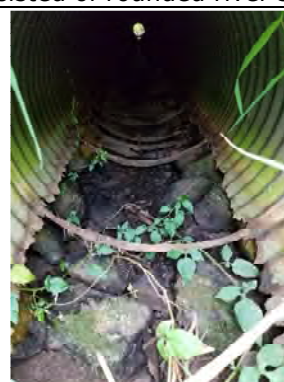
CSP at upstream extent of reach **HN4-4**. Note the degradation of the pipe.

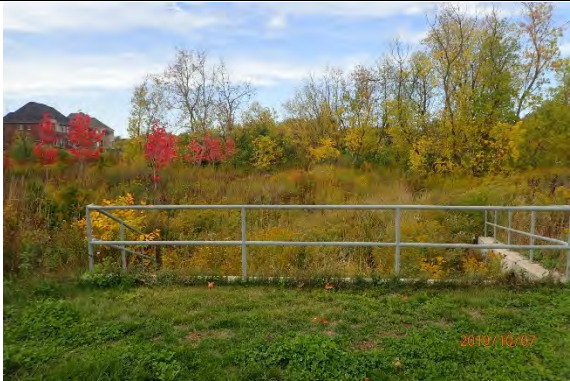
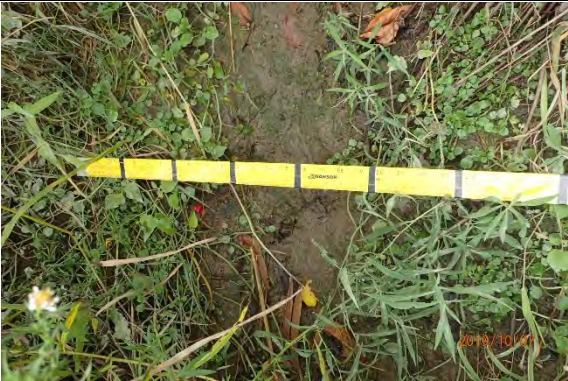
Photograph taken facing upstream from HWY 27. Wide riparian zone with mixed vegetation was observed.	A narrow swale feature was present with poor bank definition.

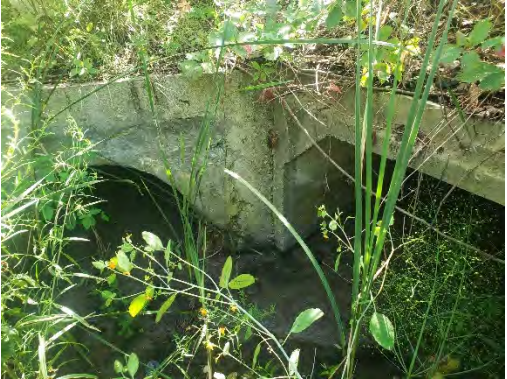
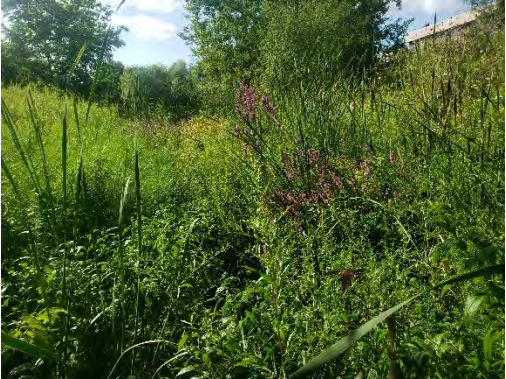
Double concrete culvert downstream of Robinson Road.	Channel upstream of Robinson Road. The channel was heavily vegetated with grasses and cattails.

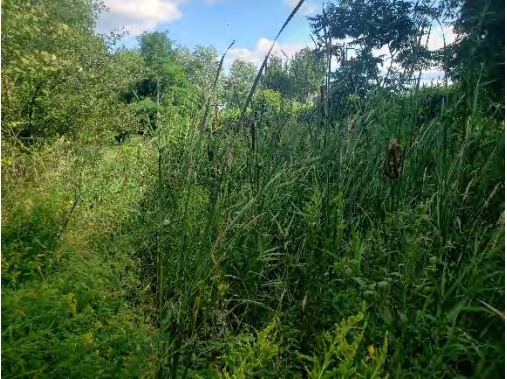
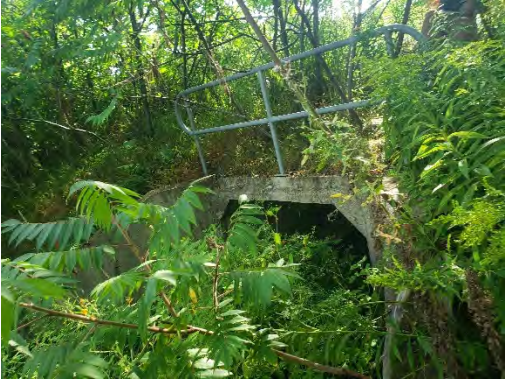
Downstream of Wilkie Avenue the channel was heavily vegetated with cattails.	Double concrete culvert upstream of Wilkie Avenue.

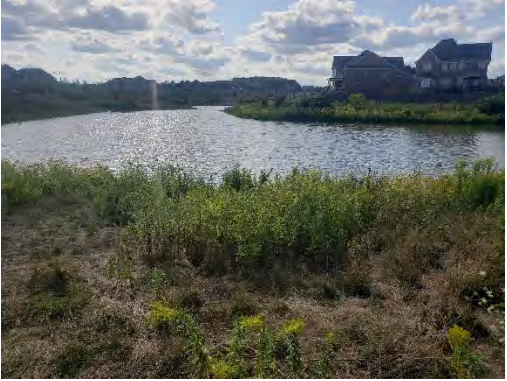
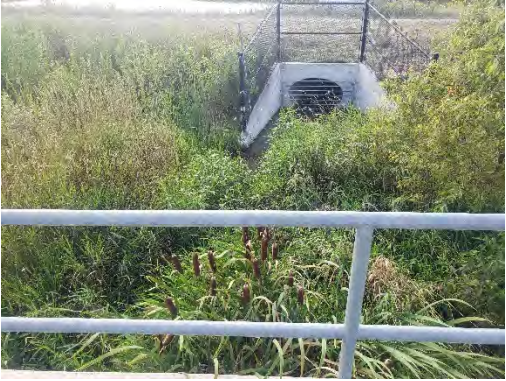
Photograph facing downstream at the pond which flows towards Highway 27.	Upstream of Highway 27. There was no flow between the outlet from the pond towards the culvert under Highway 27.

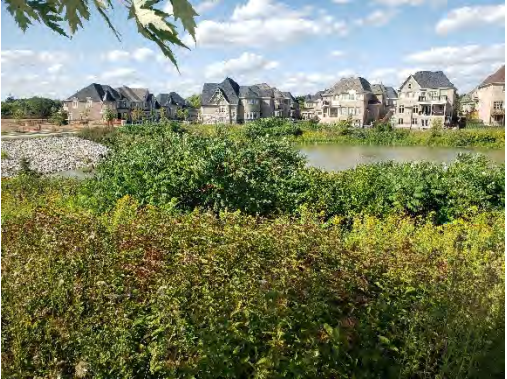
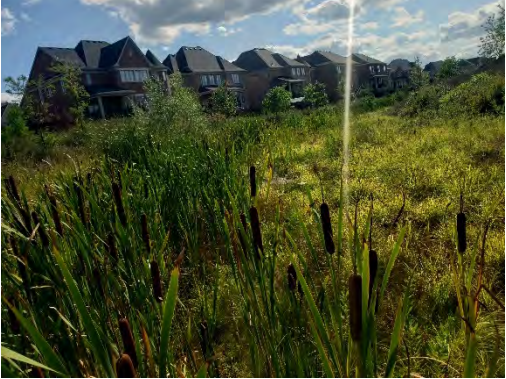
Reach HN7 flows into a pond, reach HN6 , downstream of Oliver Emerson Avenue.		Photograph taken upstream of the crossing at Oliver Emerson Avenue. Standing water and soft sediment was present within the channel.

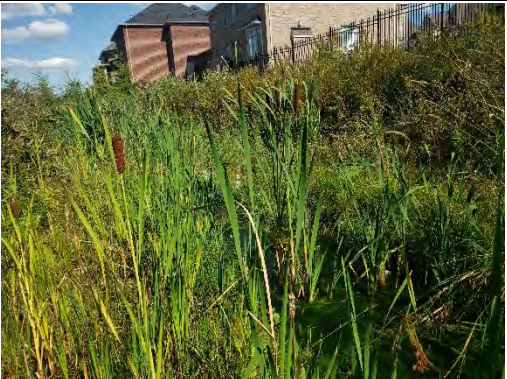
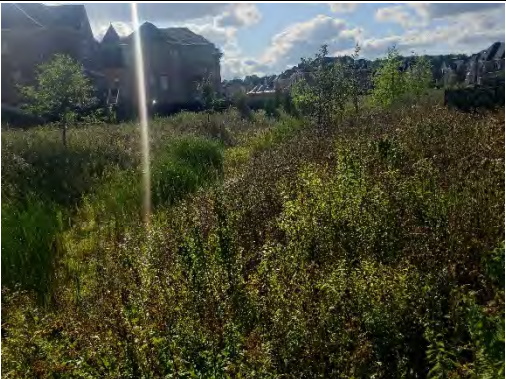
Photograph taken downstream of Starrett Street. Cattails were present throughout the reach.		Photograph taken facing upstream of Starrett Street.

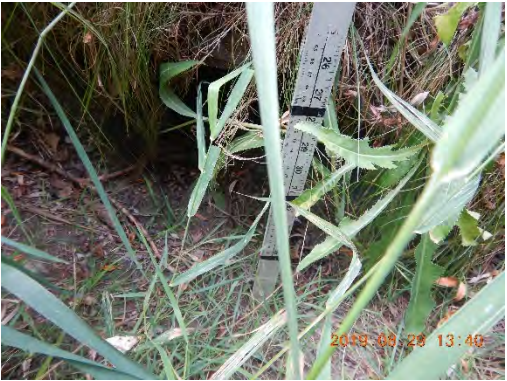
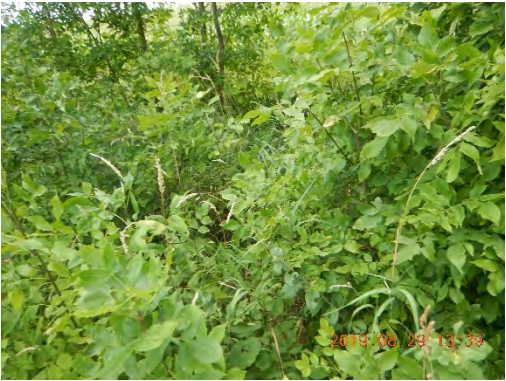
Reach HN8

Pipe downstream of 10 th Concession. Pipe and roadside were dry.		Undefined channel upstream of 10 th Concession.

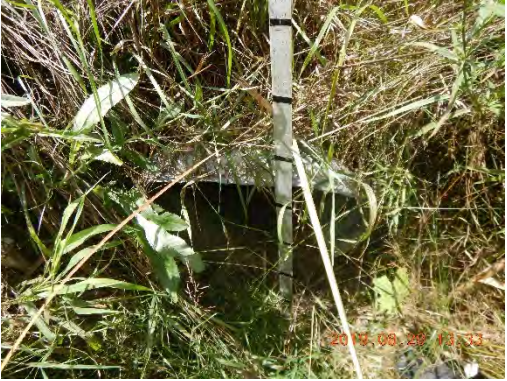
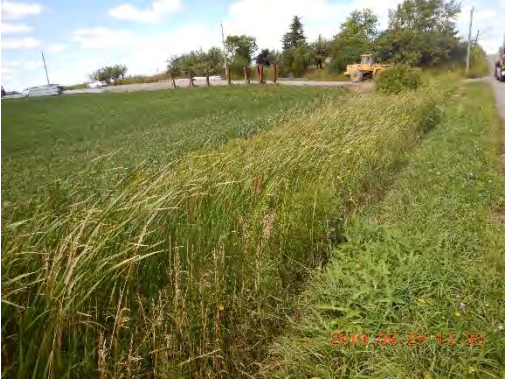
Reach HN10

CSP under 10 th Concession. Channel was dry and vegetated with cattails.		Roadside ditch both upstream and downstream of the road crossing.

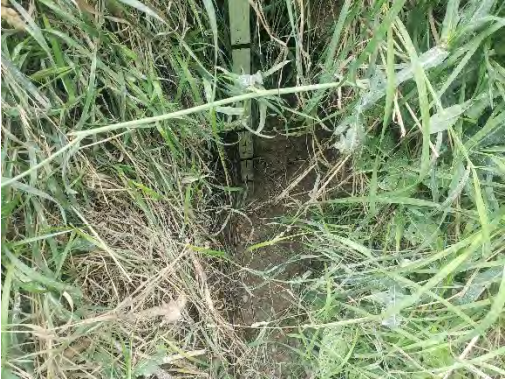
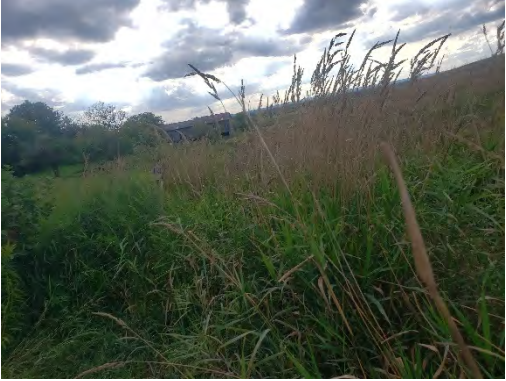
Reach HN11

Pipe upstream of road crossing. The channel was dry at the time of assessment.	Undefined channel downstream of road crossing. Channel was overgrown with grasses.

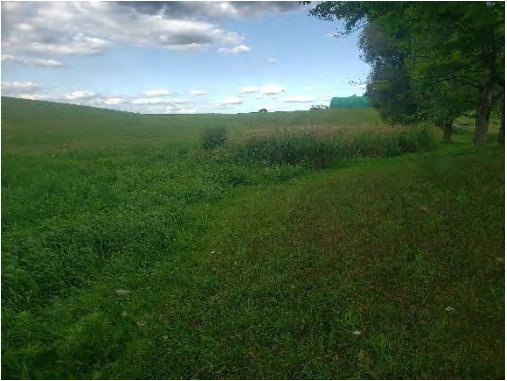
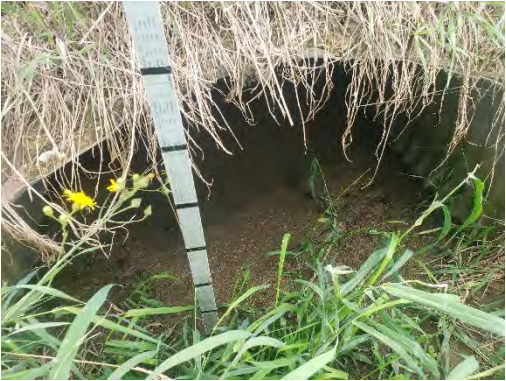
Reach HN12

Upstream of 10 th Concession. Heavily vegetated swale feature.	CSP under 10 th Concession. The channel was dry but there was some water inside the pipe.

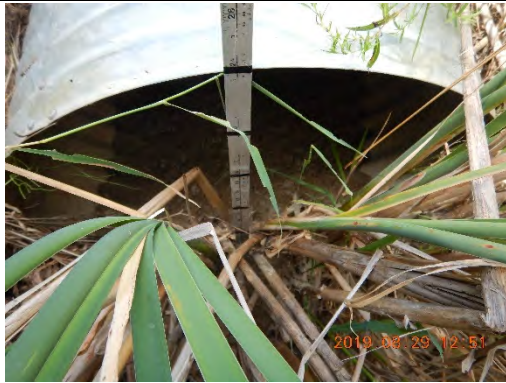
CSP downstream of 8th Concession. The channel was dry at the time of assessment.

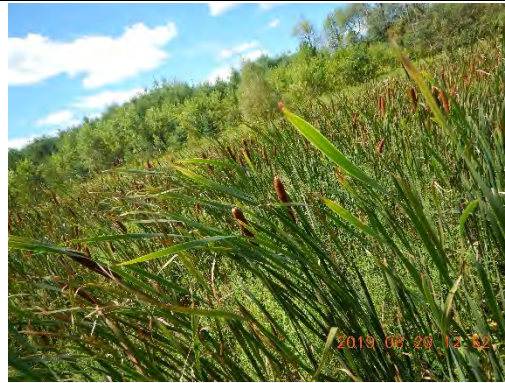
Photograph facing upstream of 8th Concession. The reach had cattails growing in the poorly defined channel.

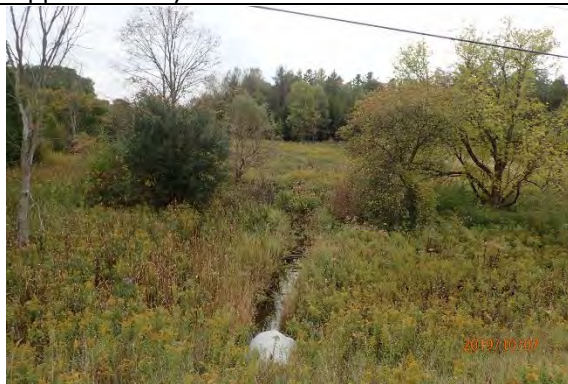
Photograph taken facing upstream from Lloydtown/Aurora Road. The riparian buffer zone was wide.

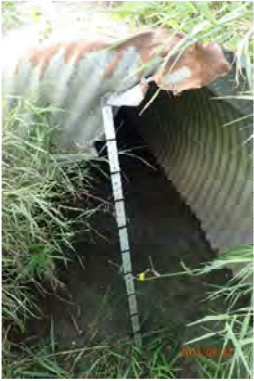
Reach WHP1a

Damage CSP at road crossing. The channel was dry at the time of assessment.		The channel was heavily encroached with grasses, offering little bank definition.

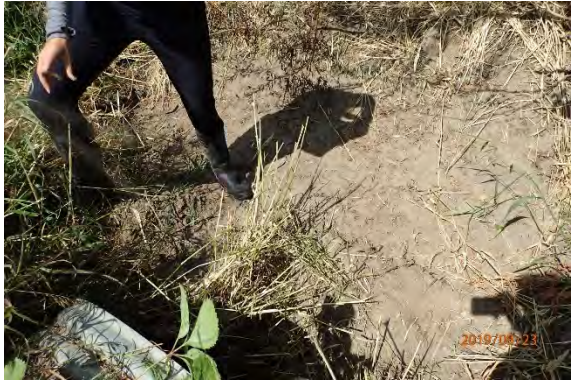
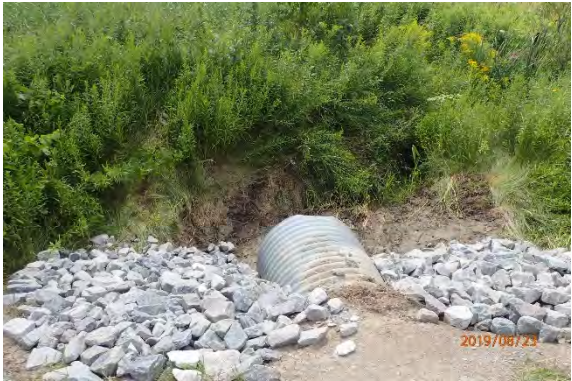
Reach WHP1-1 and Reach WHP1-2

Reach WH1-1 downstream of 18 th Sideroad. Feature was also undefined. Recent excavation of the roadside ditch.	Reach WHP1-2 upstream of 18 th Sideroad. The reach consisted of an undefined channel which passed through an agricultural field.

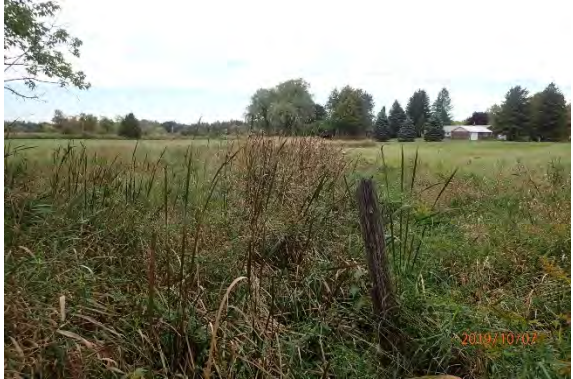
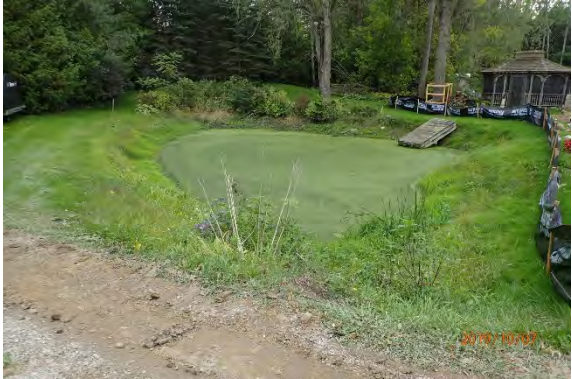
Reach WHP2 and Reach WHP2-1

Reach WH2 downstream of Birds Lane consisted of a swale feature. The swale was dry, vegetated with cattails, and moderately entrenched. Manicured lawns were noted to the top of bank.	Reach WHP2-1 upstream of Birds Lane consisted of a pond. The water levels in the pond were much lower than the CSP crossing the road.

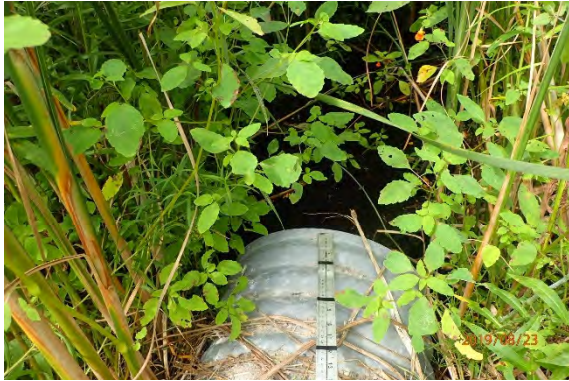
Photograph taken upstream of the crossing. The channel had cattails growing on the bed and grasses on the banks.

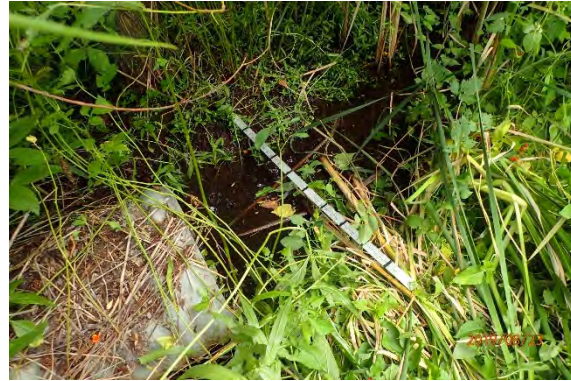
Downstream of the crossing. Both upstream and downstream the reach resembled a wetland feature.

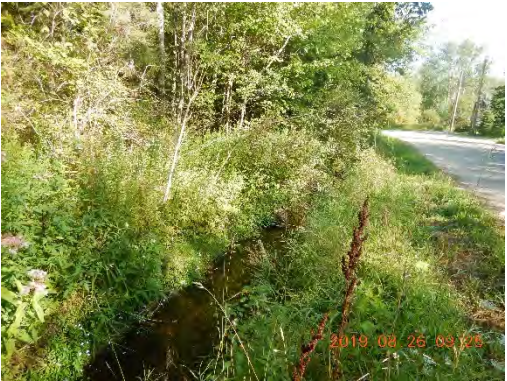
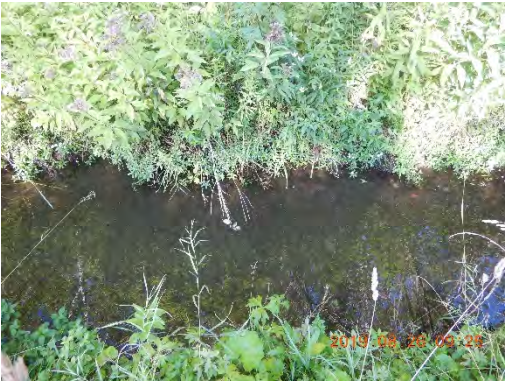
Reach WHP3

Photograph facing upstream of the reach. The reach was confined in a ditch beside 7 th Concession.	Bed substrates consisted of sand and gravel. The reach was uniform in width along the road.

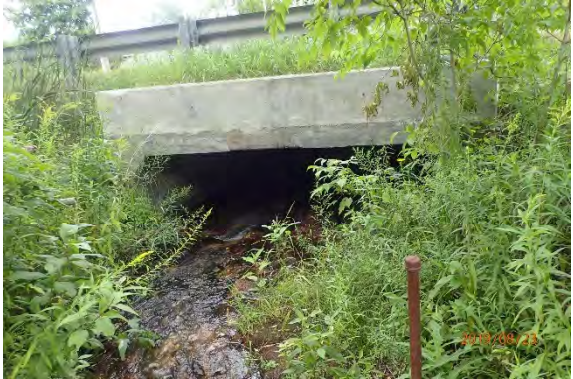
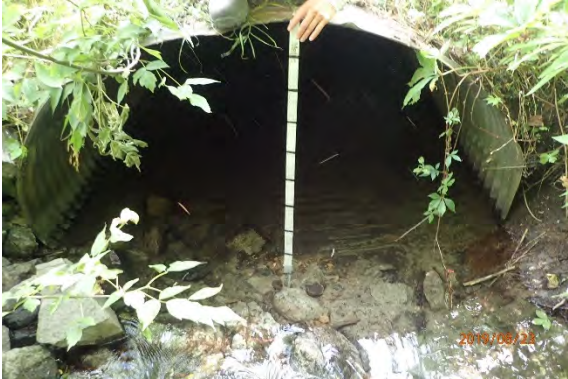
Concrete box culvert upstream of Lloydtown/Aurora Road. No access downstream of crossing.	CSP under 7 th Concession.

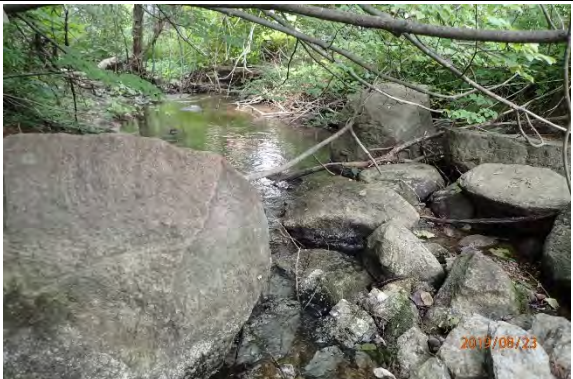
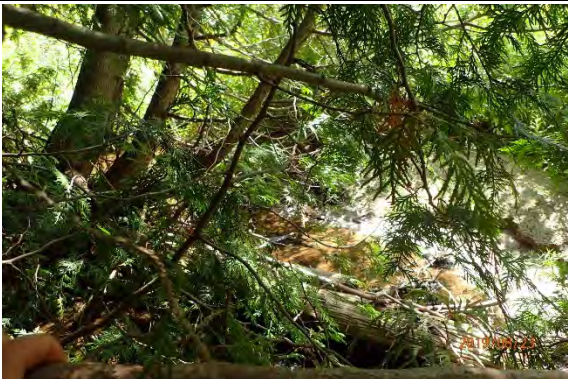
Downstream of 7 th Concession. The channel had a dense canopy cover of hedges and trees.	Upstream of 7 th Concession. The channel was less urbanized, with low bank angles.

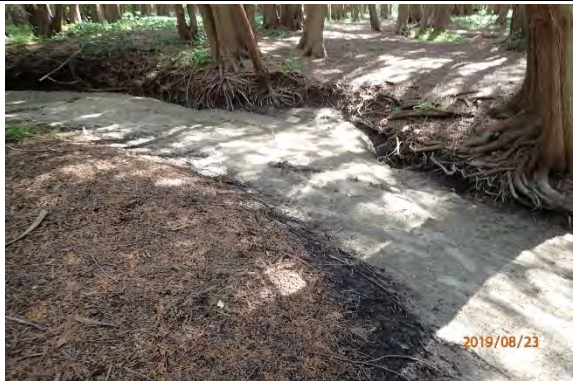
Abandoned channel (oxbow) that has been filled in with sand.	Photograph facing downstream approaching 18 th Sideroad. There was a moderate density of woody debris in the channel.

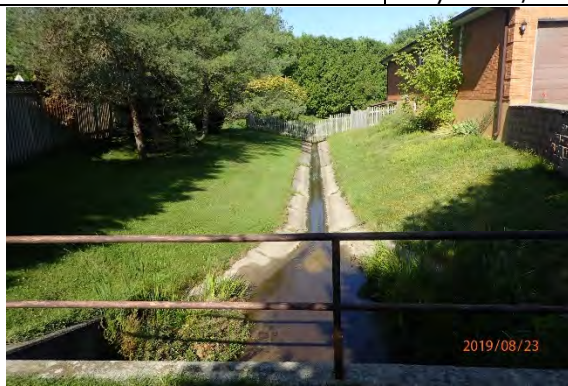
The reach was a concrete channel downstream of Archibald Road.

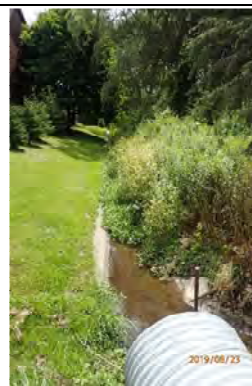
Photograph taken upstream of Lloydtown/Aurora Road.

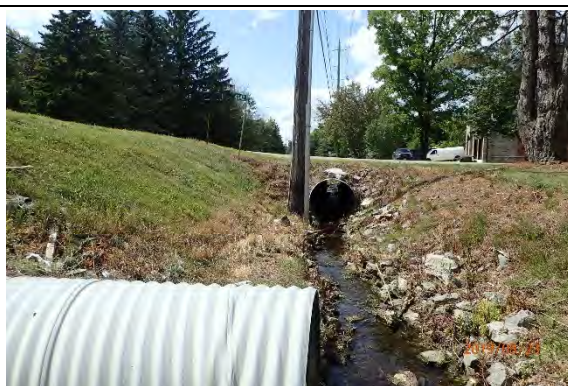
Downstream of Lloydtown/Aurora Road. The channel flowed through roadside ditch which passed under driveways.

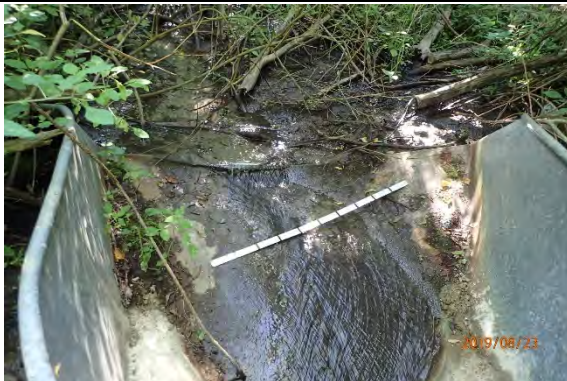
Photograph looking upstream at Cook Drive. The channel had poor bank definition.

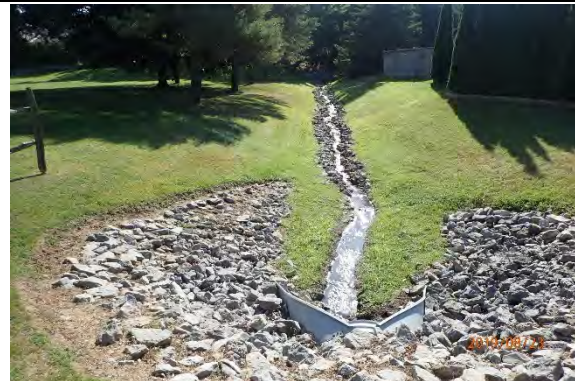
Reach channelized upstream of Cutting Crescent.

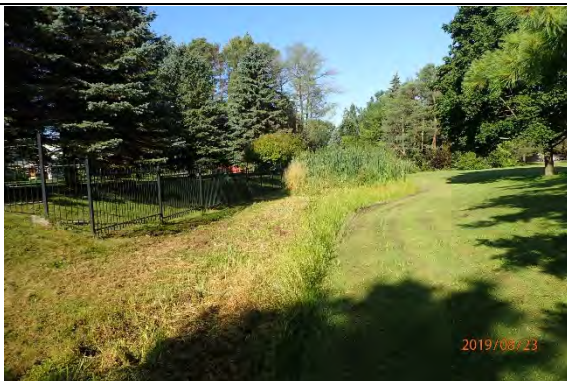
Downstream Cutting Crescent. Poorly defined swale feature which was heavily encroached with grasses. Note cattails further downstream.

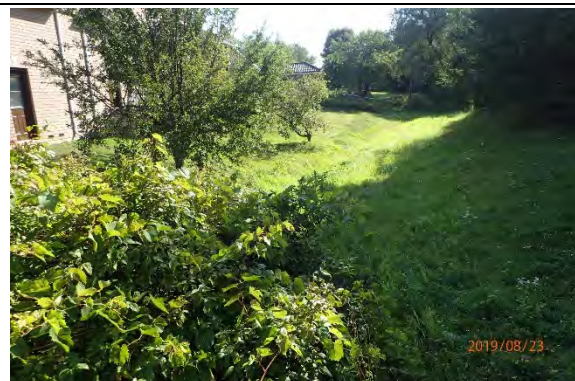
Upstream of Archibald Road. The swale continued to be poorly defined and heavily encroached with grasses.

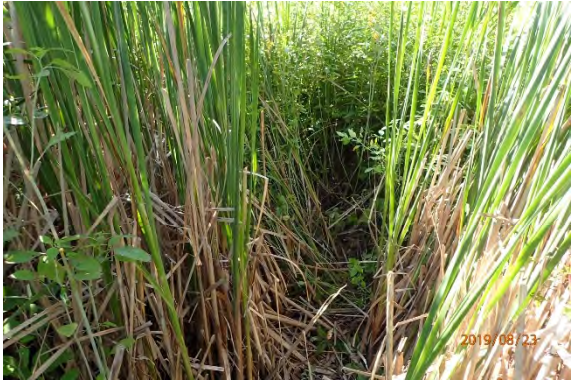
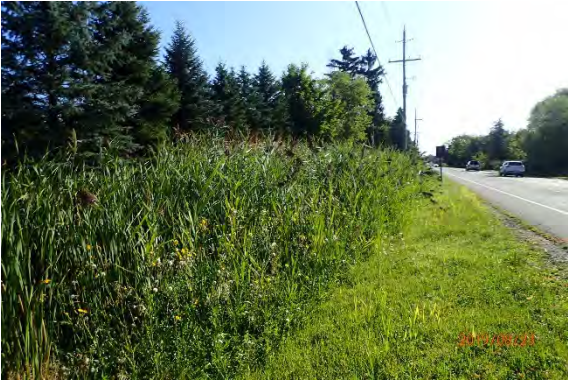
Reach WHP6-2

The channel was dry and poorly defined.		View of the channel from the road. Note the large quantity of cattails growing within the channel.

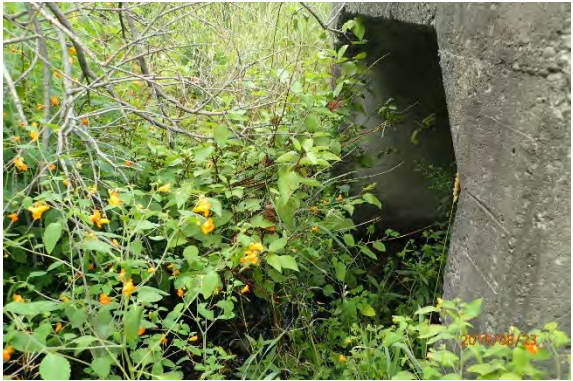
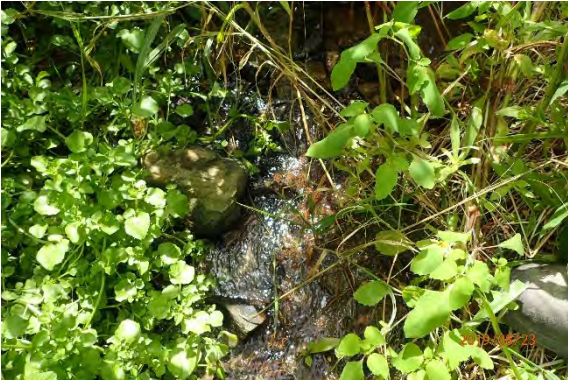
Upstream Lloydtown/Aurora Road. Confluence of both WHP7-3 and WHP7-a .	Upstream Lloydtown/Aurora Road - Reach WHP7-3 .

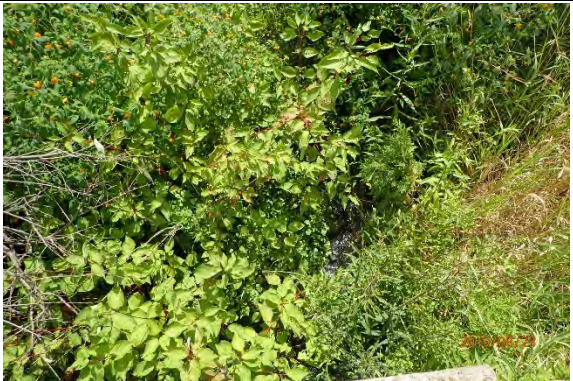
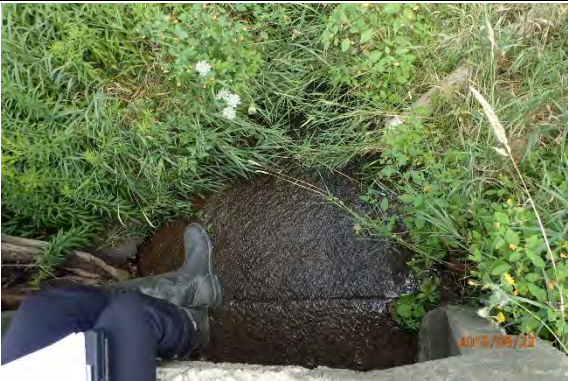
Upstream Lloydtown/Aurora Road - Reach WHP7-3a .	Downstream Lloydtown/Aurora Road – Reach WHP7-2 .

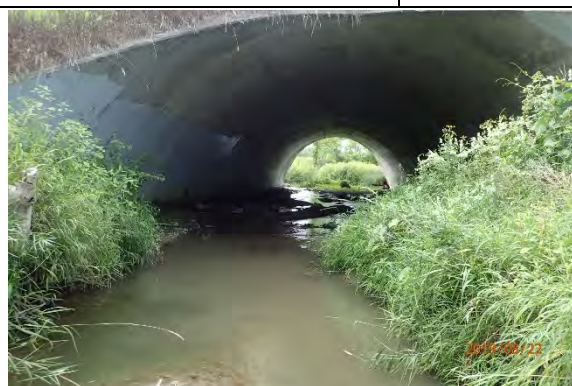
Photograph facing downstream at the downstream extent of the reach towards the crossing at Highway 9.

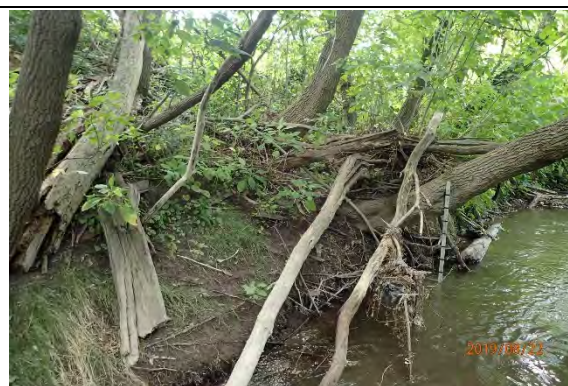
Leaning trees and exposed roots along the bank. Note the woody debris present along the banks and in the channel.

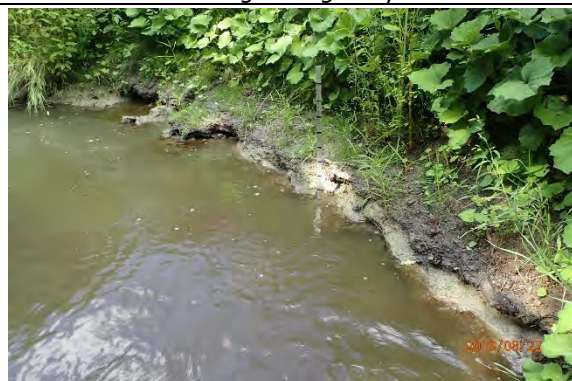
Exposed till located along the channel bank on the outside of a meander bend. There was also till located in pools.

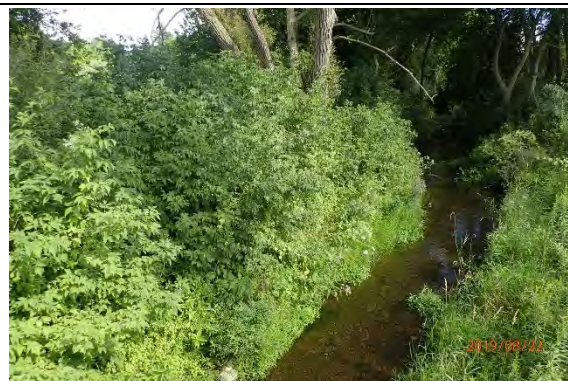
Downstream of the pedestrian bridge crossing. The banks were heavily vegetated with shrubs.

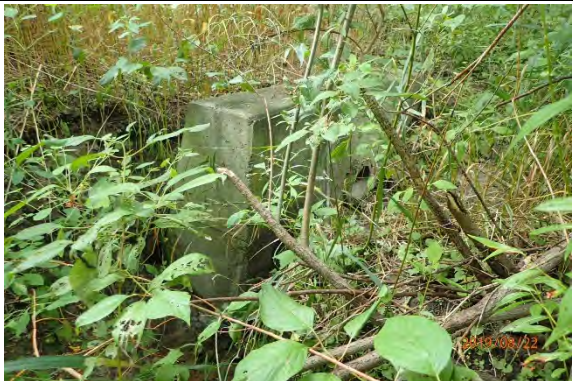
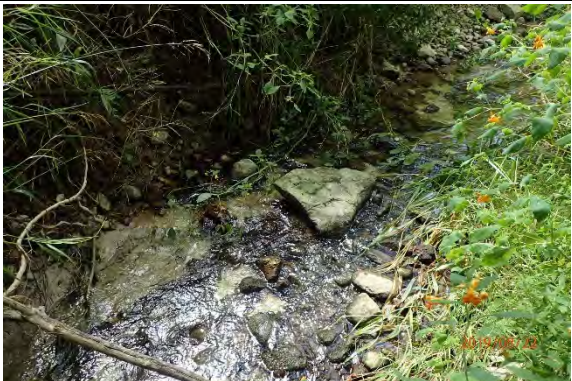
A slump occurred in front of a headwall, partially blocking the outlet.	Riffle sequence with substrates consisting of sand, gravel, cobble, and exposed till.
