Reach WHSL6

Location: Church Street, Lloydtown	Watershed: Humber River	Type of Assessment: Roadside
Valley Type: Unconfined	Land use: Residential	Riparian Coverage: Fragmented trees and grasses
Bankfull Width (m): 5.75	Bankfull Depth (m): 1.08	Bed Substrate: Clay, silt, and sand
RGA Score: N/A	RGA Condition: N/A	RGA Dominant Process: N/A
RSAT Score: N/A	RSAT Condition: N/A	RSAT Limiting Feature: N/A
Down's Channel Evolution: N/A	Notes: Roadside assessment at Church Street and Centre Street. Soft sediment accumulation from downstream pond. No erosion concerns visible from either road crossing.

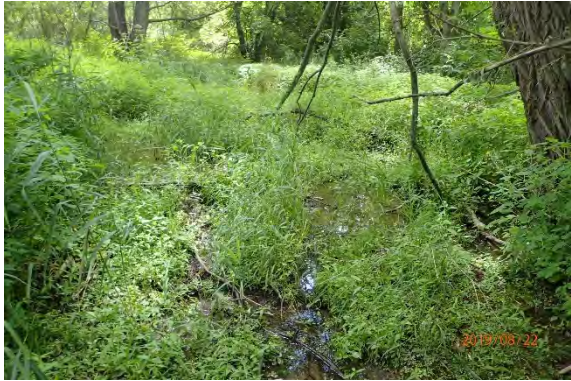
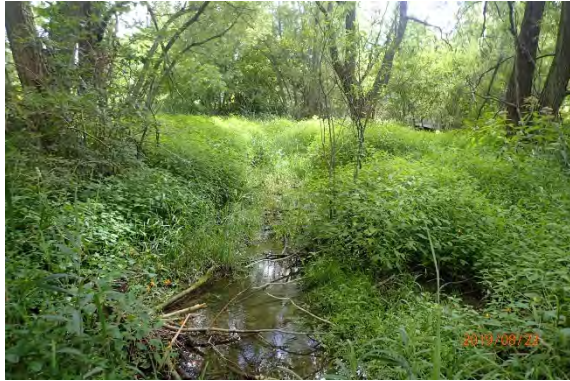
Photograph facing upstream. The reach had poor bank definition and was moderately encroached.	Photograph taken facing upstream. There was no riffle-pool development and no meanders.

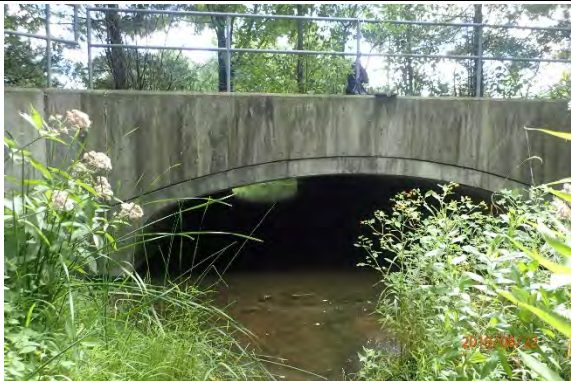
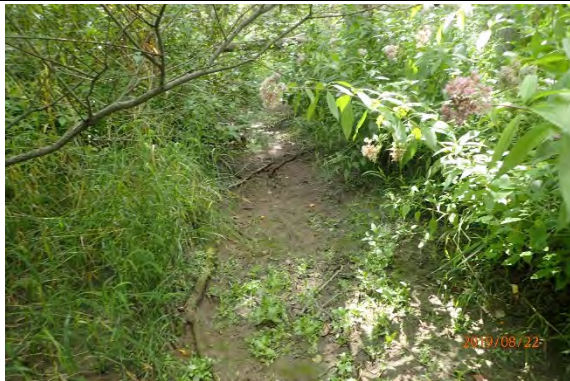
Photograph taken facing upstream towards crossing at Roselena Drive.	Reach was dry and less defined upstream of Roselena Drive.

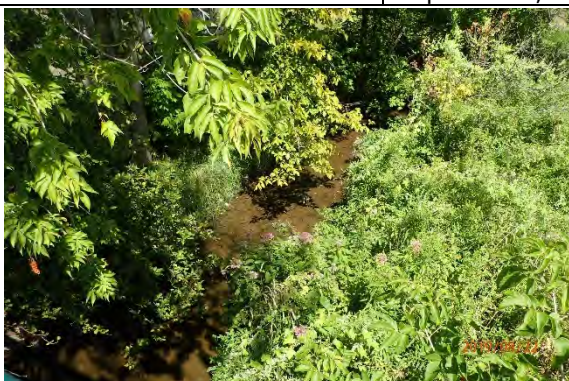
Photograph taken facing downstream from Main Street crossing. There was riprap on both banks.

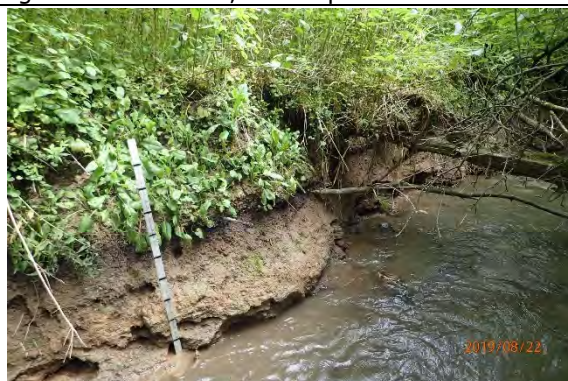
Eroded bank causing leaning and fallen trees.

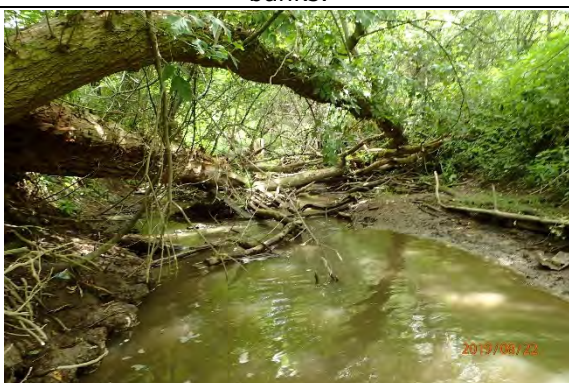
Photograph taken facing downstream towards a woody debris jam.

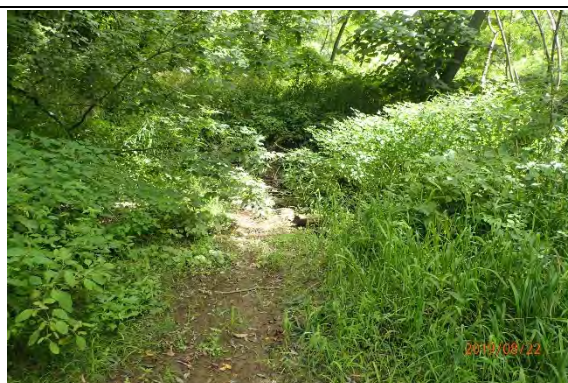
Photograph taken facing downstream of an abandoned channel – evidence of planform adjustment.

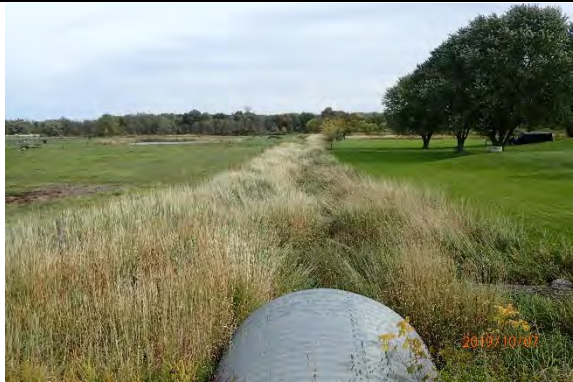
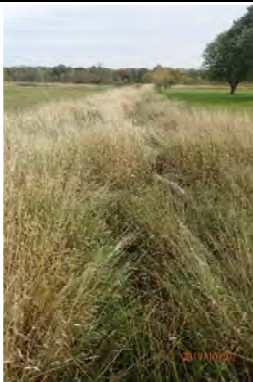
Downstream of 8 th Concession. The riparian zone was narrower downstream.		Downstream of 8 th Concession. The reach was heavily encroached with grasses.

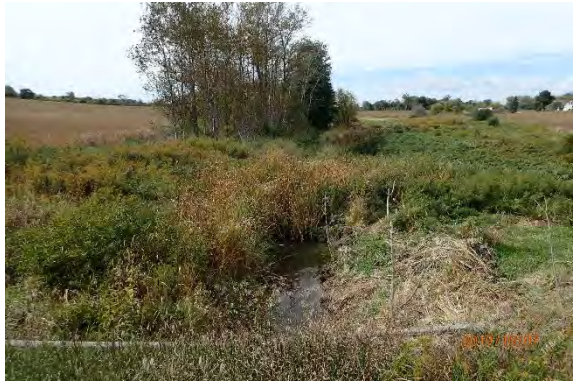
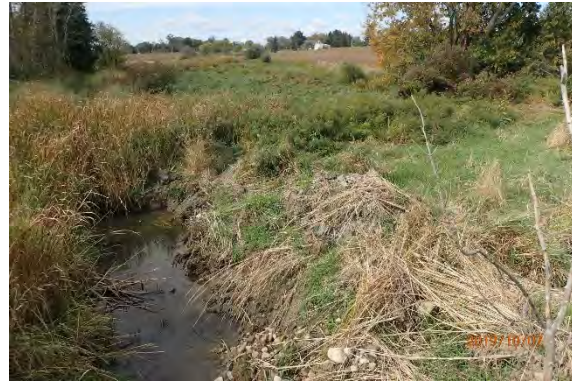
Upstream of 8 th Concession. A swale feature with a wider riparian zone was observed.		Upstream of 8 th Concession. Recent excavation for only 10 m upstream of the crossing was noted.

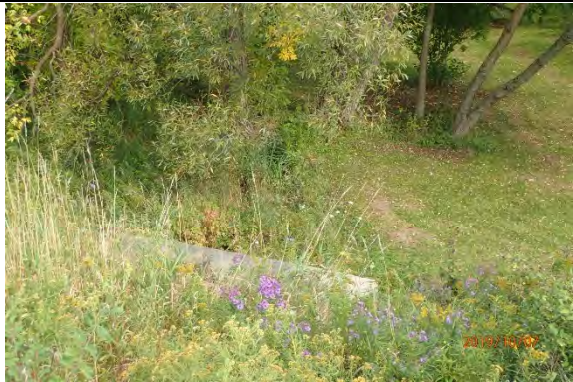
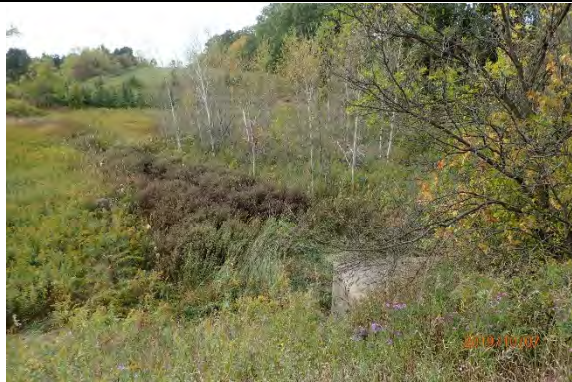
Photograph taken facing downstream of HWY 27. A narrow swale feature with manicured lawns to the top of bank was observed.	Photograph taken facing upstream of HWY 27. A swale feature with a wider riparian zone was observed.

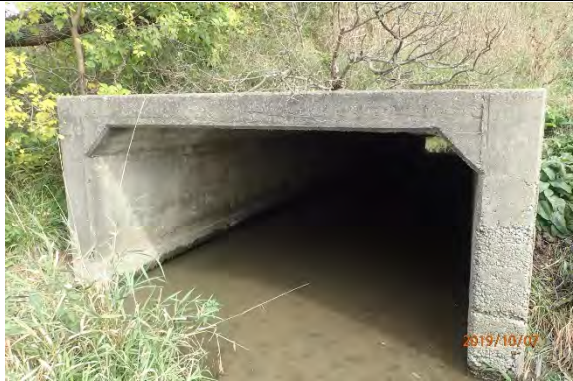
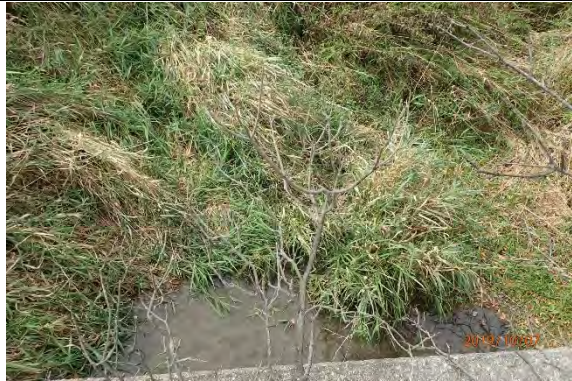
Upstream of HWY 27. Water was only present within the box culvert. No erosion concerns were noted.	Upstream of HWY 27. No defined channel or depression was observed upstream of the crossing.

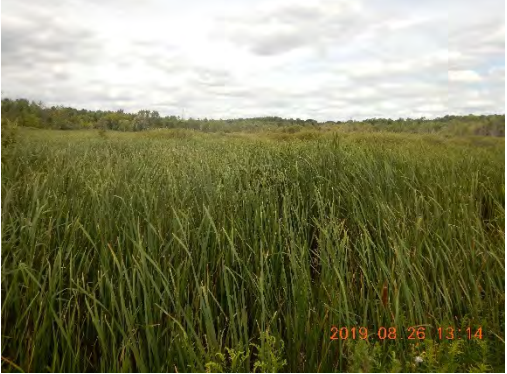
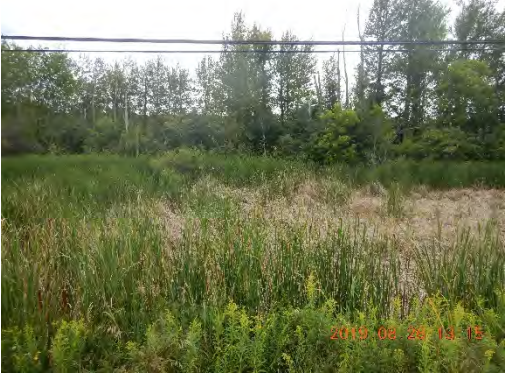
Wetland feature downstream of Wellington Street West.		Wetland feature upstream of Wellington Street West. There were fewer cattails but still no channel definition.

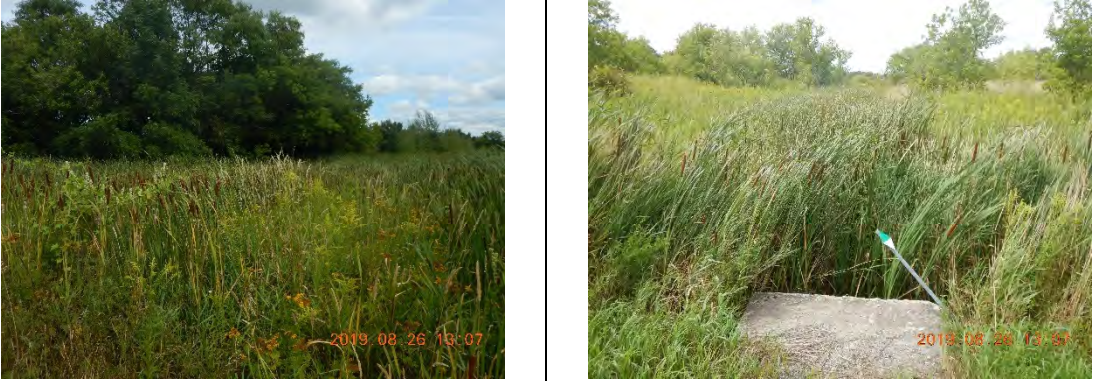
Wetland feature downstream of Dufferin Street.	Wetland feature upstream of Dufferin Street. There was a box culvert passing under Dufferin Street.
