APPENDIX P

Facility Condition Assessments

Component Inspection Report

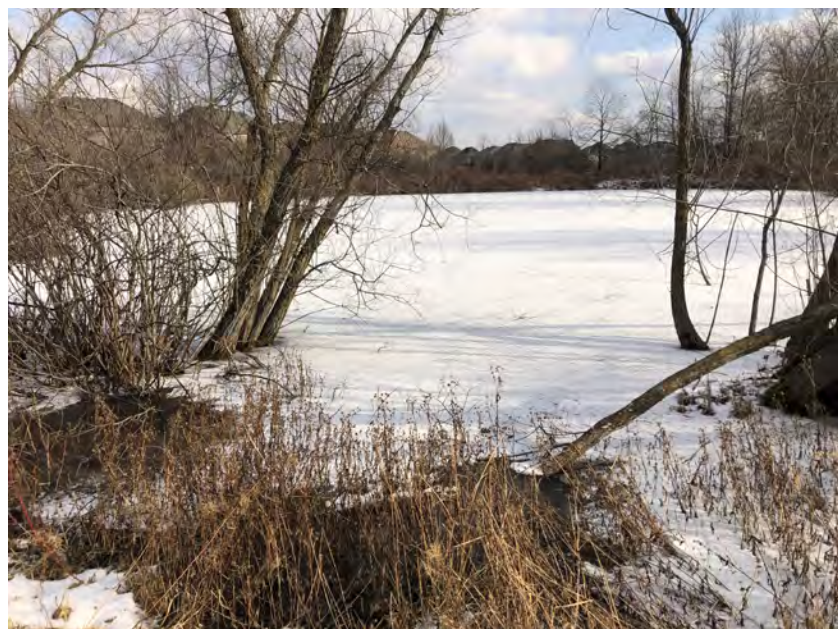
| Component Name | Condition | Inspector | Inspection Date | Comments |
|---|---|---|---|--|
| INLET_01 | Attention Required | HS | 2019-12-11 | Structurally, the inlet head wall is in good condition. Functionally, the inlet is submerged 90%. There is significant sediment build up at the inlet as well. |
| FACILITY_01 | Satisfactory | HS | 2019-12-11 | Flow path leading to main pond is in good condition. |
| FACILITY_02 | Satisfactory | HS | 2019-12-11 | The facility is in good condition. There is minor erosion points around the banks of the facility. This facility does not have a constructed outlet. The pond outlets through a small channel located on the east side of the facility. |
| OUTLET_01 | Satisfactory | HS | 2019-12-11 | The facility does not have a constructed outlet structure. All water flows downstream through a channel located on the east side of the facility and leads to a natural stream flowing east. Overall, the condition of the channel is good. There is some minor erosion along the banks of the outlet channel. |

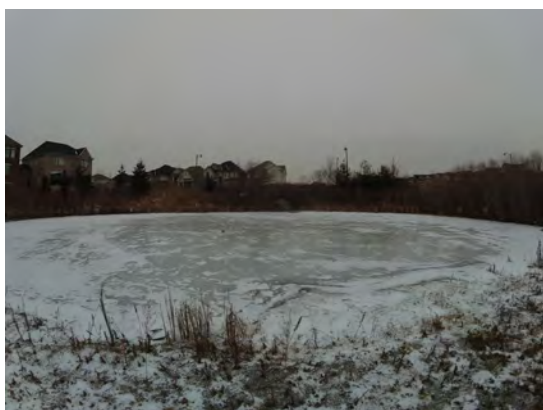
| Component Name | Condition | Inspector | Inspection Date | Comments |
|---|---|---|---|---|
| INLET_01 | Attention Required | HS | 2019-12-12 | Headwall structure is slightly damaged. Minor damage around bottom corners of headwall by pipe where water is entering the facility. Pipe and grate are in excellent condition. Baffle blocks are in good condition. Baffle on front left side is slightly damaged. Water level is normal and there is no sediment build up. Fence along top of headwall is slightly damaged. Fence is detached from pole connection. |
| FACILITY_01 | Satisfactory | HS | 2019-12-12 | Berm is in good condition. |
| OUTLET_04 | Satisfactory | HS | 2019-12-12 | Outfall structure into stream is in good condition. Grate is in good condition. Water level is at normal level. Slight erosion around outfall channel. |
| FACILITY_03 | Satisfactory | HS | 2019-12-12 | Overall, the facility is in very good condition. Water levels are normal. No significant areas with erosion. Hard to judge sediment level in pond due to frozen water but lack of sediment in outlet components shows no concerning sediment issues. |

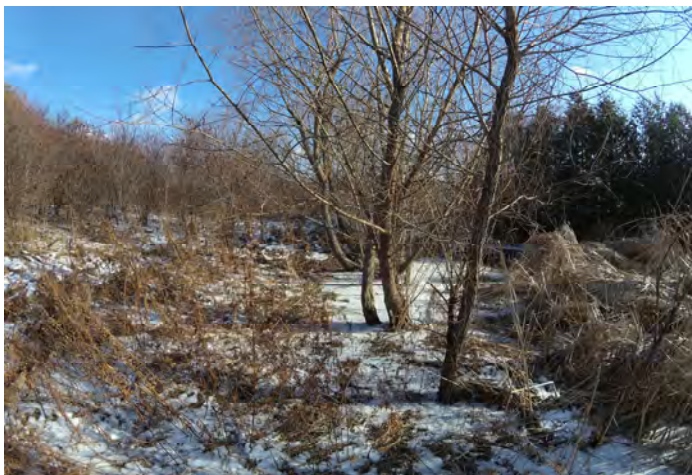
| Component Name | Condition | Inspector | Inspection Date | Comments |
|---|---|---|---|--|
| OUTLET_02 | Attention Required | HS | 2019-12-11 | Outlet pipe is in good condition. Tree is blocking the outlet pipe. Slight damage on the bottom right corner of the headwall. Water is leaking out the side of the headwall. Downstream outlet channel is in good condition. Slight erosion at the edges of the channel. |
| FACILITY_02 | Attention Required | HS | 2019-12-11 | Water level in pond is slightly high. General condition of the facility is good. No erosion around pond area. However, inlet sediment build up indicates high sediment levels in pond. |

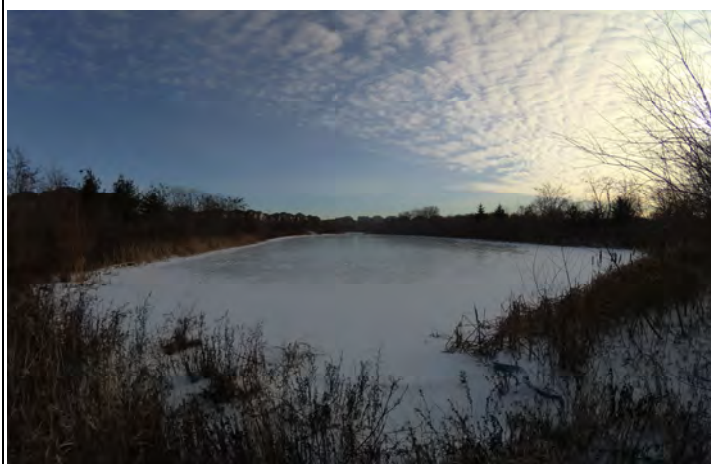
| Component Name | Condition | Inspector | Inspection Date | Comments |
|---|---|---|---|---|
| OUTLET_02 | Satisfactory | HS | 2019-12-12 | Outlet control maintenance hole structure is in good condition. There is no debris build up and no flow obstructions. |
| OUTLET_03 | Attention Required | HS | 2019-12-12 | The overall structural condition of the outfall headwall structure is good. There is a minor crack on the bottom left side of the outfall pipe. Minor ragging caught on the outfall grate. Minor vegetation growth in front of outfall structure. |
